Fire Review Report for the Island Mountain Property and Surroundings, Elko County, Nevada

Field Visit Performed on November 7-9, 2018

**Douglas C. Peters
President
ARNEVUT Resources Nevada LLC**

Report Date: November 20, 2018

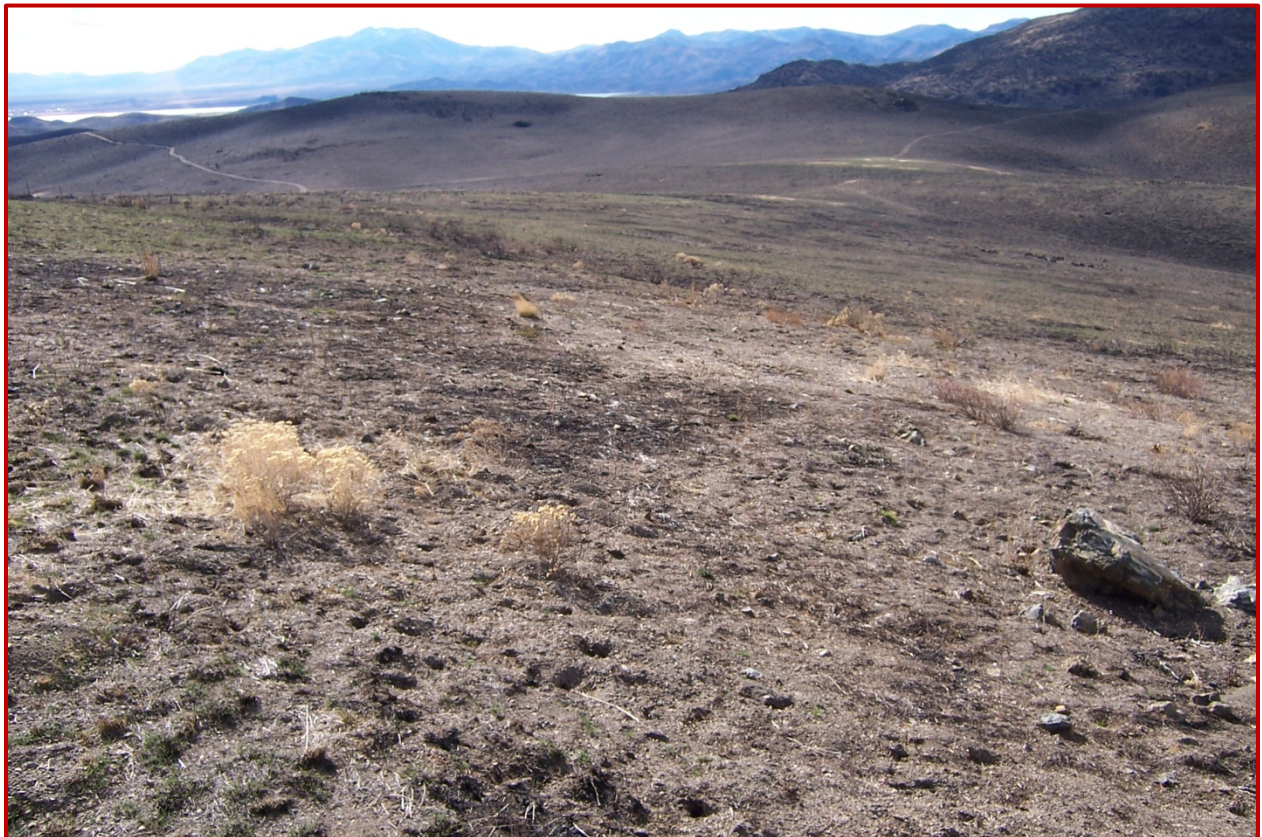
Figure 3. Drill site GG-NW2 looking southwest (drilled in 2012).

Drill site GG-NW2 (Figure 3) is burned in excess of 95%. Of interest is that grass sprouts were common to abundant in this area (visible as green in the foreground and in the background in Figure 3), so there should be significant ground cover in 2019 if the winter is sufficiently wet. There was little sage in this area originally, but any present before has been mostly (low blackened bushes in background) to fully burned. This site is on USFS land.

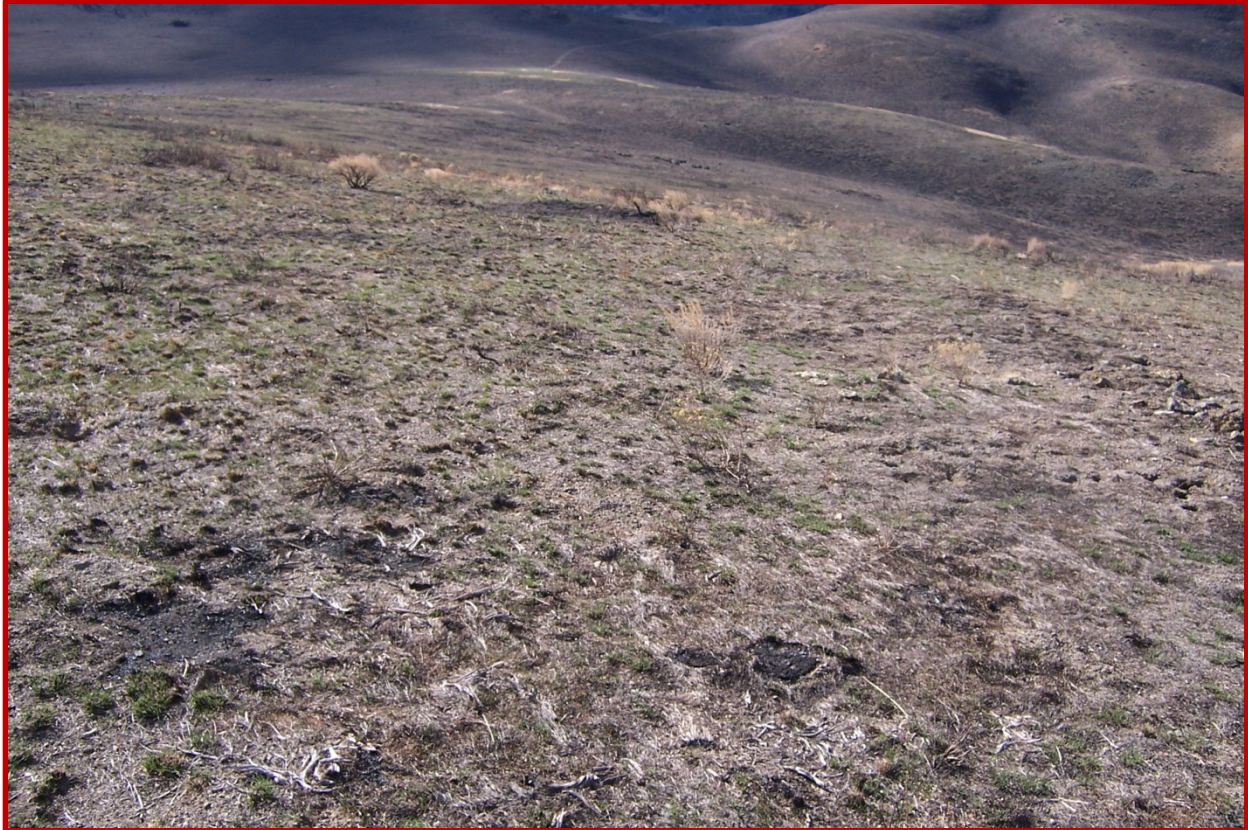
Figure 4. Accessway between GG-NW1 and GG-NW2 looking west from edge of GG-NW1.

The accessway from site GG-NW1 to GG-NW2 is partially seen in the foreground. This path also was burned in excess of 95%, but also shows new grass growth. The accessway closer to site GG-NW1 is shown in Figure 4. It likewise shows considerable grass growth since the fire.

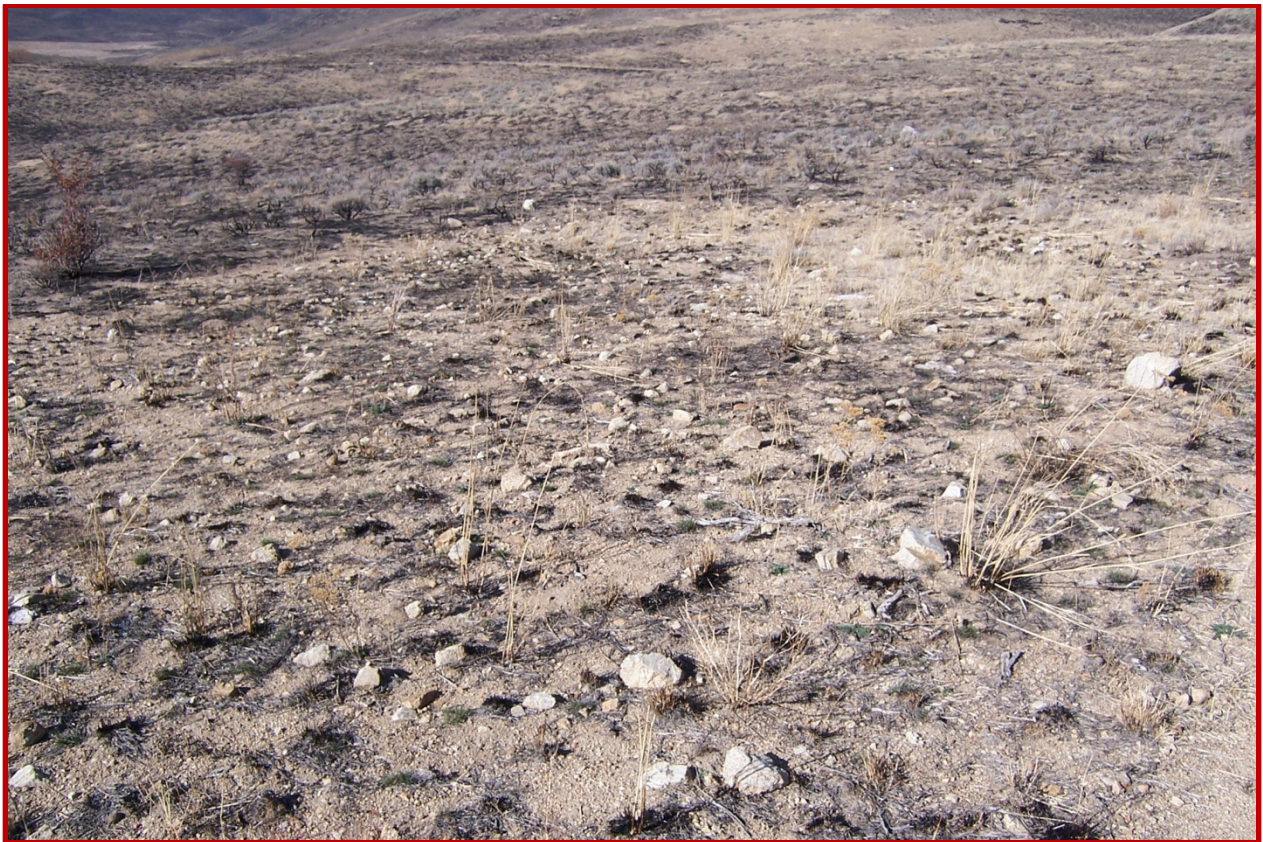
Figure 7. Drill site NE2 looking northwest (drilled in 2013).

Drill site NE2 (Figure 7) is burned approximately 70%. The fire must have moved through this area fairly quickly given that many clumps of vulnerable dry grass remained untouched. Very scattered new grass sprouts were apparent, but presumably the unburned grasses will regrow normally in 2019. There did not appear to have been significant growth of shrubs at this site following revegetation work in late 2013. The natural small shrubs in the background in Figure 7 appeared to have largely scattered fire impacts. This is in keeping with the patchy nature of the burned area as the fire progressed to the east within the project area. This site is on USFS land.

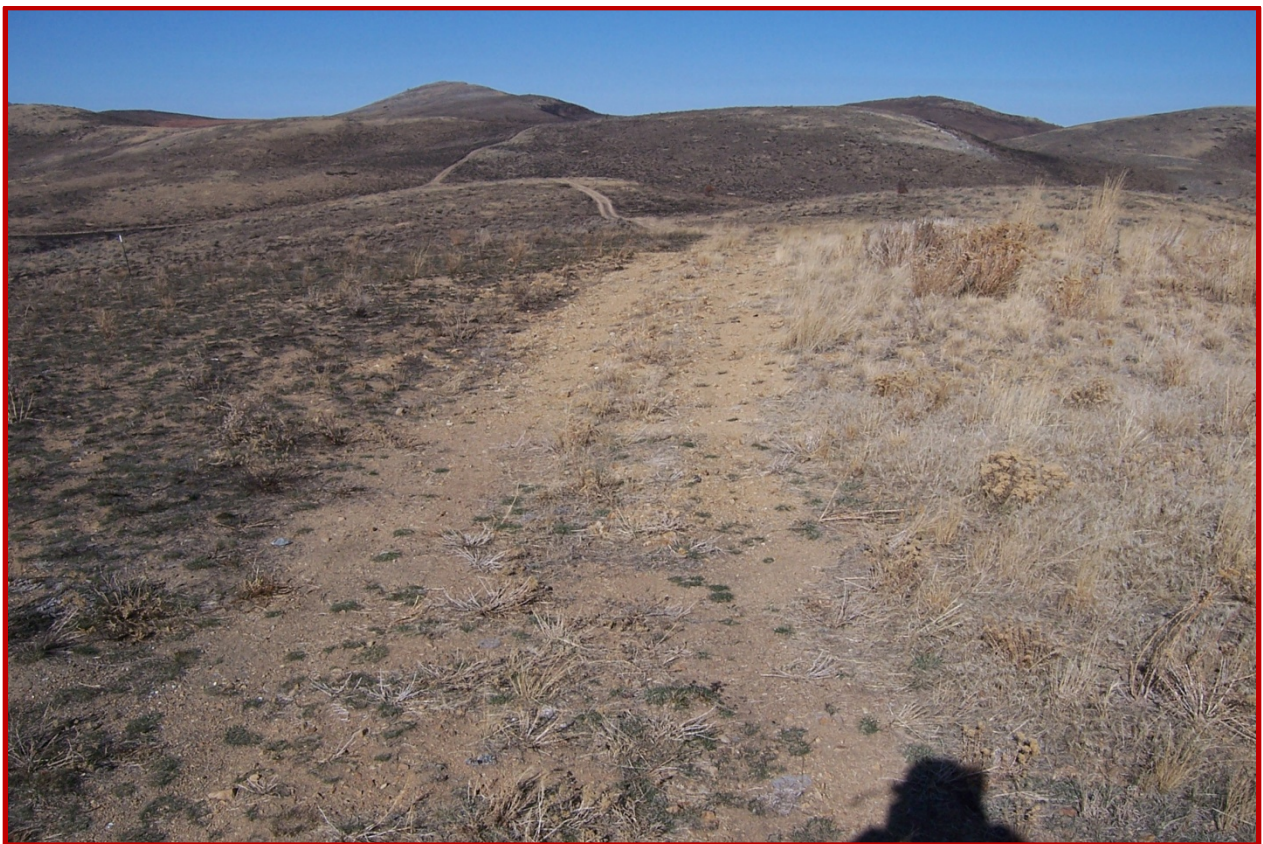
Figure 8. Drill site DT1 looking north (drilled in 2013).

Drill site DT1 (Figure 8) is about 50% burned. The drilling took place on the USFS road with some of the disturbance spread to both sides of the road to allow for the pad to be big enough to handle the equipment and sump. The vegetation on west side of the road was burned almost 100%. The road clearly acted as a firebreak, with the vegetation on the east side of the road and on the road midline showing little to no burn impacts. This site is on USFS land.

The drill site was on an existing USFS road, and that was used for all drilling access. Therefore, no reclamation was done to the roadway other than any smoothing needed to maintain the road quality. The only evidence of the drill site on the road itself is a color difference (yellow versus tan) in the surface material, which can be seen in Figure 8.

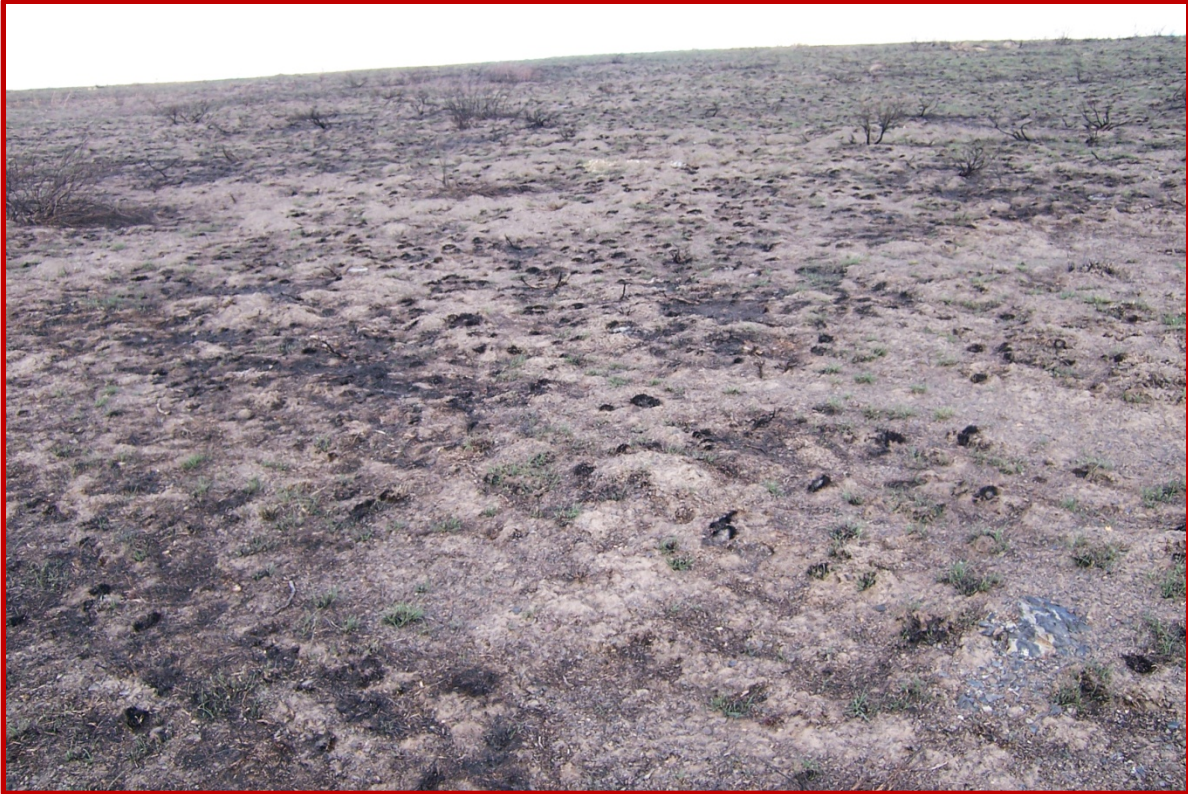
Figure 9. Drill site NW1 looking north (drilled in 2012).

Drill site NW1 (Figure 9) is burned 100%. Significant regrowth of grasses has occurred since the fire, with many sprouts visible in Figure 9. This site is on USFS land.

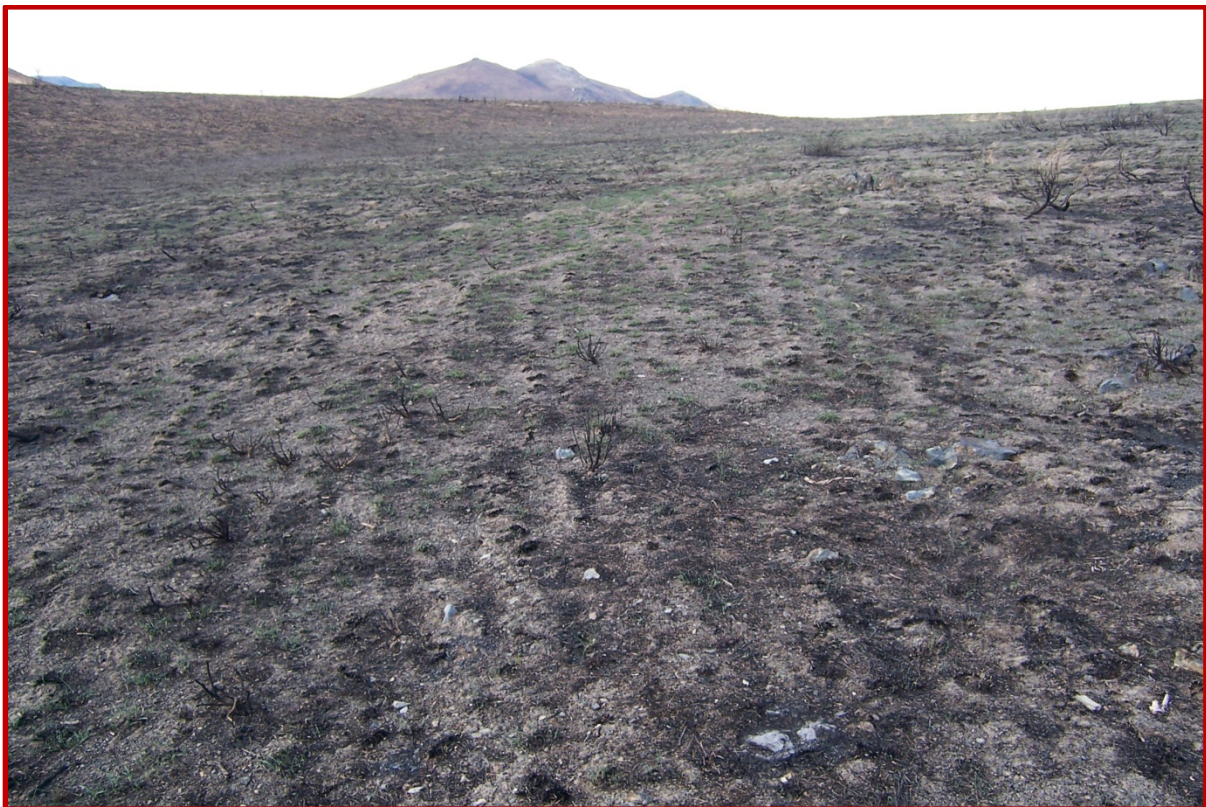
Figure 10. Accessway between NW1 and NW6 looking north from edge of NW6.

Likewise, the accessway between drill site NW6 and NW1 is burned 100% (Figure 10). Again, grass regrowth is significant and should provide useful cover in 2019 if there is sufficient winter moisture. Note that the slightly furrowed appearance of drill site NW1 and the accessway is due to the raking and reseeding process for the site reclamation.

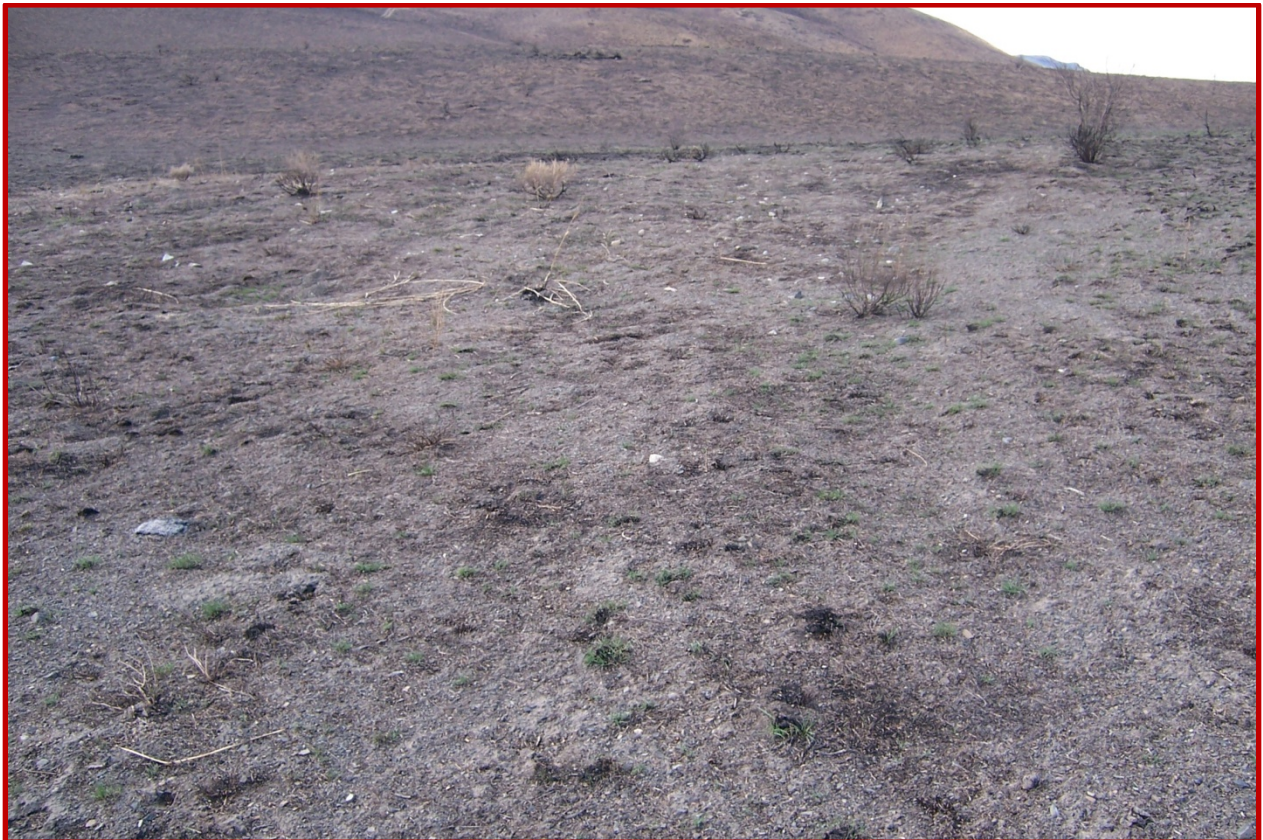
Figure 11. Drill site NW6 looking northwest (drilled in 2012).

Drill site NW6 (Figure 11) is burned almost 100%. A few small shrubs appear to have only partially burned and a few grass clumps remain as well. Significant but patchy regrowth of grasses has occurred since the fire, with many sprouts visible in Figure 11. This site is on USFS land.

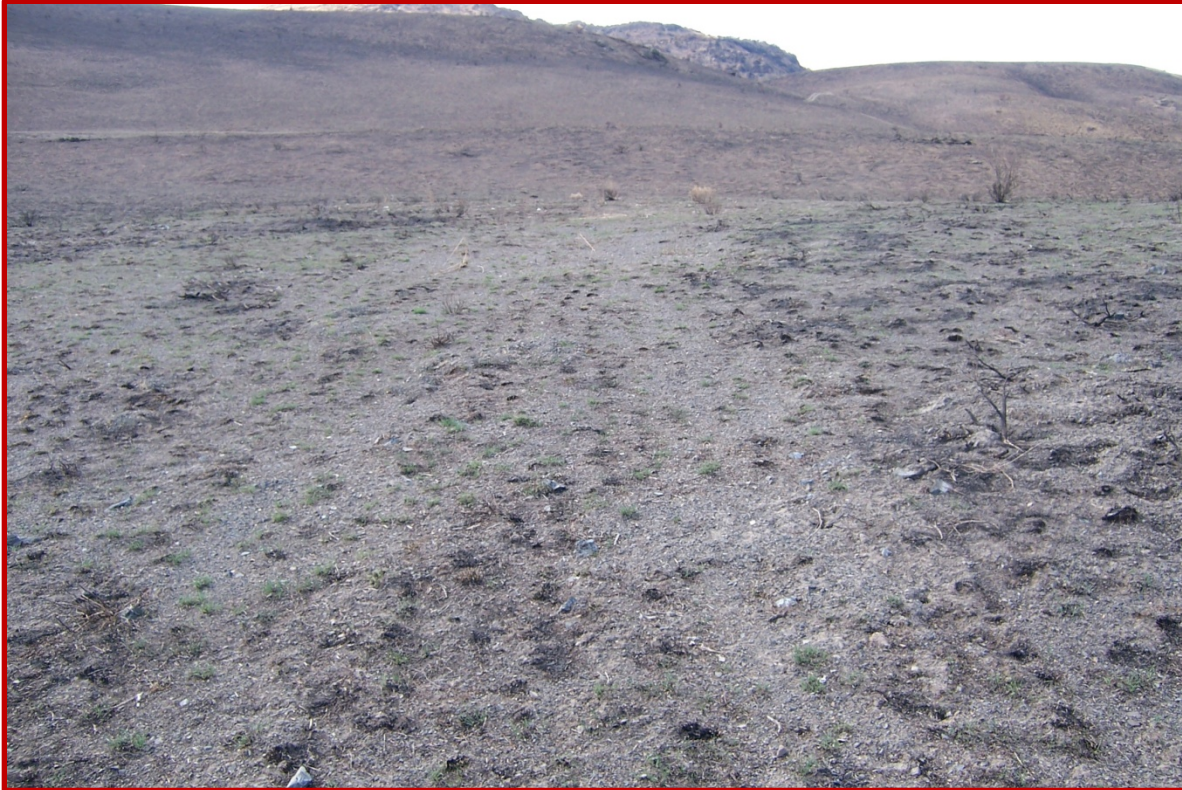
Figure 12. Part of accessway between NW6 and NW3 looking northwest.

The accessway between drill site NW3 and NW6 is burned 100% (Figure 12). Again, grass regrowth is significant and should provide useful cover in 2019 if there is sufficient winter moisture. Note that the slightly furrowed appearance of the accessway is due to the raking and reseedling process for the site reclamation.

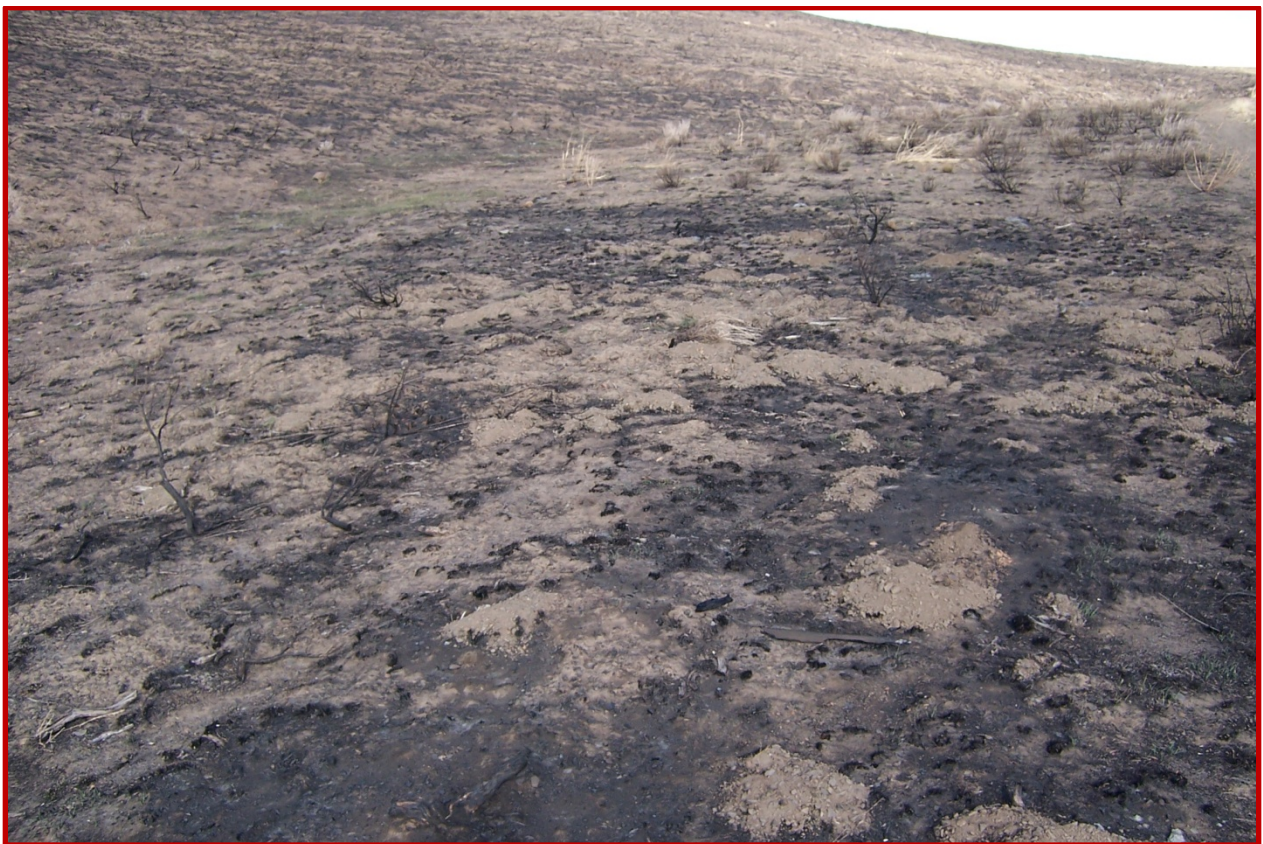
Figure 14. Drill site NW2 looking northeast (drilled in 2012).

Drill site NW2 (Figure 14) is burned in excess of 95%. A cluster of clump grasses from the revegetation process remains at the east end of the site. There has been very patchy regrowth of grasses since the fire, with sprouts visible in the background of Figure 13 along a small ephemeral stream. There is a considerable amount of rodent burrow activity at this site, evidenced by the numerous mounds of loose soil. This site is on USFS land.

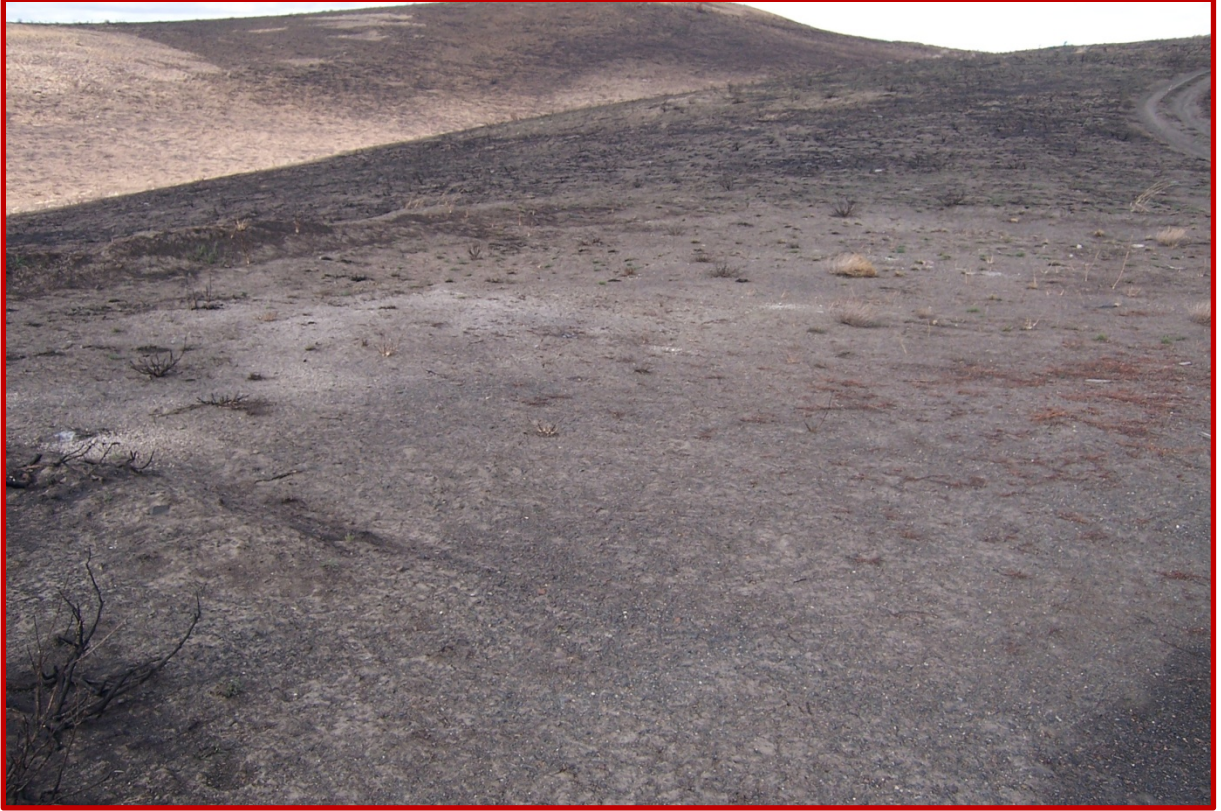
Figure 15. Former drill pad site for DT8 (drilled in 2012).

Drill site DT8 (Figures 15 and 16) is burned close to 100%. The drill site is included in the general area of Staging Area 1 that ARN used and is using for equipment and other logistical support for drilling and other exploration activities on the property. The overall staging area is burned in excess of 80%. The berm seen in Figures 15 and 16 was retained after recontouring of the drill site so that supplies, vehicles, and trailers would have a backstop for the hillside when parked in this flat area. Staging Area 1 (additionally shown in Figure 17) was set up based on an

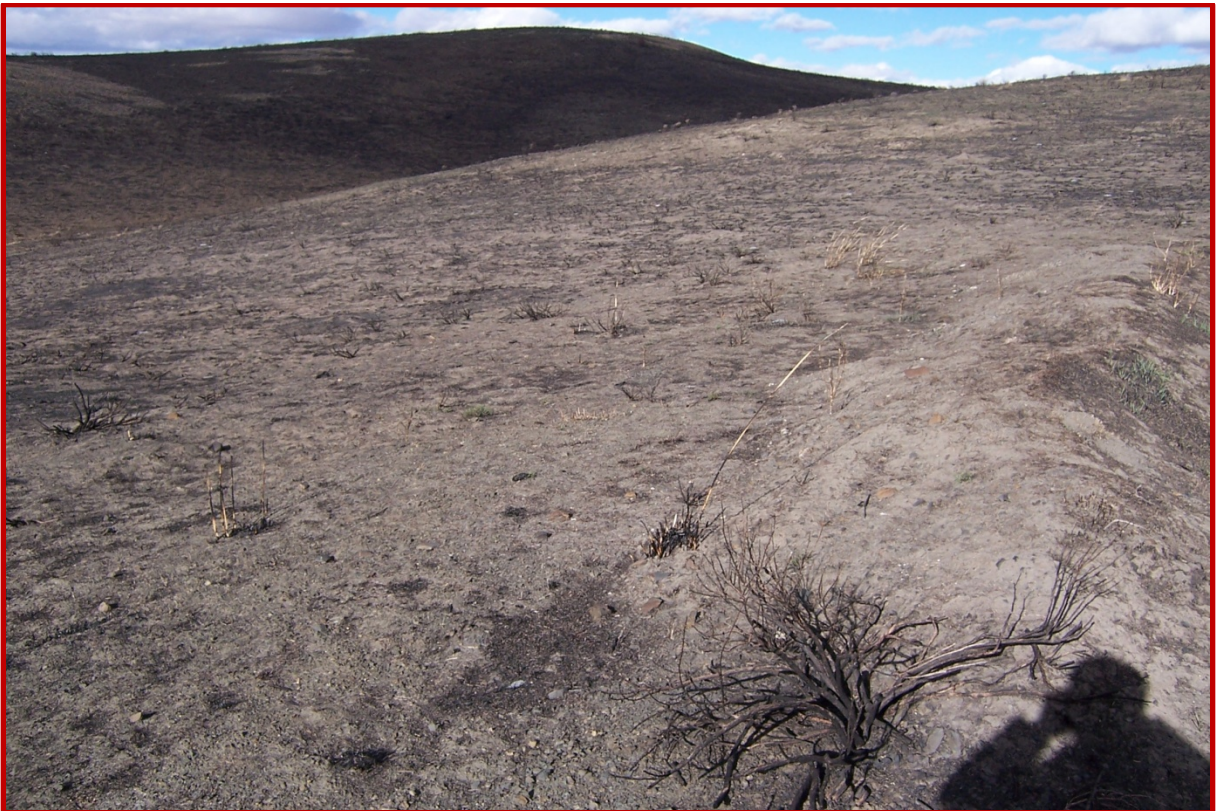
Figure 16. Former sump site for drill site DT8.

The sump portion of site DT8 (Figure 16) was revegetated and is now 100% burned. Given that the rest of the drill site is part of Staging Area 1, which will continue to be used for further exploration work in the area, final reclamation and revegetation on this site and area will be done in the future. The existing road through the staging area will not be reclaimed in order to maintain access that was available at the time ARN began operations on this project.

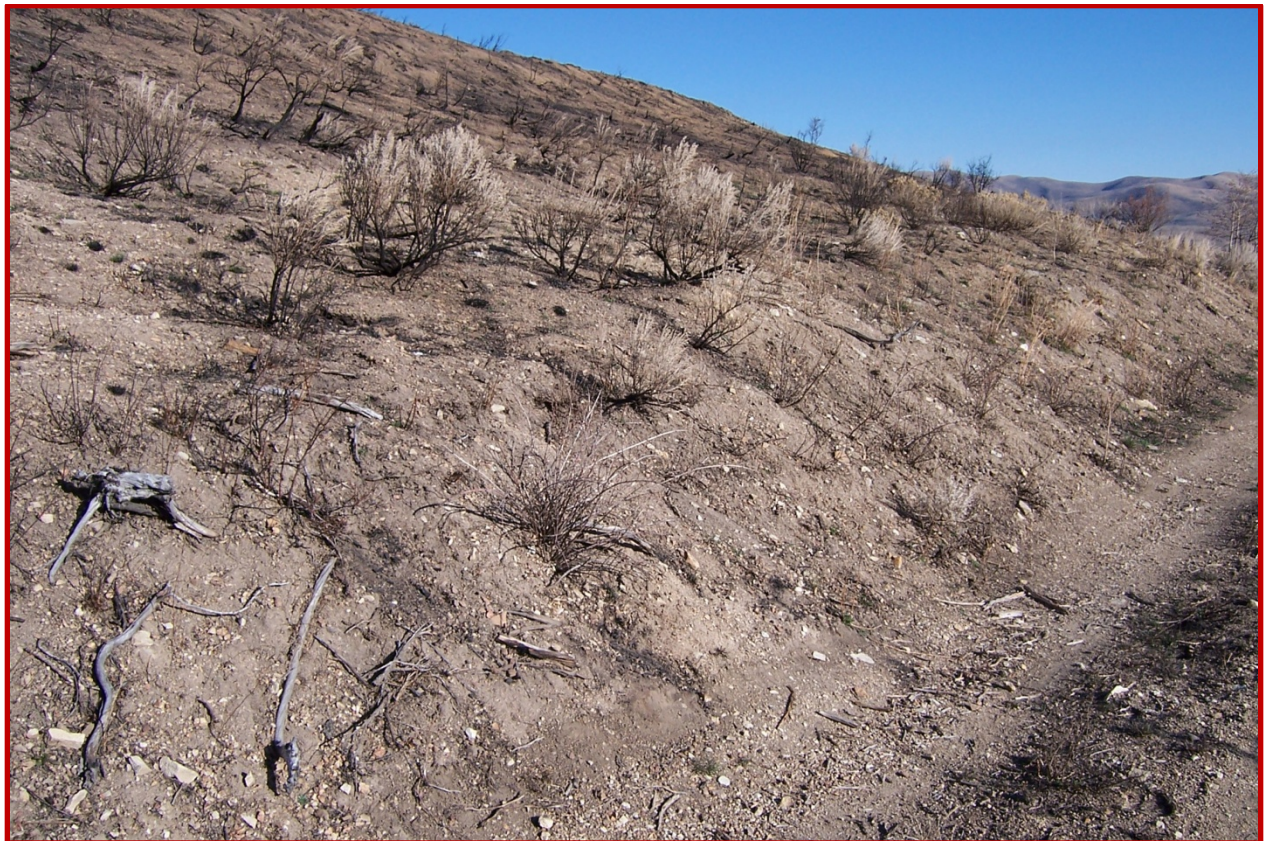
Figure 18. Drill site DT2 looking east (drilled in 2013).

Drill site DT2 (Figure 18) is burned at least 80%. The drilling was done on the road surface whereas the sump was located in the hillside to reduce potential impacts to the roadway after drilling. Regrowth of some grass, sage, and other shrubs appeared to have happened since the revegetation of this site in late 2013. The sage probably re-grew quickly given that the soil and near-surface broken rock was laid up onto the hillside during sump excavation rather than being mixed into the overall drill site material. That would have preserved at least some roots that could re-establish growth quickly. This site is on private land.

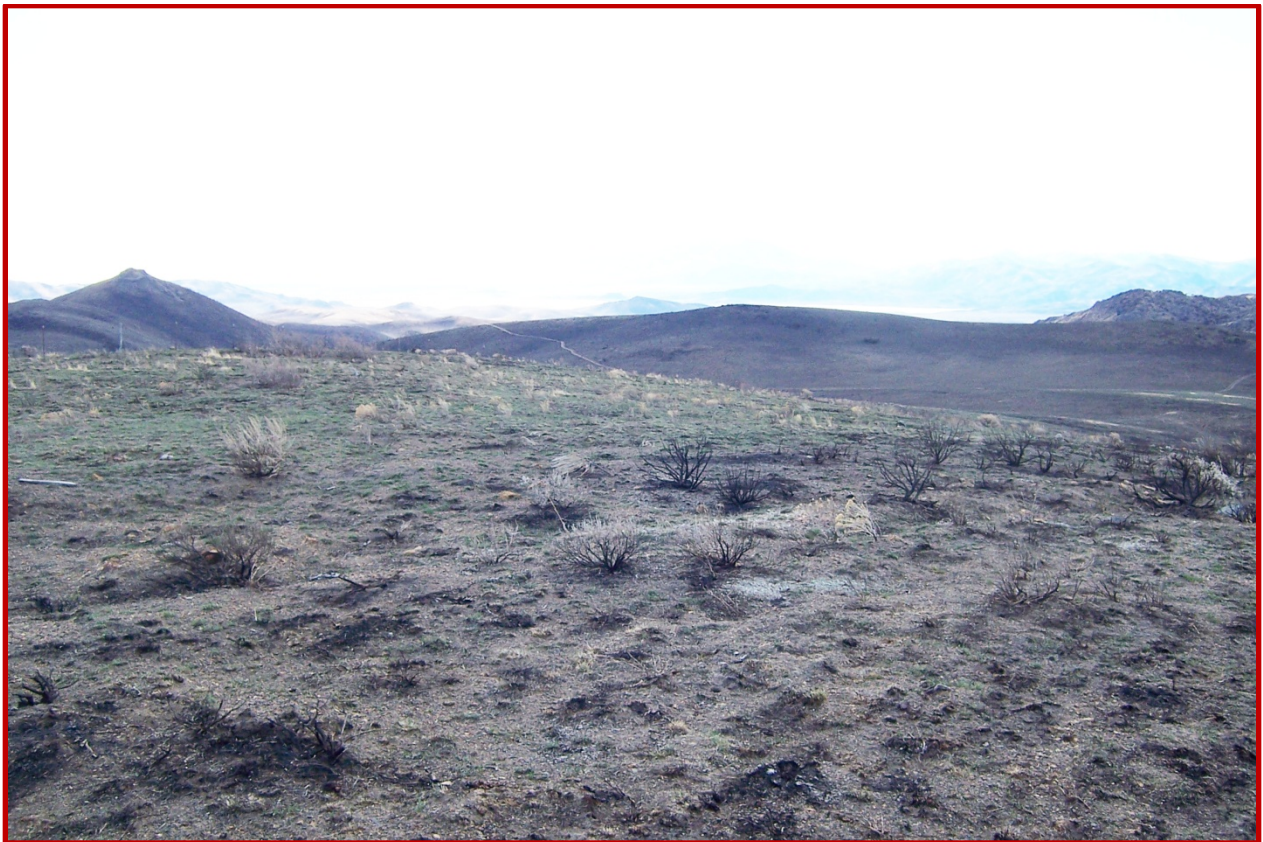
Figure 19. Drill site NW7 looking southwest (drilled in 2012).

Drill site NW7 (Figure 19 in middleground) is burned in excess of 90%. The drilling was done mostly on a remnant accessway (visible from exploration work by a previous operator). That was done to reduce new exploration impacts as well as aid further reclamation of the old accessway after drilling. Growth of clump grass and shrubby plants appeared to have happened since the revegetation of this site in late 2012, some of which remain after the fire. There also is apparent abundant growth of grass (green area in middleground of Figure 19) across the drill site which should provide significant cover in 2019. This site is on USFS land.

The accessway from Staging Area 1 to NW7 is very short, given that the drill site was close to the staging area boundary, and is shown in Figure 19 in the foreground. Revegetation appeared to have done well before the fire. Regrowth of some sage and other shrubs appeared to have happened since the revegetation of this site in late 2013. Because the remnant accessway was available, traffic was able to minimize impacts to at least some of the vegetation that had grown along and adjacent to that previous track. The accessway is now close to 100% burned.

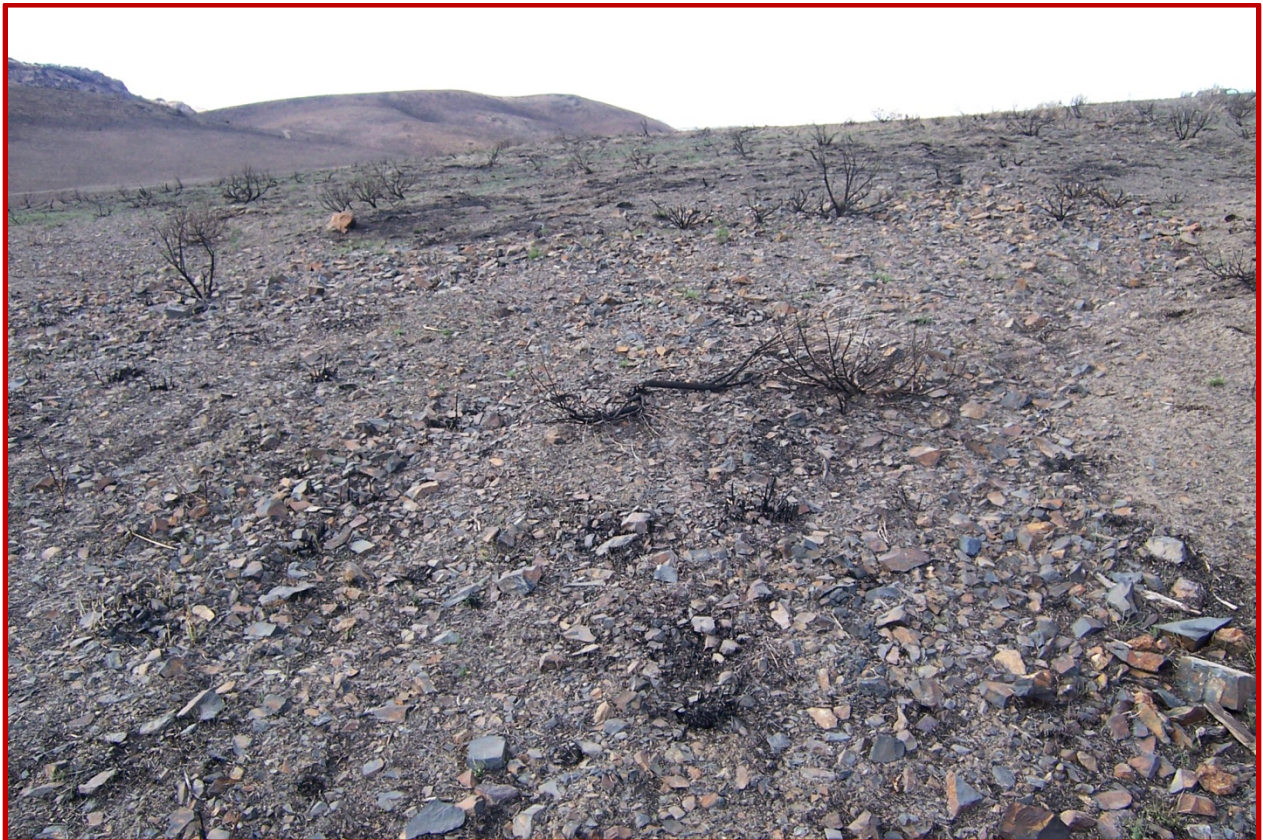
Figure 20. Drill site NW8 looking northwest (drilled in 2012).

Drill site NW8 (Figure 20) is burned close to 100%. The drill site was fairly flat originally, so minimal excavation besides the sump was needed to prepare the site. This helped maintain at least some roots for sage and other shrubs that then were able to regrow quickly after reclamation. Note that the slightly furrowed appearance of the drill site is due to the raking and reseeded process for the site reclamation. This site is on USFS land.

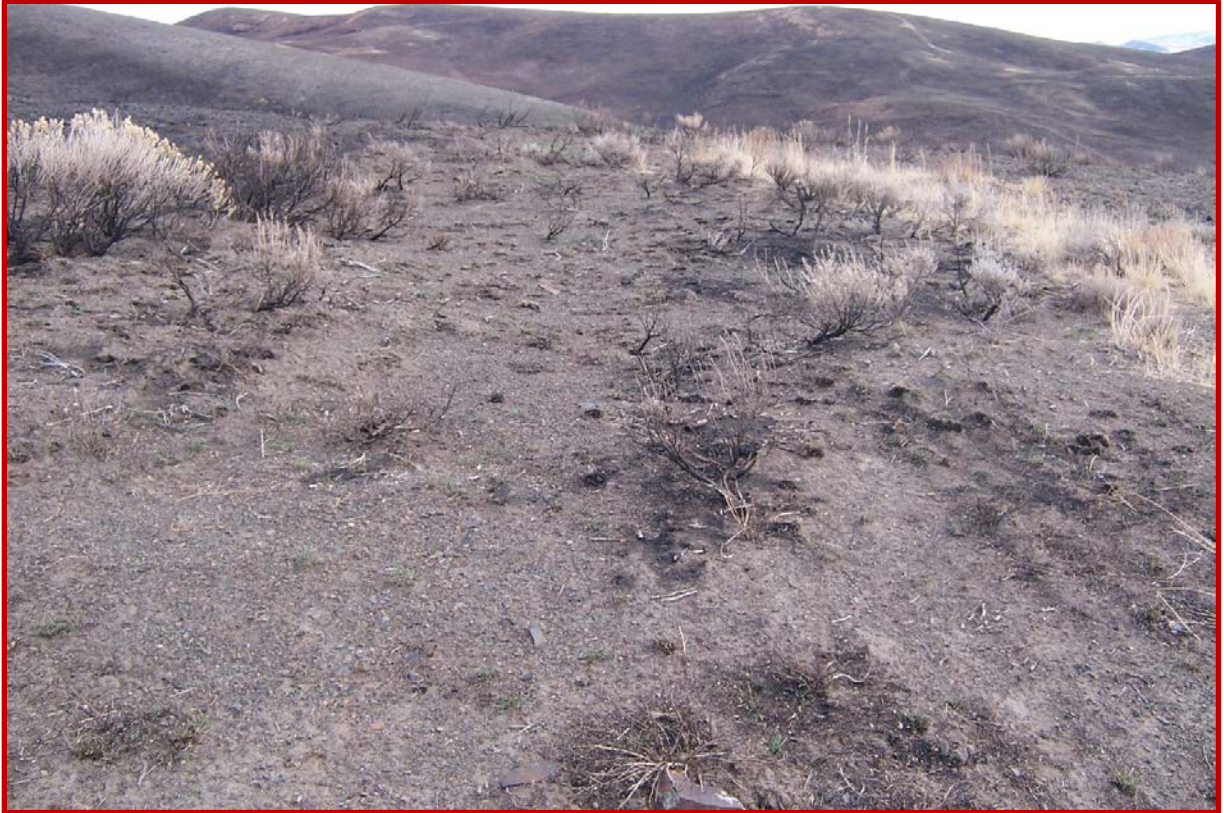
Figure 21. Part of accessway between site NW7 and NW8 looking south toward NW8.

The accessway from NW7 to NW8 is shown in Figure 21. As with the drill site, the slightly furrowed appearance of the accessway is due to the raking and reseeded process for the site reclamation.

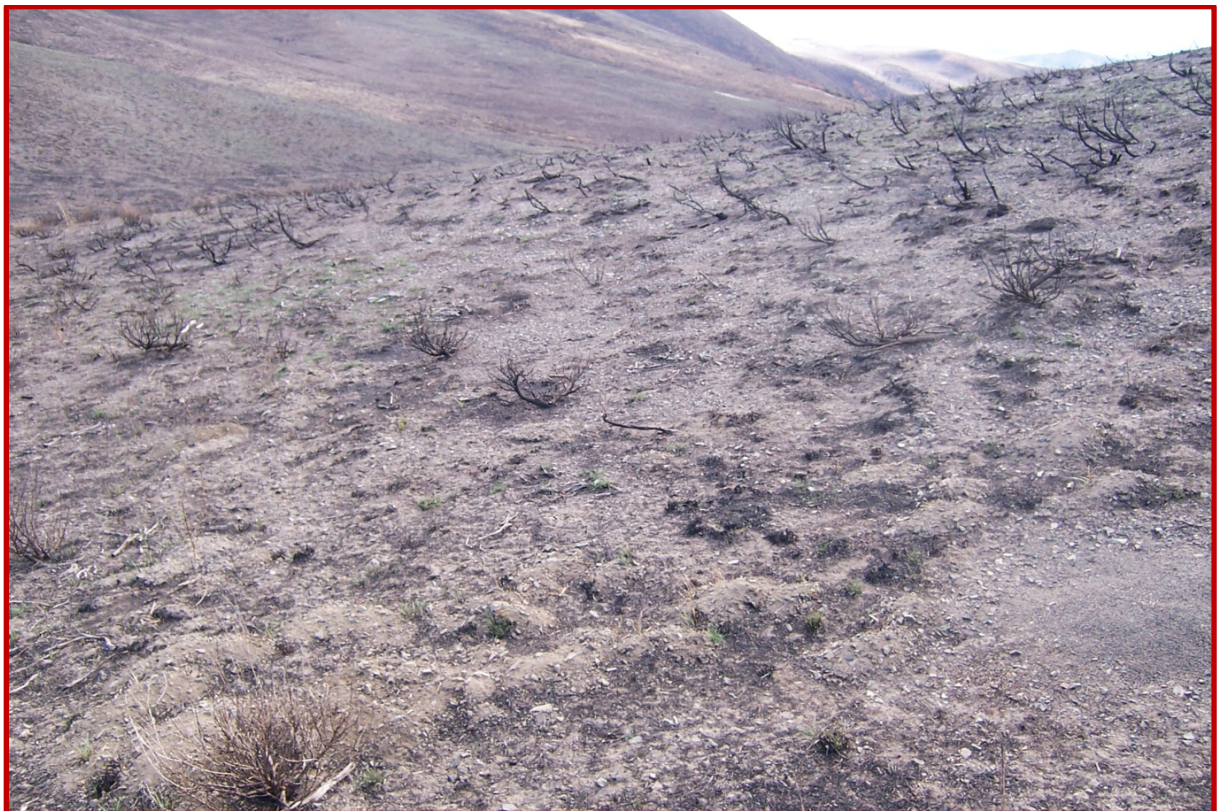
Figure 22. Drill site NW5 looking southwest (drilled in 2012).

Drill site NW5 (Figure 22) is burned close to 100%. There has been very patchy regrowth of grasses since the fire, with sprouts visible throughout Figure 22 and in the middleground and background. This site is on USFS land.

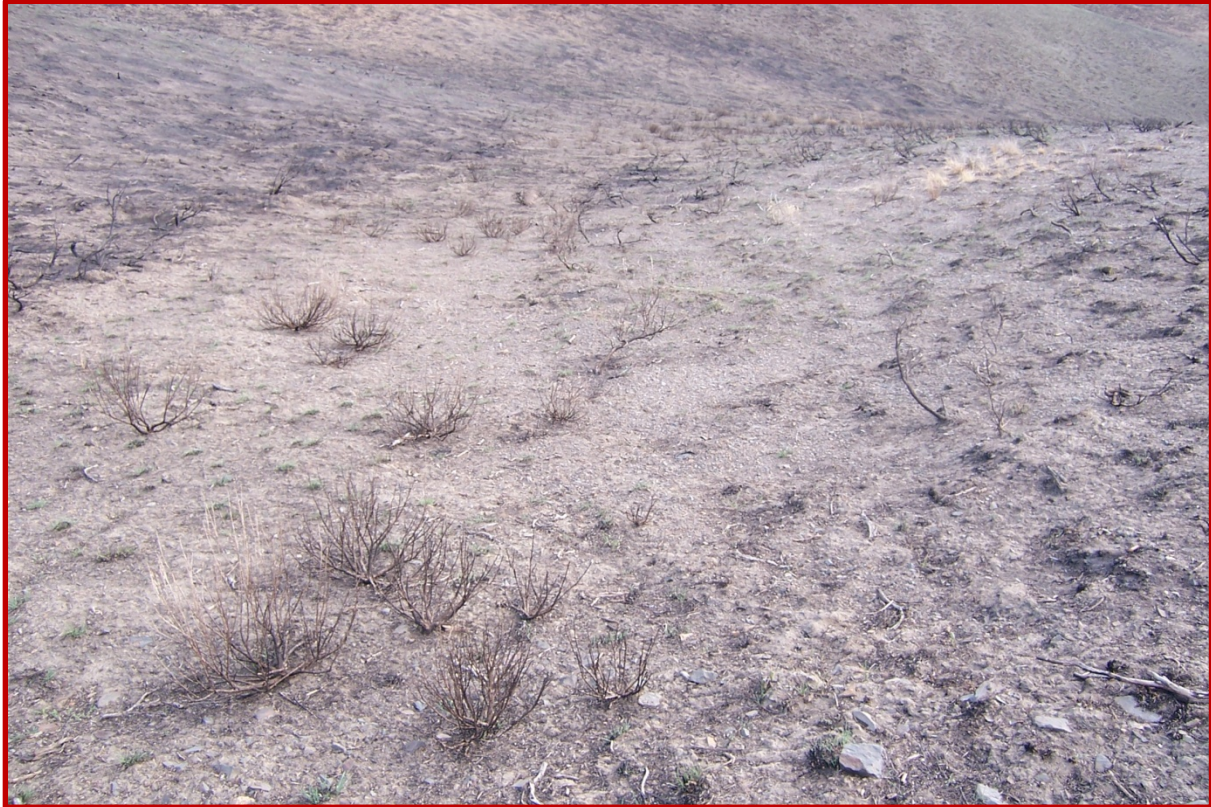
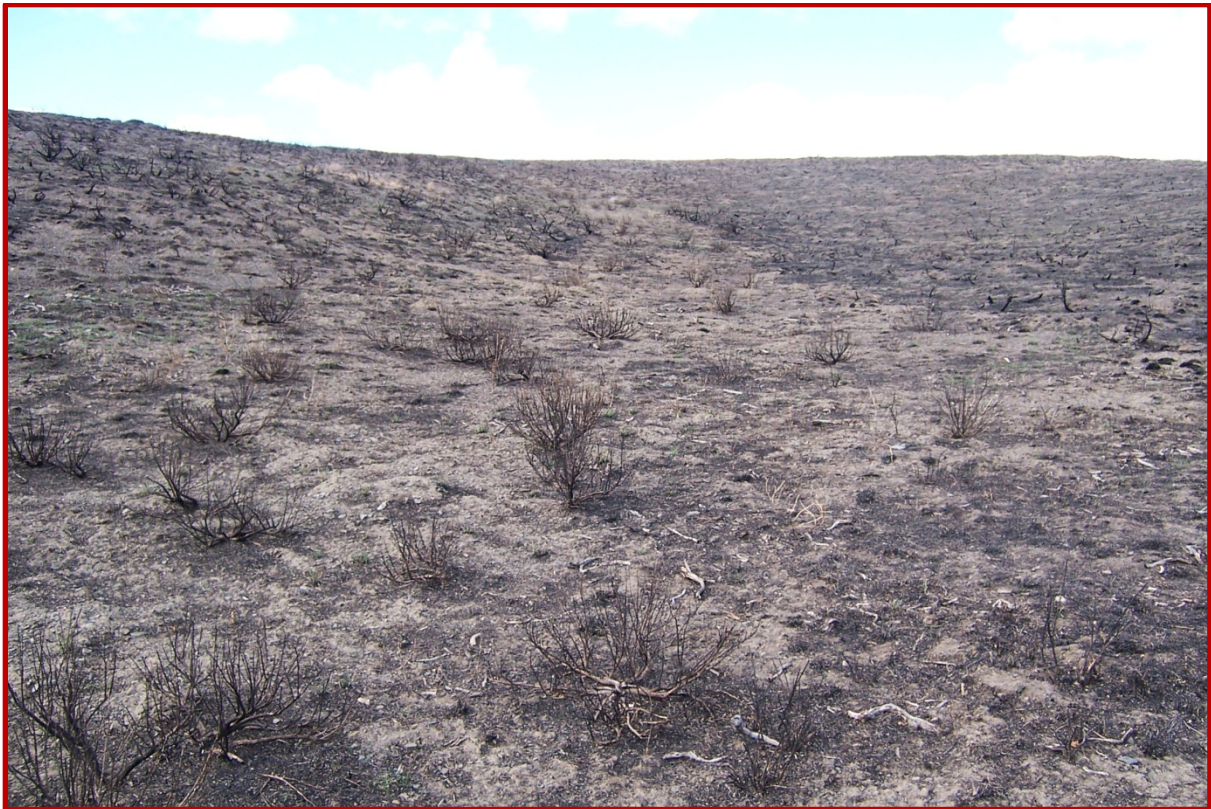
The accessway from NW8 to NW5 is shown in Figures 23 and 24. The burn in this area was essentially 100%. Our cross-country accessways were intended to have as little impact on the area as possible. The upper part of the accessway appears probably to have been dominated

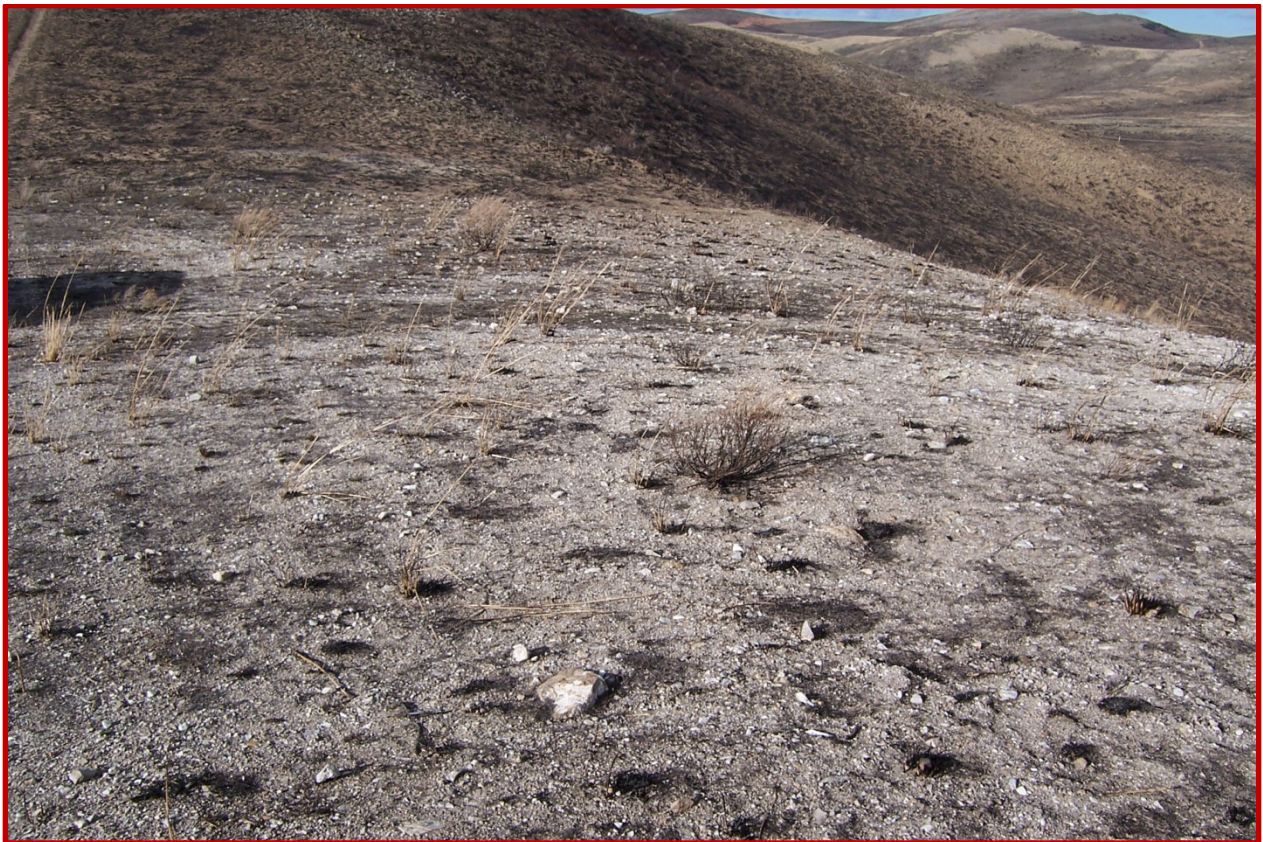
Figure 25. Drill site C1 looking north-northwest (drilled in 2012).

Drill site C1 (Figure 25) is burned in excess of 95%. There has not been any obvious regrowth of grasses since the fire. Nonetheless, some clump grasses from the site revegetation remained unburned. This site is on private land.

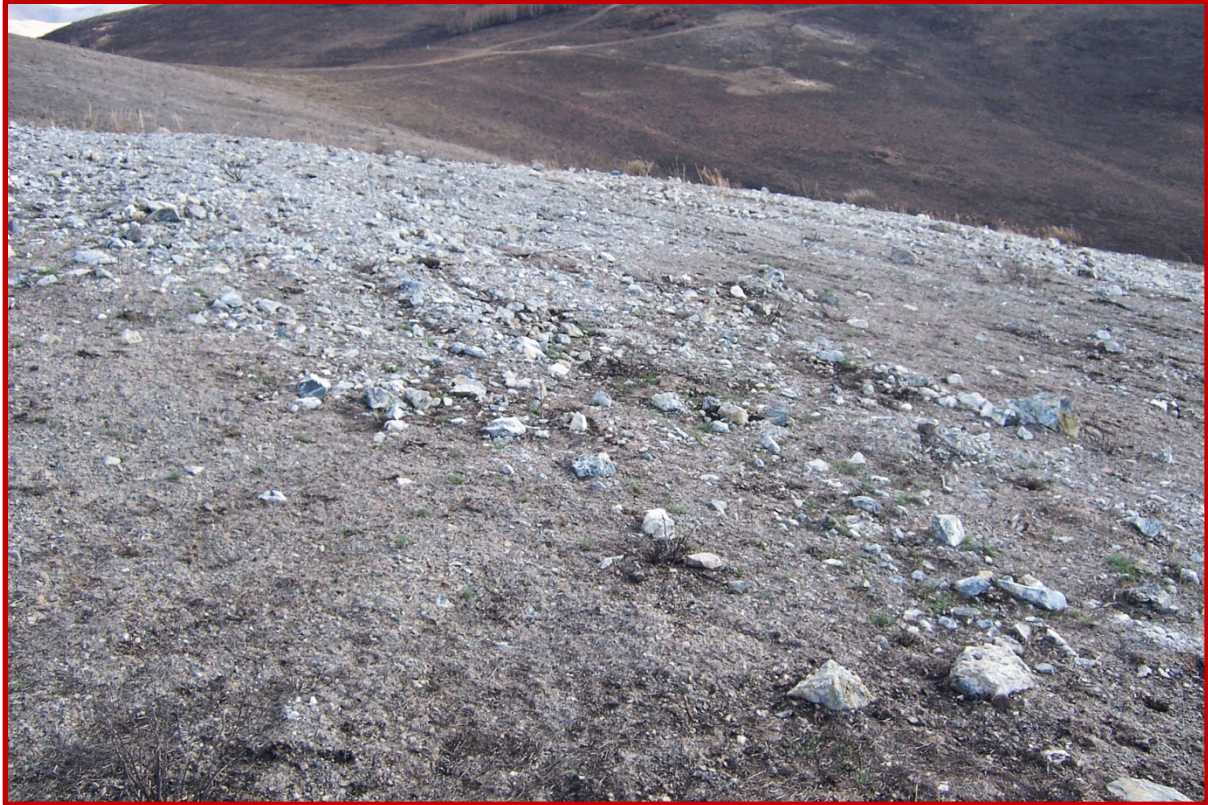
Figure 26. Drill site C8 looking southeast (drilled in 2013).

Drill site C8 (Figure 26) is burned 100%. Because the soil was quite thin in the drill site area, much rock was excavated during the pad and sump development, as apparent on the reclaimed site (Figure 26). There has been very patchy regrowth of grasses since the fire, with sprouts visible in parts of Figure 26. This site is on private land.
