Fire Review Report for the Island Mountain Property and Surroundings, Elko County, Nevada

Field Visit Performed on November 7-9, 2018

**Douglas C. Peters
President
ARNEVUT Resources Nevada LLC**

Report Date: November 20, 2018

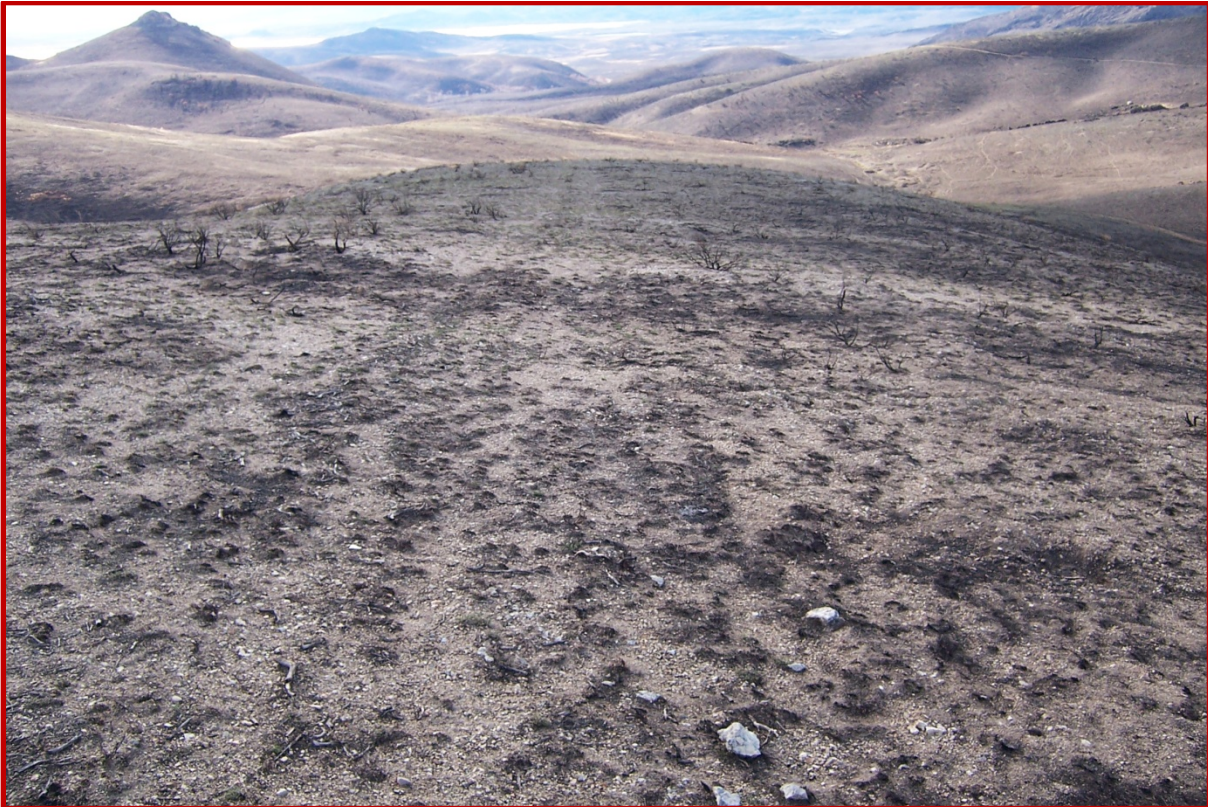
Figure 27. Accessway from the near the fenceline to site C8 looking southwest.

The accessway (Figure 27) to C8 from a fenceline along the ridge was chosen to minimize impacts to the land. The upper contour of the valley and then the ridge line were

followed both for safety purposes and to prevent the need for any excavation along the accessway. The accessway is burned 100%, but areas of new grass growth can be seen along it.

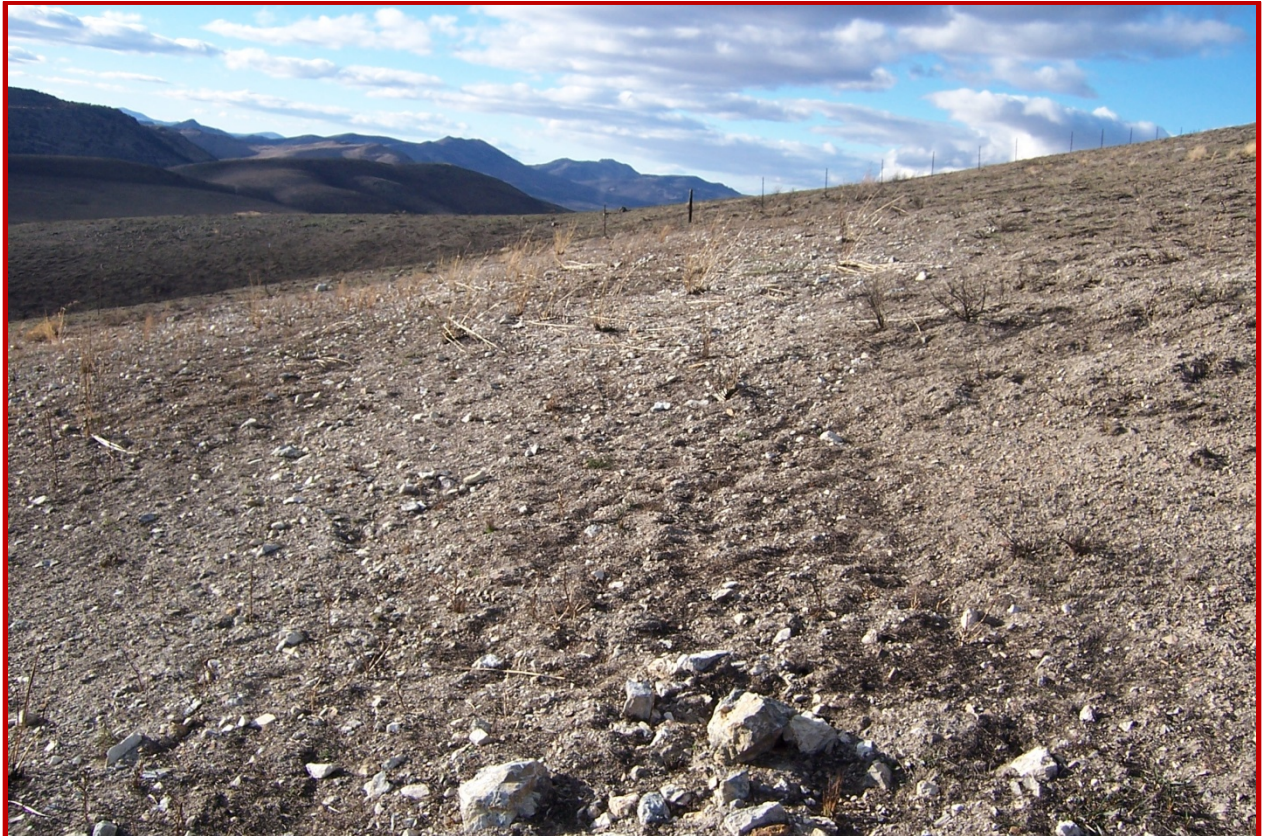
Figure 28. Drill site C7/C12 looking northwest (drilled in 2012).

Drill site C7/C12 (Figure 28) is burned about 95%. Two drill holes were merged into one site at the time the prior PoO was submitted for approval to USFS. Keeping them separate would have required significant excavation of a steep access path between the two original sites. C7 was an angled hole to reach approximately the same area and vertical column as the original planned separate drill site. C12 was a vertical drill hole. Very scattered regrowth of grass and some other plants is visible. This site is on USFS land.

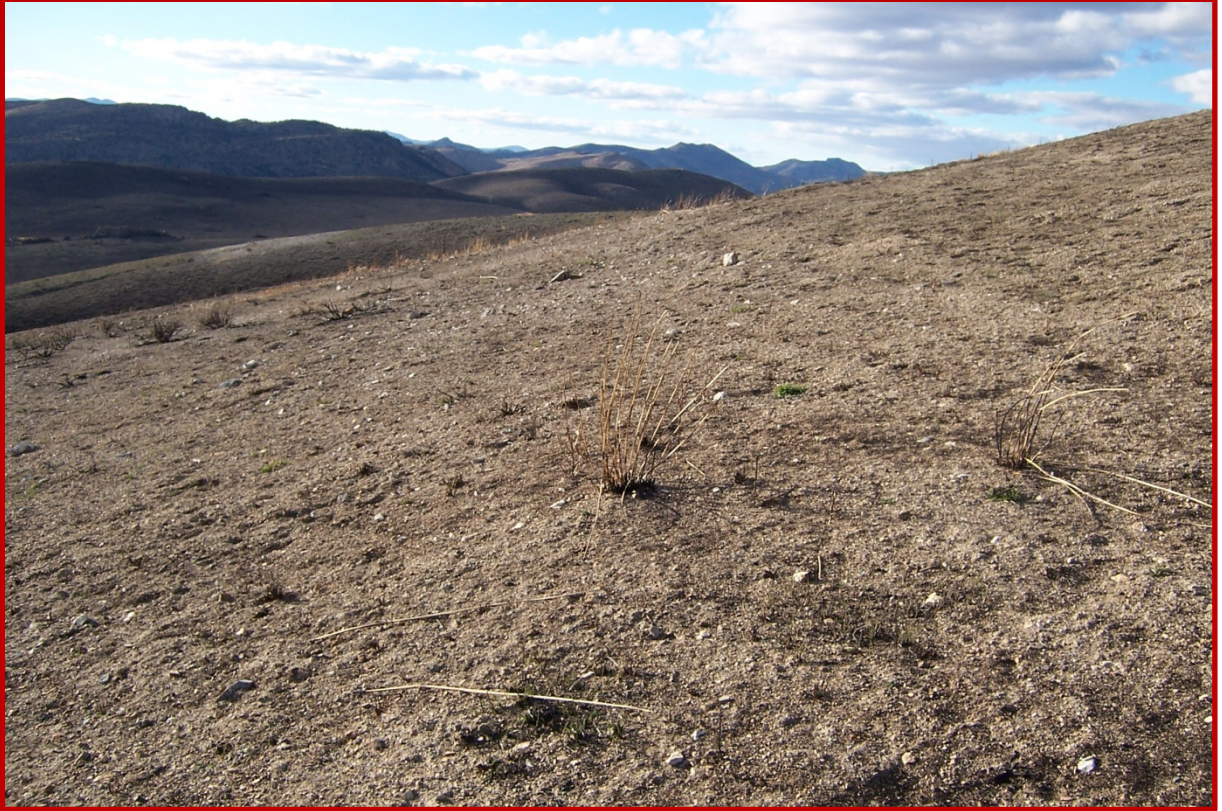
Figure 29. Accessway from the USFS road to drill site C7/C12 looking northwest.

The accessway from the USFS road to C7/C12 (Figure 29) is burned close to 100%. Scattered regrowth of grass and some other plants is visible.

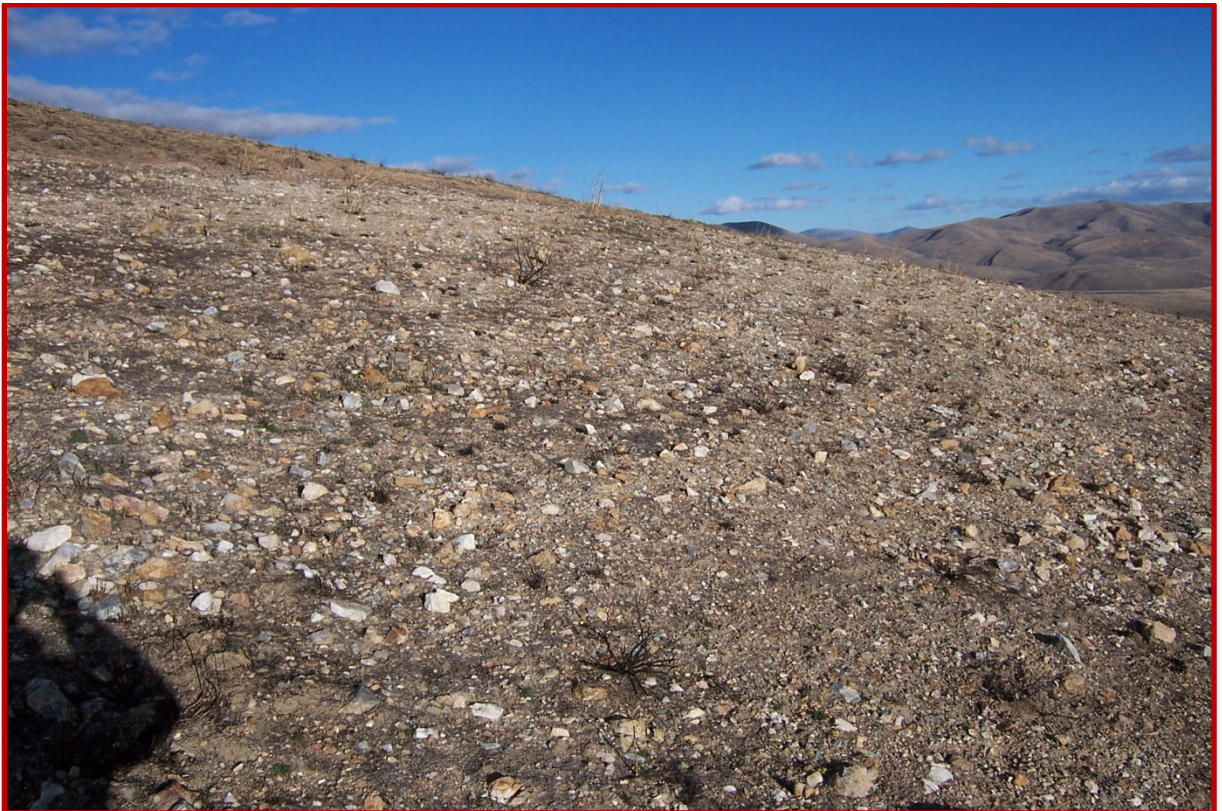
Figure 30. Drill site DT3 looking northeast (drilled in 2013).

Drill site DT3 (Figure 30) is burned 100%. Very scattered regrowth of grass is visible. This site is on USFS land.

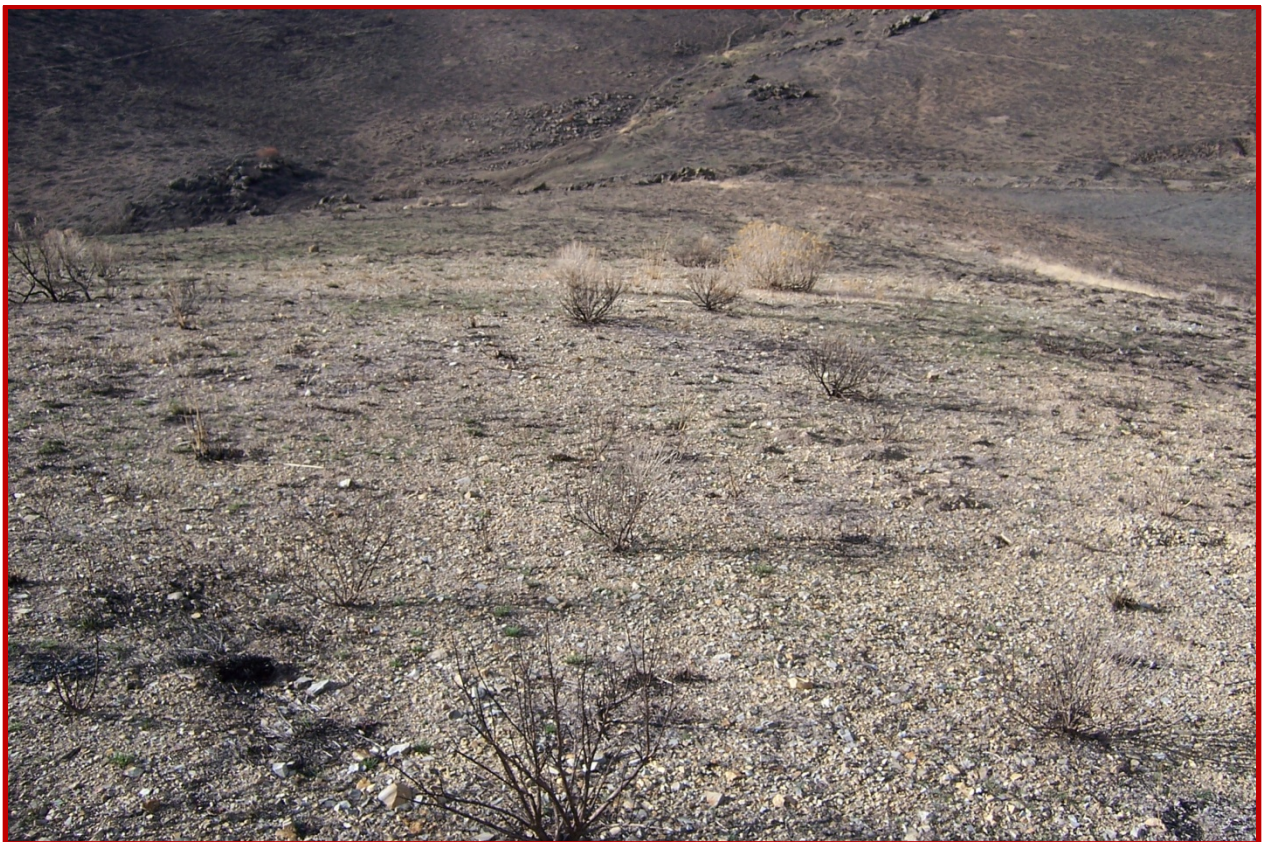
Figure 31. Drill site SW2 looking northwest (drilled in 2012).

Drill site SW2 (Figure 31) is burned in excess of 95%. A number of small shrubs at the site were incompletely burned. Scattered to patchy regrowth of grass is visible in Figure 21. This site is on USFS land.

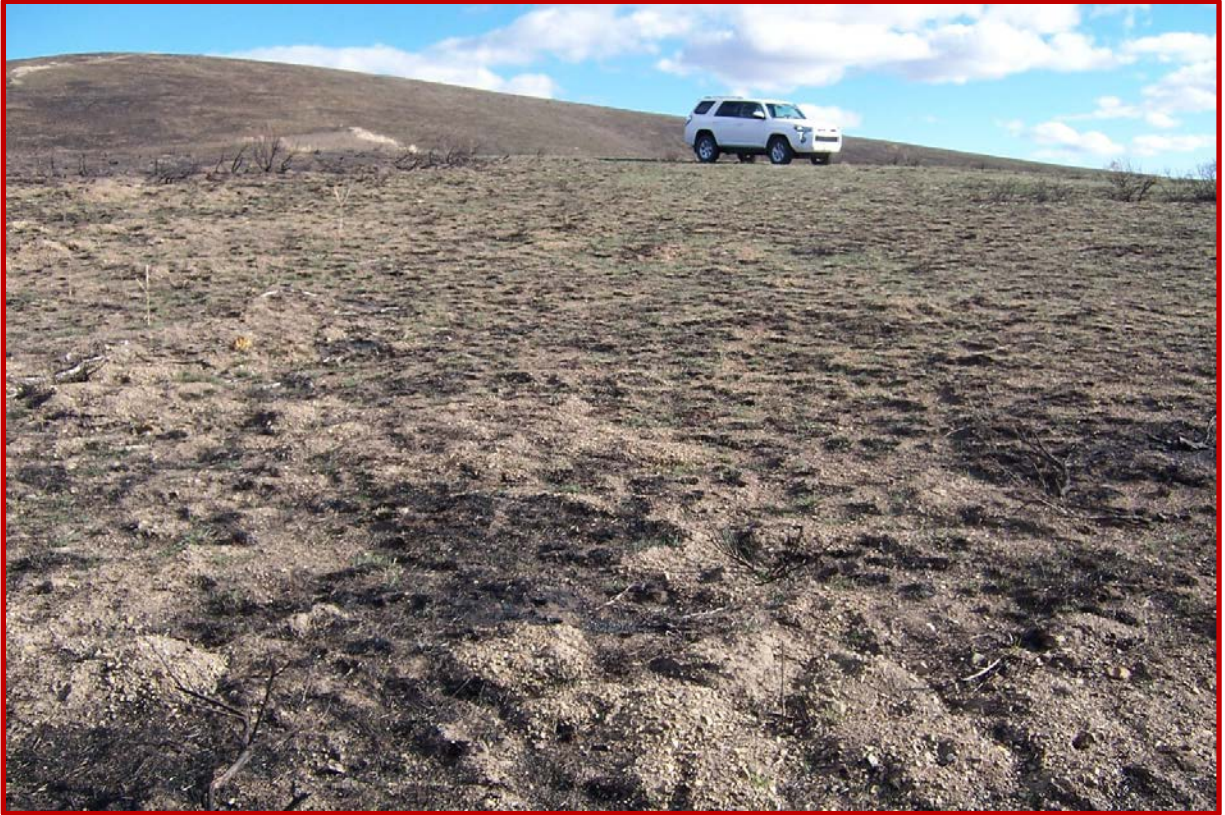
Figure 32. Accessway from the USFS road to drill site SW2 looking southeast.

The accessway from the end of the USFS road to SW2 (Figure 32) is burned 100%. Abundant regrowth of grass is visible. There is a considerable amount of rodent burrow activity along and adjacent to the accessway, evidenced by the numerous mounds of loose soil in Figure 32.

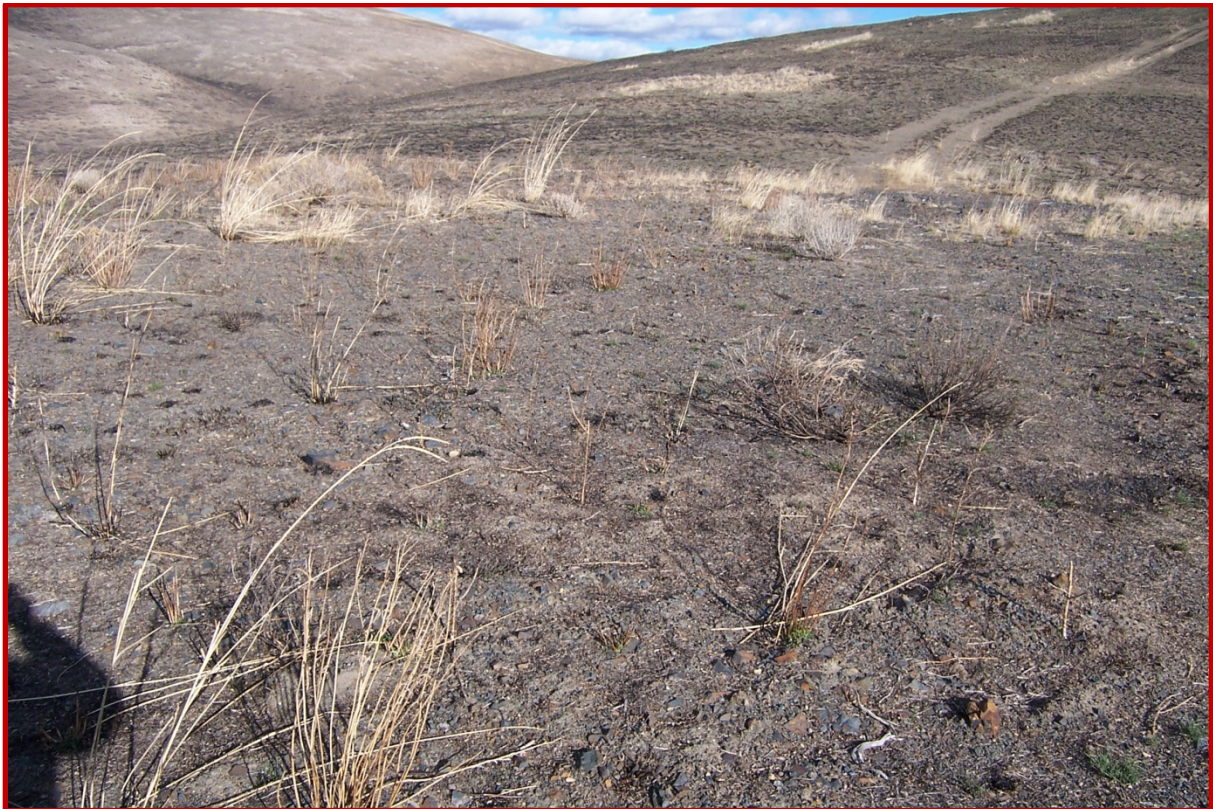
Figure 33. Drill site SW5 looking east (drilled in 2013).

Drill site SW5 (Figure 33) is burned about 60%. A number of clump grasses and small shrubs at the site were incompletely burned to untouched. Where the burn was more complete, very scattered regrowth of grass is visible in Figure 33. Nonetheless, the significant amount of unburned grasses and shrubs indicates that overall regrowth on the site should proceed quickly if winter moisture is sufficient. This site is on USFS land.

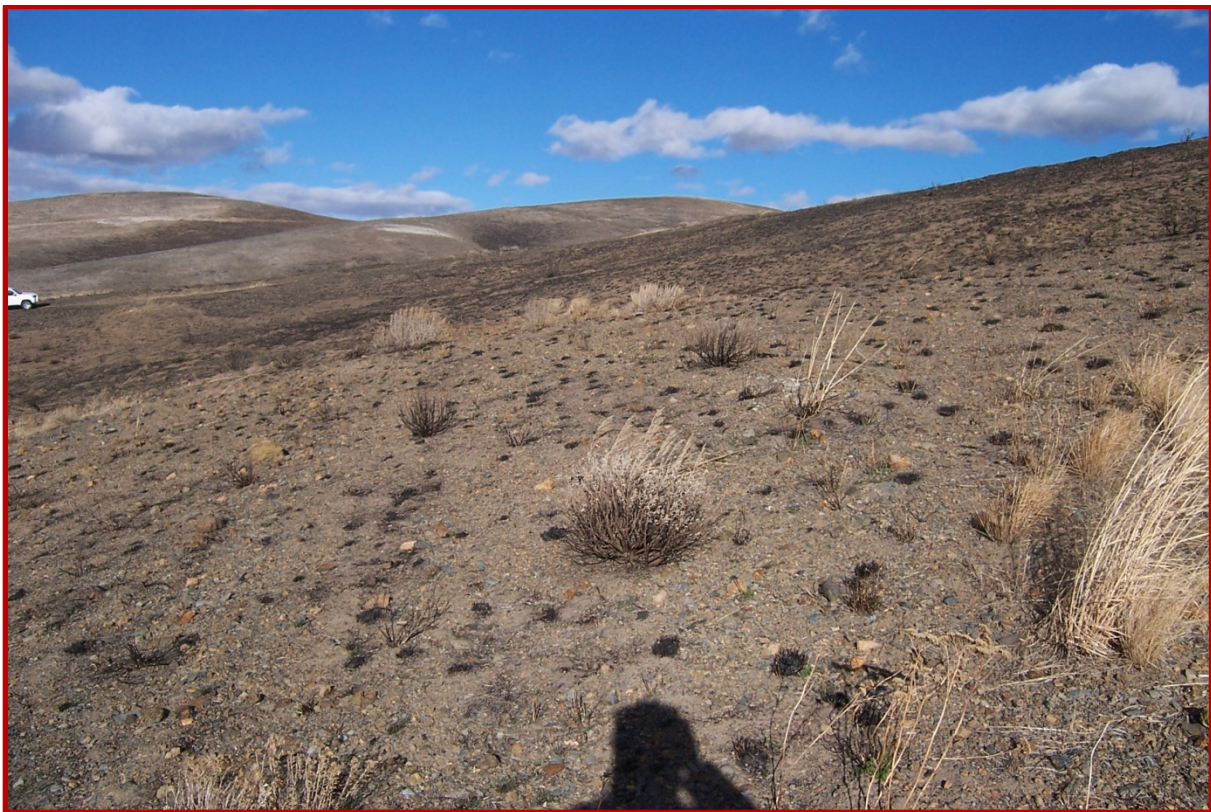
Figure 34. Drill site SW11 looking north-northeast (drilled in 2013).

Drill site SW11 (Figure 34) is burned in excess of 95%. A number of small shrubs and clump grasses at the site were untouched to incompletely burned. Very scattered regrowth of grass and some other plants is visible in Figure 34. This site is on USFS land.

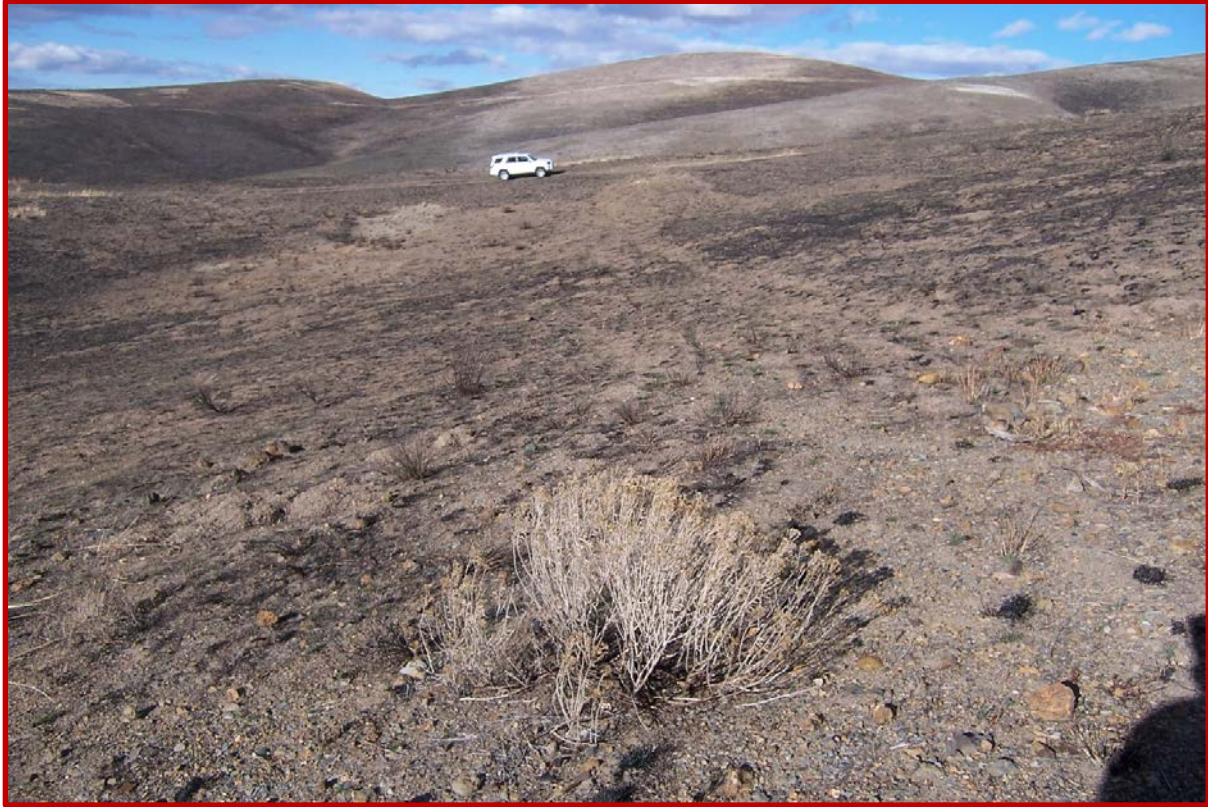
Figure 35. Accessway between drill site SW6 (middleground) and drill site SW11 looking north.

The accessway between site SW6 and SW11 (Figure 35) is burned 100%. Very scattered regrowth of grass is visible.

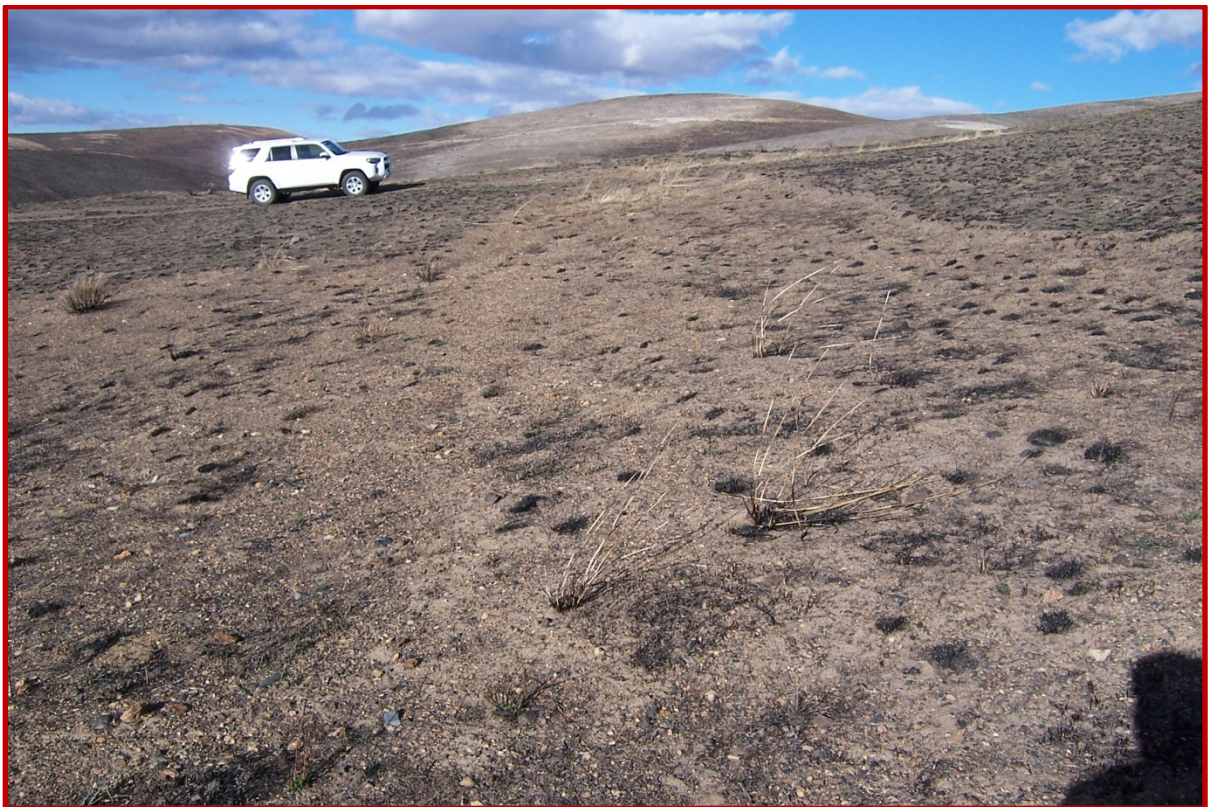
Figure 36. Drill site SW6 (drilled in 2013) and short accessway looking north.

Drill site SW6 (Figure 36) is burned close to 100%. Very scattered regrowth of grass and some other plants is visible in Figure 36. This site is on USFS land.

The short accessway between the USFS road and drill site SW6 also is shown in Figure 36. It is burned in excess of 90%, with some clusters of clump grasses from the site revegetation remaining unburned.

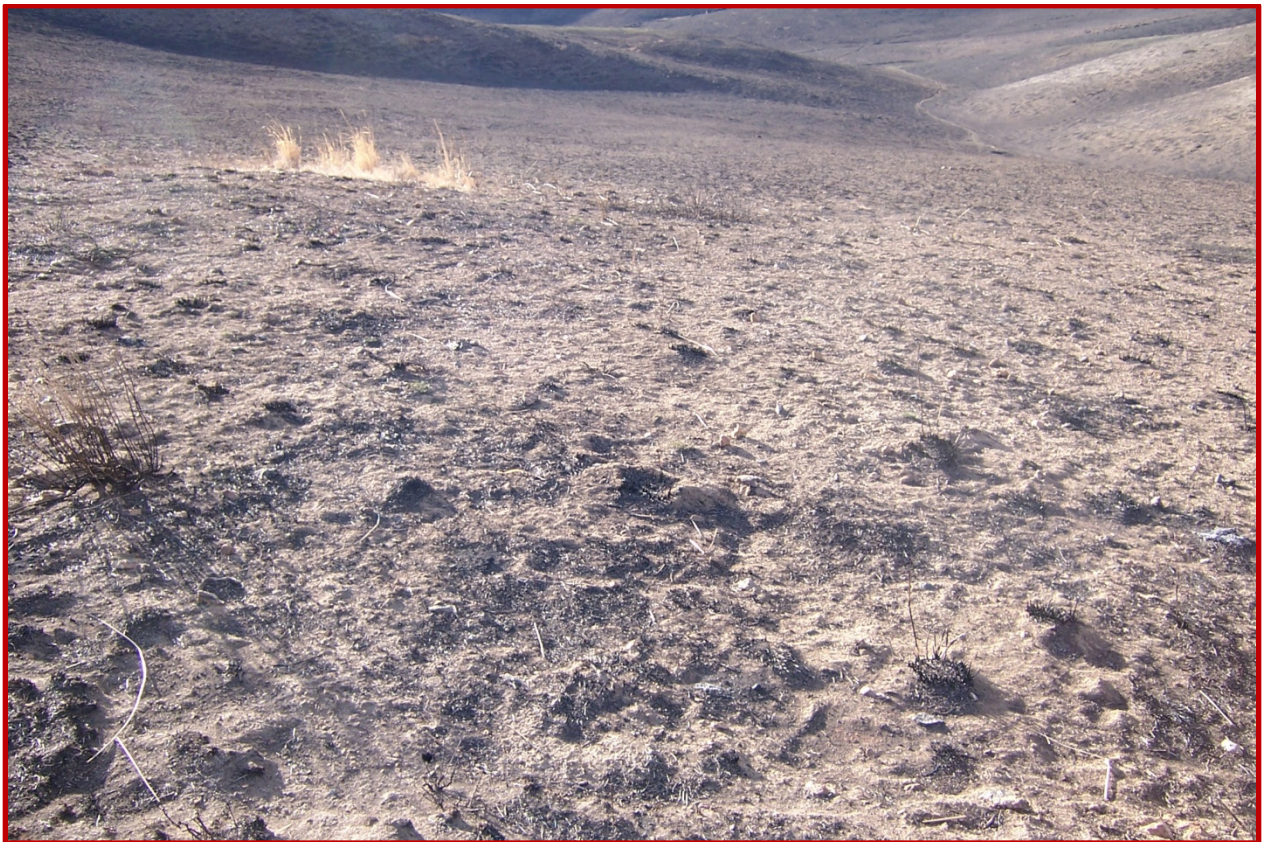
Figure 37. Drill site C9 looking west (drilled in 2012).

Drill site C9 (Figure 37) is burned close to 100%. Very scattered regrowth of grass was seen. This site is on USFS land.

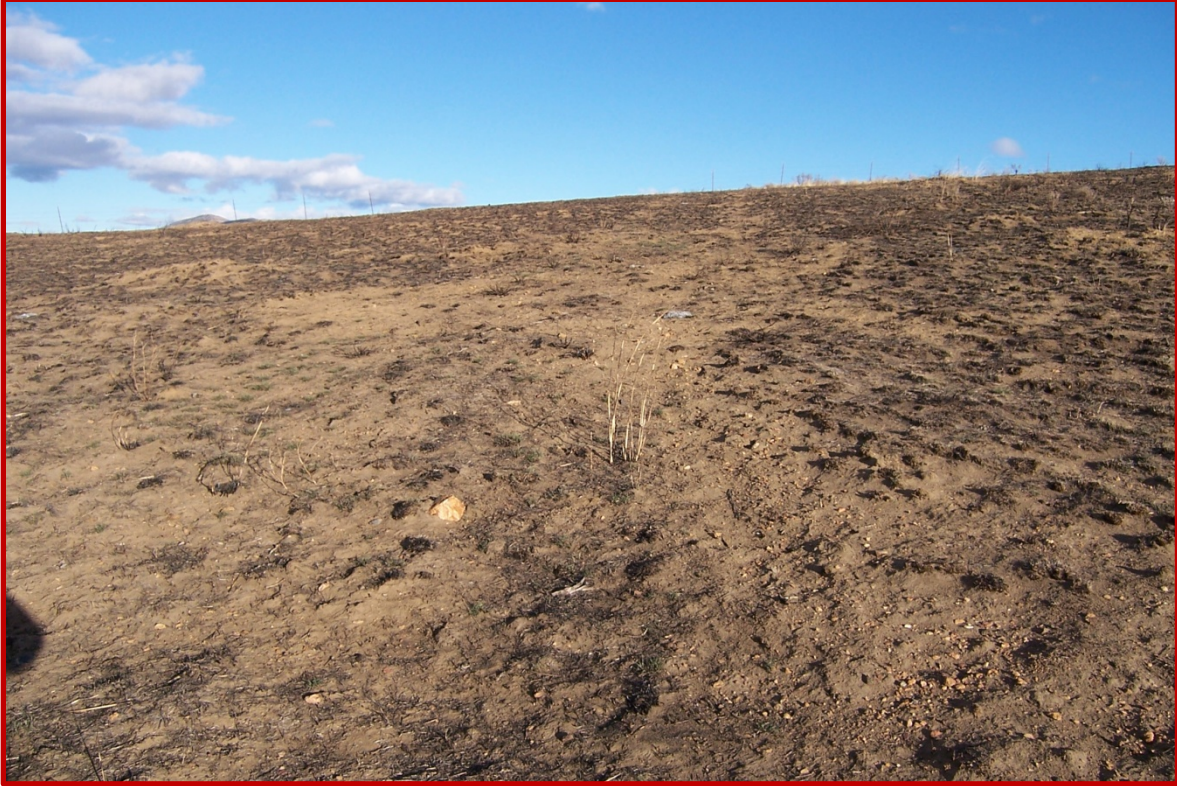
Figure 38. Accessway between USFS road (near fenceline in background) and drill site C9 looking east.

The accessway between the USFS road and site C9 (Figure 38) is burned 100%. Very scattered regrowth of grass was seen.

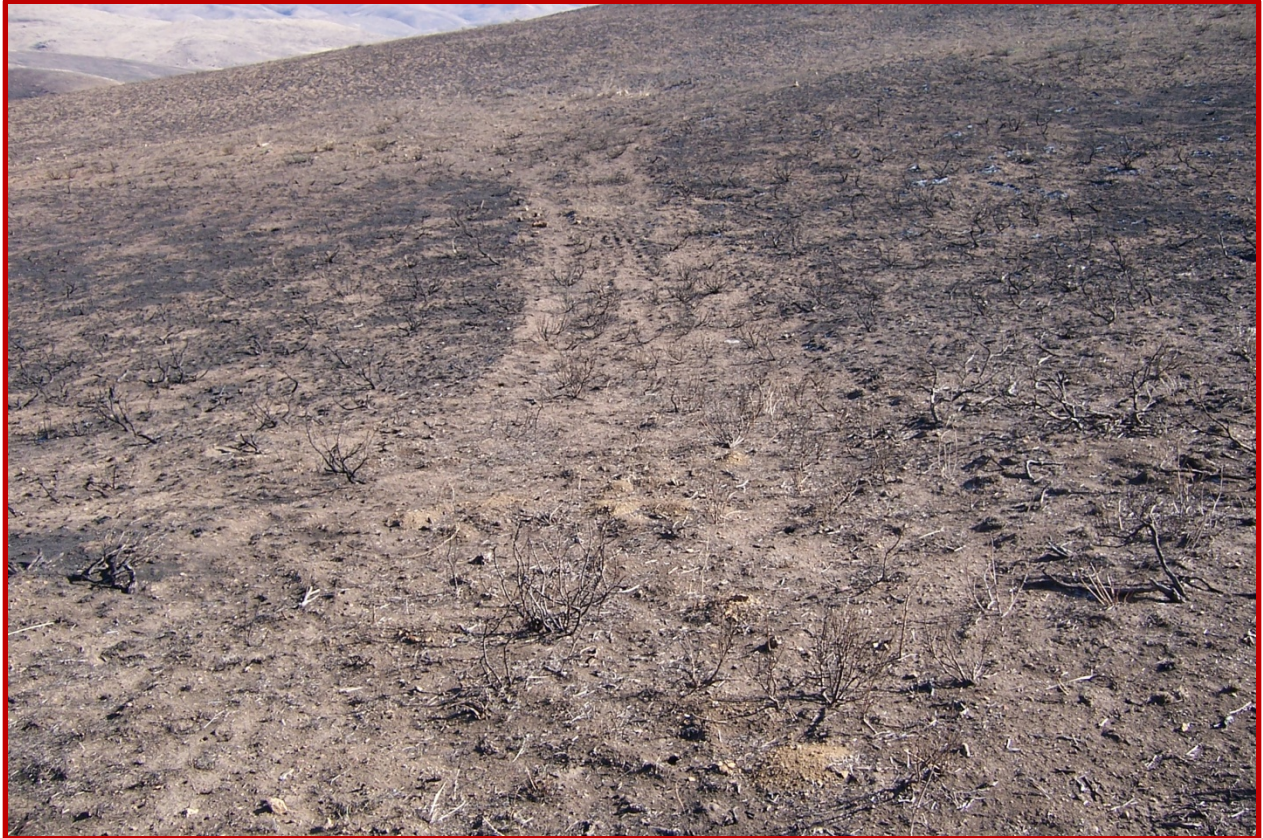
Figure 40. Accessway between USFS road and drill site C10 looking east.

The accessway between the USFS road and site C10 (Figure 40) is burned in excess of 95%. Very little regrowth of grass was seen. Nonetheless, many small shrubs and sage were incompletely burned, so it is possible this area will see some significant regrowth if winter moisture is sufficient to trigger that.

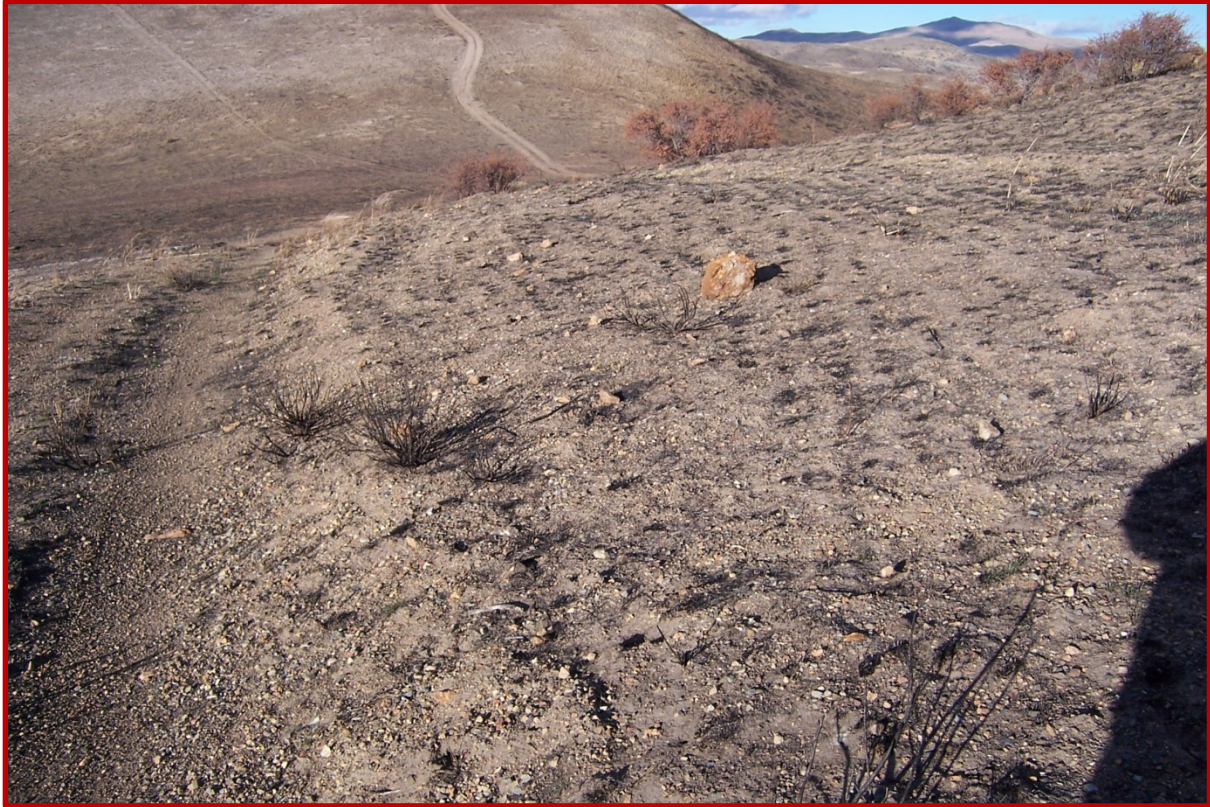
Figure 41. Drill site DT4 looking northeast (drilled in 2013).

Drill site DT4 (Figure 41) is burned 100%. Very scattered and patchy regrowth of grass is visible in Figure 41 (left middleground). This site is on USFS land.

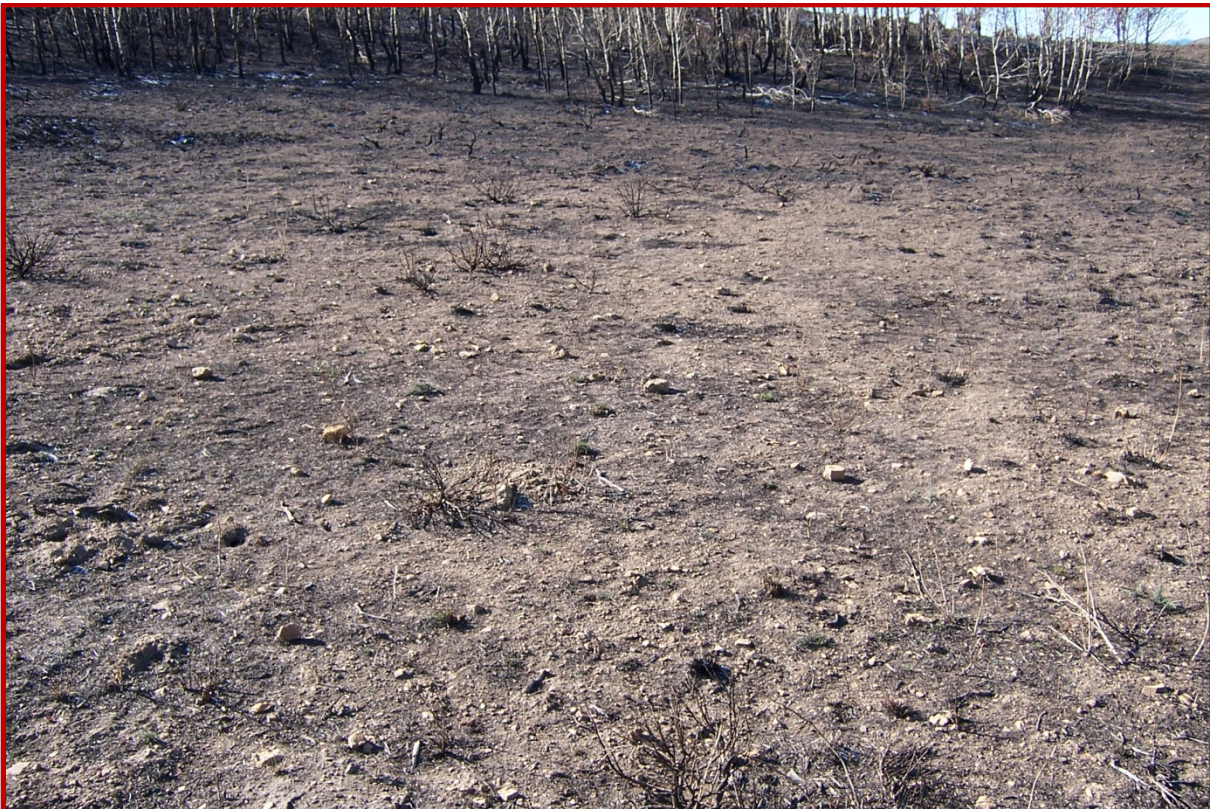
Figure 42. Drill site C11 looking southwest (drilled in 2012).

Drill site C11 (Figure 42) is burned close to 100%. Very scattered regrowth of grass is visible in Figure 41 (left middleground). Some incompletely burned small shrubs remain as well which could help with revegetation of the area. The undergrowth in the aspen grove southwest of the site was heavily impacted by the fire, but the trees appear to mostly remain unburned (other than variable scorching around their bases). This site is on USFS land.

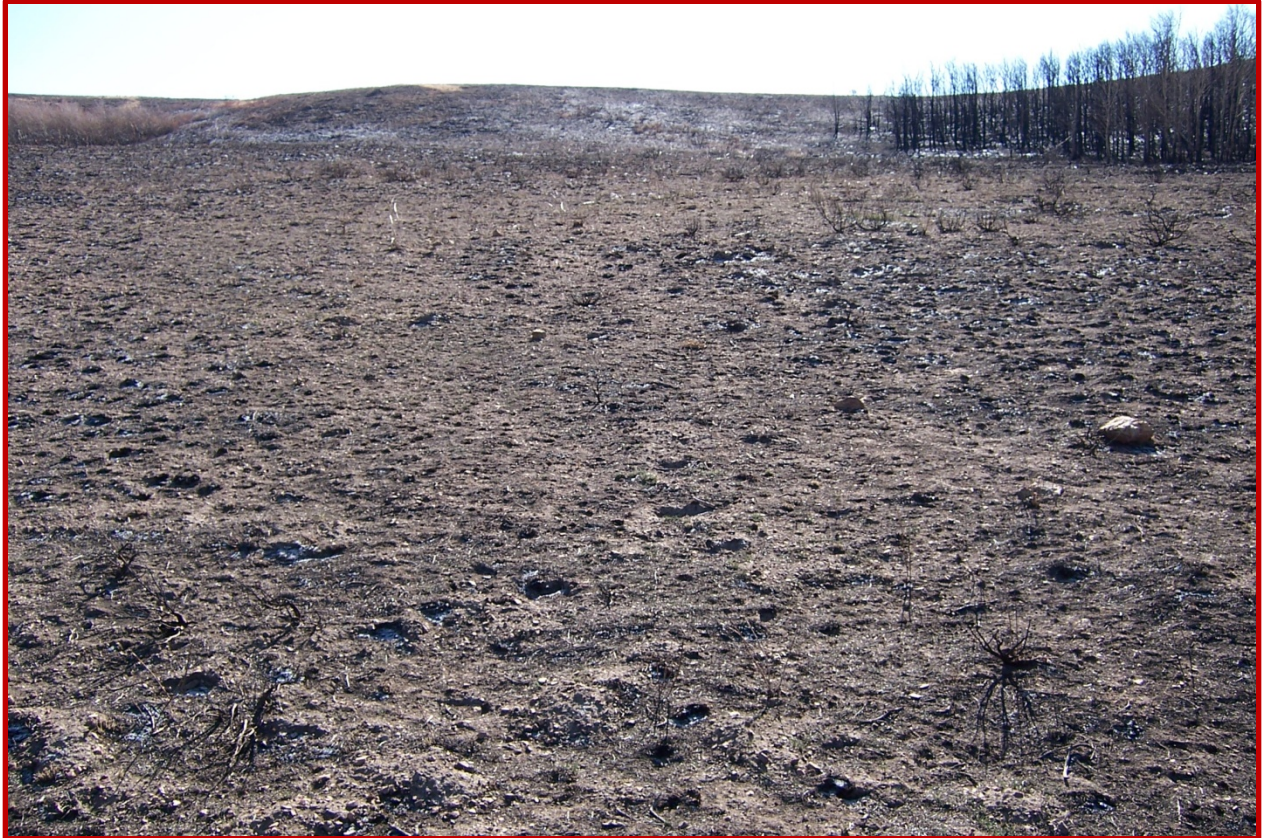
Figure 43. Accessway between drill site C10 and drill site C11 looking south.

The accessway between site C10 and C11 (Figure 43) is burned 100%. Scattered regrowth of grass is visible.

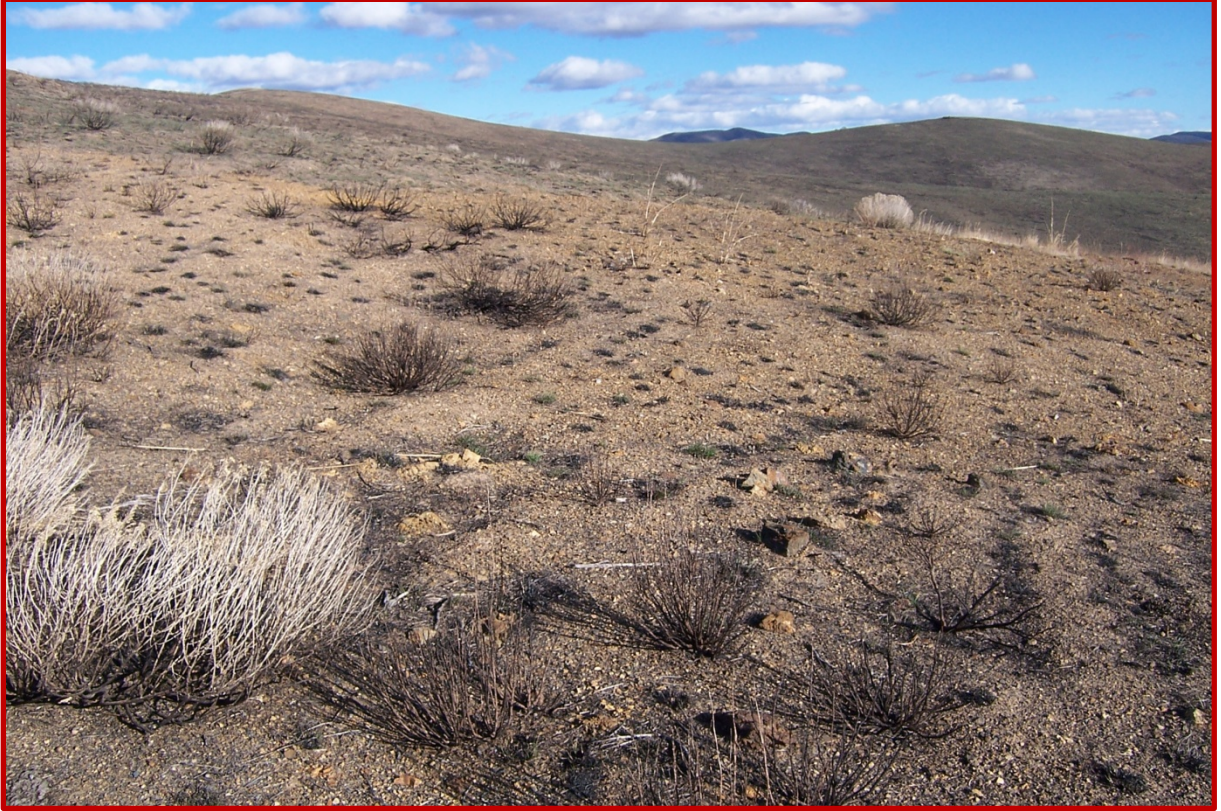
Figure 44. Drill site DT5 looking east-northeast (drilled in 2013).

Drill site DT5 (Figure 44) is burned in excess of 90%. Scattered regrowth of grass is visible in Figure 44. Many unburned to incompletely burned small shrubs can be seen within and around the drill site. This should improve the regrowth of the area with winter and spring moisture. This site is on USFS land.

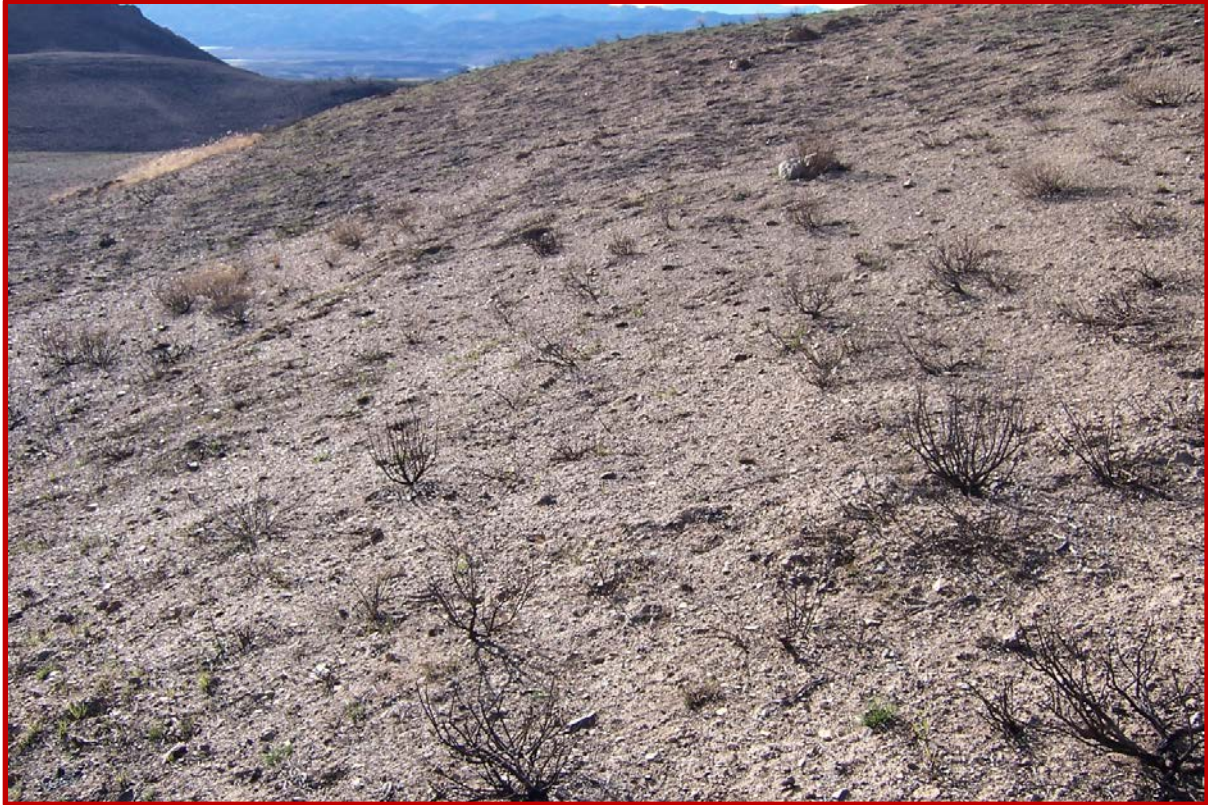
Figure 46. Drill site SW8 looking southwest (drilled in 2012).

Drill site SW8 (Figure 46) is burned in excess of 90%. Scattered regrowth of grass is visible in Figure 46. Many incompletely burned small shrubs can be seen in within and around the drill site. This should improve the regrowth of the area with winter and spring moisture. This site is on USFS land.

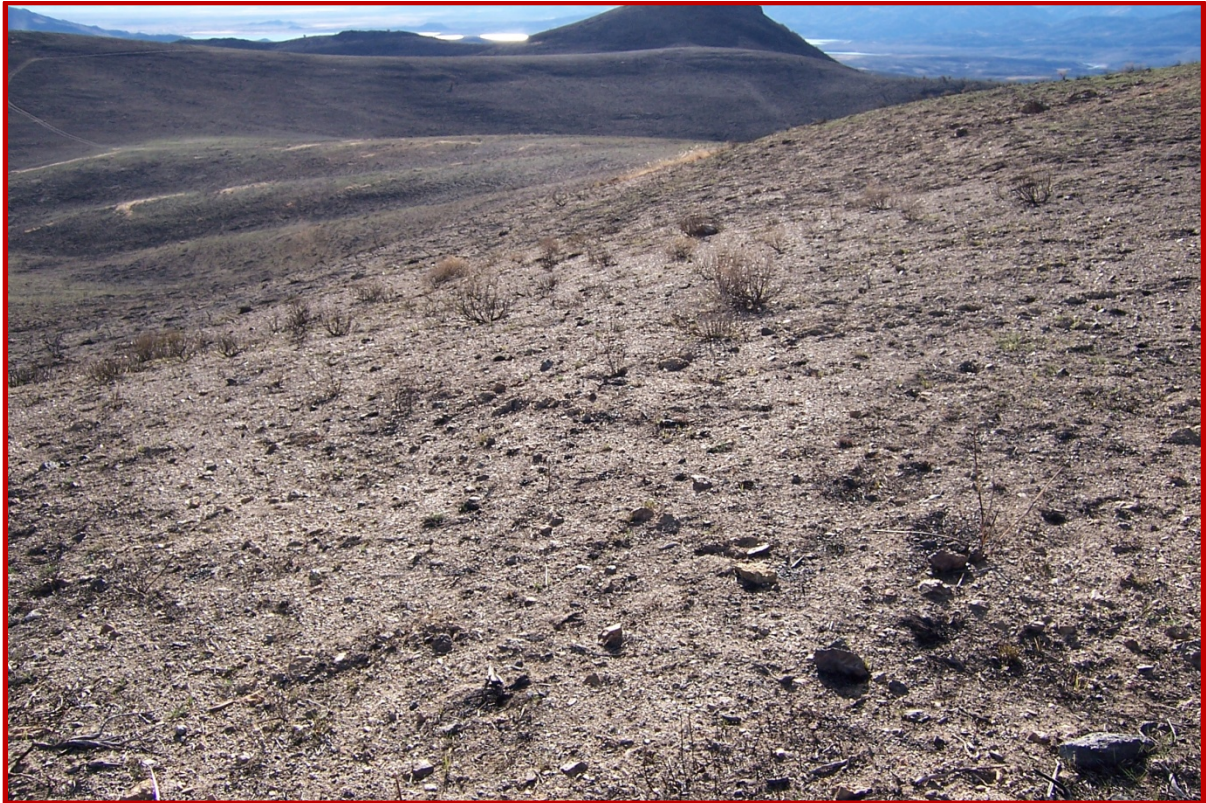
Figure 47. Accessway to drill site SW8 looking southwest.

The accessway between the USFS road and SW8 (Figure 47) is burned close to 100%. Scattered regrowth of grass is visible.

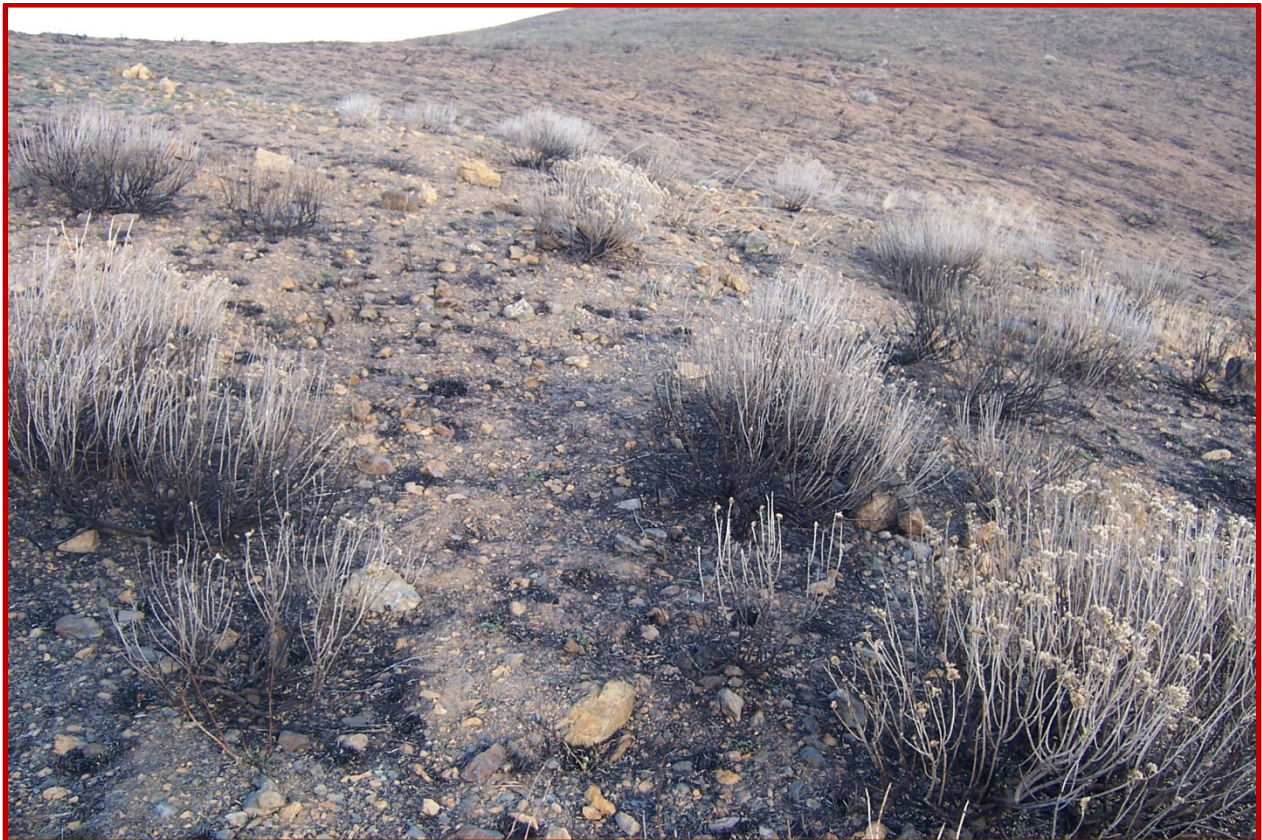
Figure 48. Drill site SW9 looking east (drilled in 2013).

Drill site SW9 (Figure 48) is burned in excess of 90%. Unburned to incompletely burned small shrubs can be seen within and around the drill site. This should improve the regrowth of the area with winter and spring moisture. This site is on USFS land.

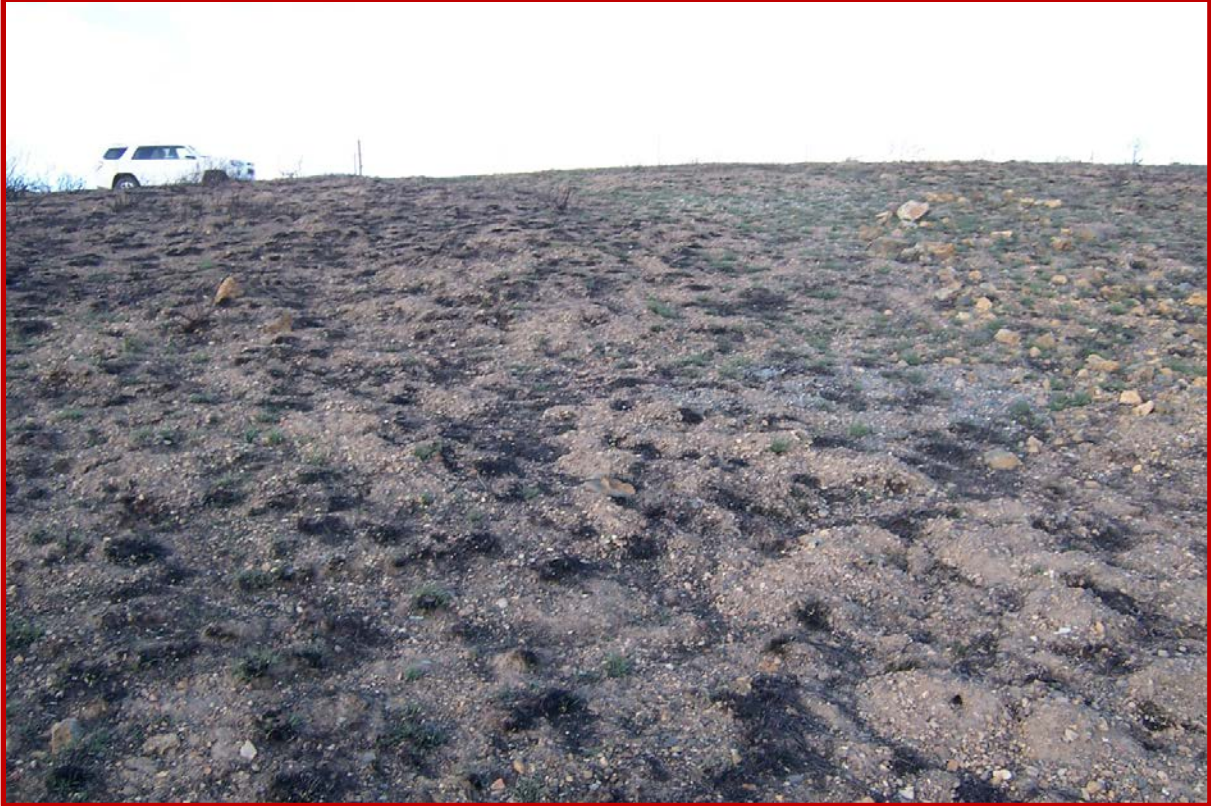
Figure 49. Accessway from USFS road to drill site SW9 looking north.

The accessway between the USFS road and SW9 (Figure 49) is burned 100%. Scattered to abundant regrowth of grass is visible.
