Fire Review Report for the Island Mountain Property and Surroundings, Elko County, Nevada

Field Visit Performed on November 7-9, 2018

**Douglas C. Peters
President
ARNEVUT Resources Nevada LLC**

Report Date: November 20, 2018

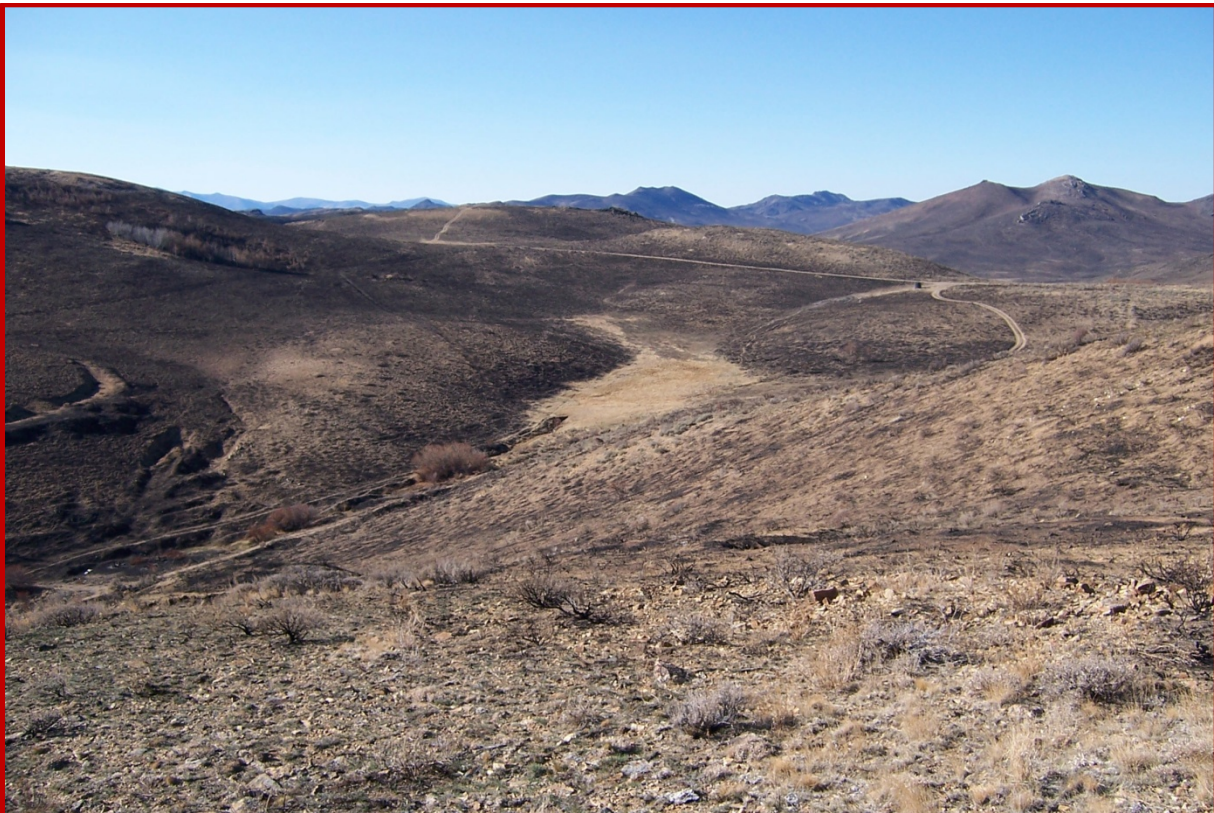
Figure 50. View of Coleman Canyon upstream of the old mining area.

Coleman Canyon on the east side of the property was variably burned due to the patchy nature of the fire on that side of the high central ridge at Island Mountain. The majority of the canyon bottom downstream of the old underground mining area was not burned significantly if at all. Upstream from the mining area (Figure 50), most of the canyon was burned, with remnant patches of vegetation remaining.

The seasonally boggy area just downstream of Staging Area 2 (large light brown patch in

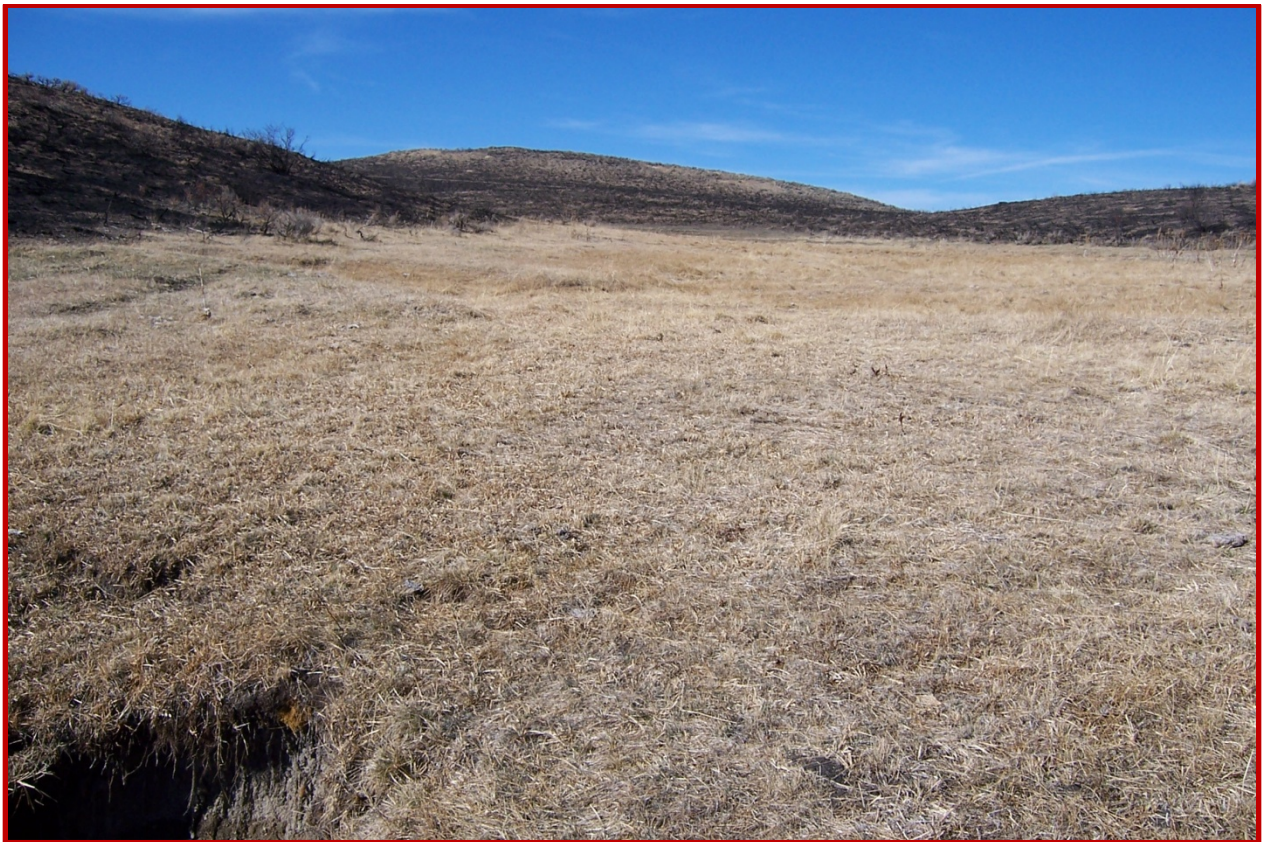
center of Figure 50 and Figure 51) was untouched probably because of the low growth of vegetation that did not support the fast-moving fire. This vegetation also probably was relatively green and high in moisture content (due to the perched water table) at the time of the fire and harder to ignite. The boggy area served as a small firebreak such that the grass and sage area to the east of it and the USFS road was not burned either.

Figure 51. Closeup looking northwest of the seasonally boggy area in upper Coleman Canyon.

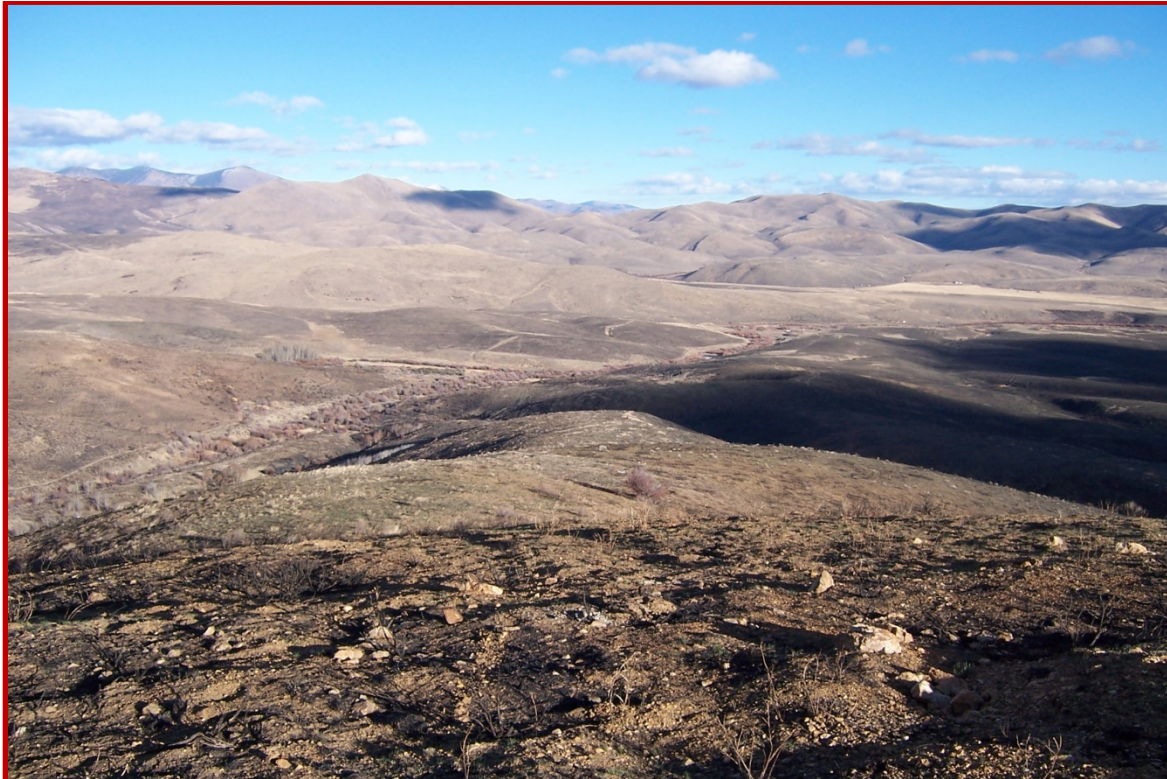
The riparian vegetation in middle to lower Coleman Canyon was largely untouched by the fire. The dense willows in this area can be seen in Figure 53 and in the closer panorama (attached with this report as a separate LowerColeman-pan.pdf file) of the area above the confluence with Hammond Canyon. As with the boggy area in upper Coleman Canyon, the willows, grasses, and sedges on the valley floor in this stretch of the stream likely were wetter at the time of the fire and did not support fire ignition and movement.

Figure 53. View of lower Coleman Canyon and region to east of Gold and Martin Creeks looking east-northeast from planned drill site SE7.

Except for a large northern finger of the fire (burn is visible in upper left of Figure 53), which extended all the way to the high hills east of Martin Creek, the fire stopped at Gold Creek and at the Gold Creek road on the east side of the hill just east of Gold Creek. Presumably, the creek and road acted as a firebreak and/or a containment line for the fire crews.

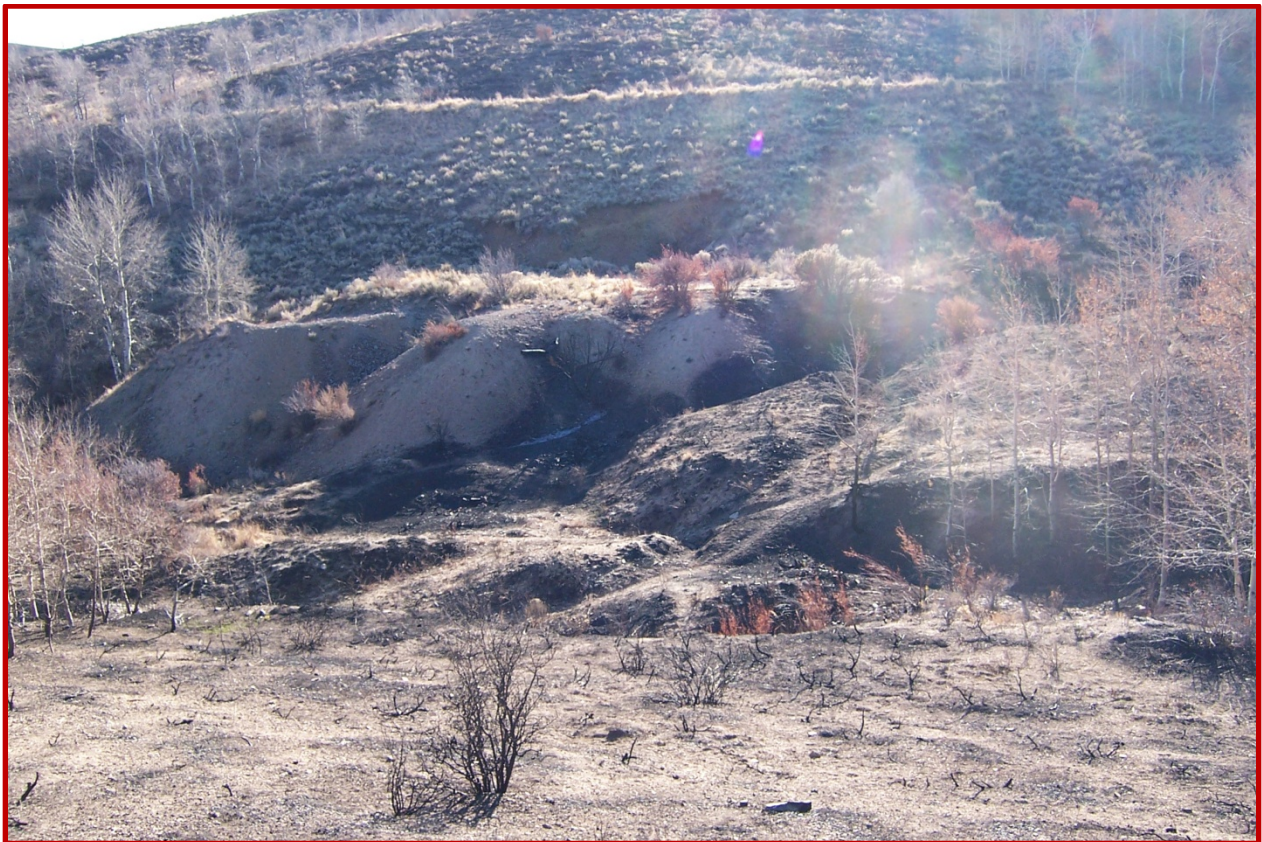
The old underground mining area in upper Coleman Canyon (the area covered by the cluster of patented claims) was largely unaffected by the fire. Figure 54 shows the central part of the workings where there is a collapsed shaft (upper center of picture) and collapsed adits (one visible at upper right in the picture). The fire burned the upstream portion of the surface workings (Figure 55) and down the streambed to the underground workings area (Figures 54 and 55). The stand of aspen and related undergrowth on the northwest side of the old workings appeared to have served as a firebreak and stopped the fire from advancing into the mining area beyond the western fringe of the trees. Only spot fires occurred within the stand of trees. The mine waste piles, being dominantly bare rock, also appear to have kept the fire from wrapping back into the mining area from the streambed. Most of the riparian streambed area to the east of the old workings also was not burned.

Figure 54. View of mine dumps and burn extent in old mining area in upper Coleman Canyon looking southwest from USFS road.

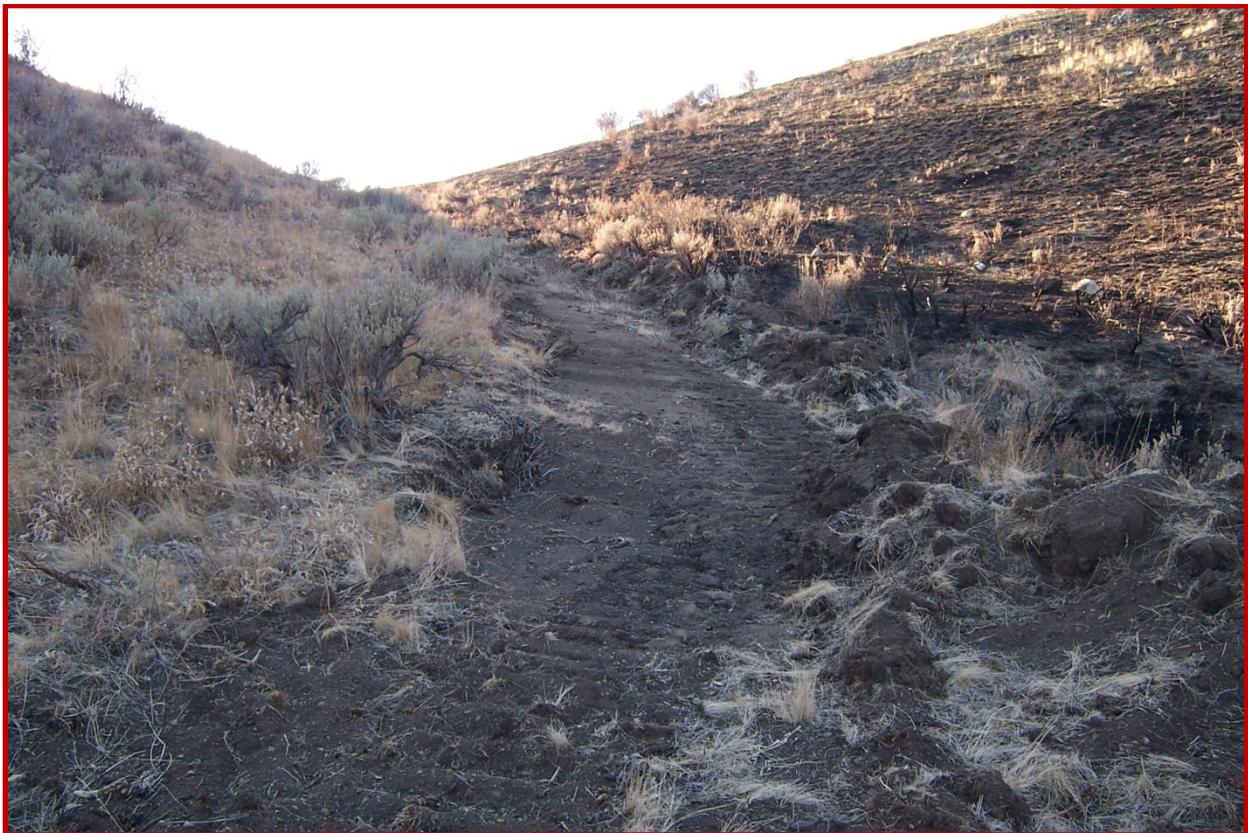
During this Fire Review, it was discovered that a portion (about 100 feet) of the Chinese Ditch in upper Hammond Canyon was damaged by the firefighting efforts. A bulldozer firebreak was cut from near drill site NE2 (on the ridge between upper Coleman and Hammond Canyons) down a small tributary into Hammond Canyon (Figures 64-69). The berm of the ditch has been variably cut or removed along this damaged section. The bowl of the ditch was mostly leveled as part of the firebreak construction.

Figure 64. Bulldozer firebreak in small tributary to Hammond Canyon looking west.

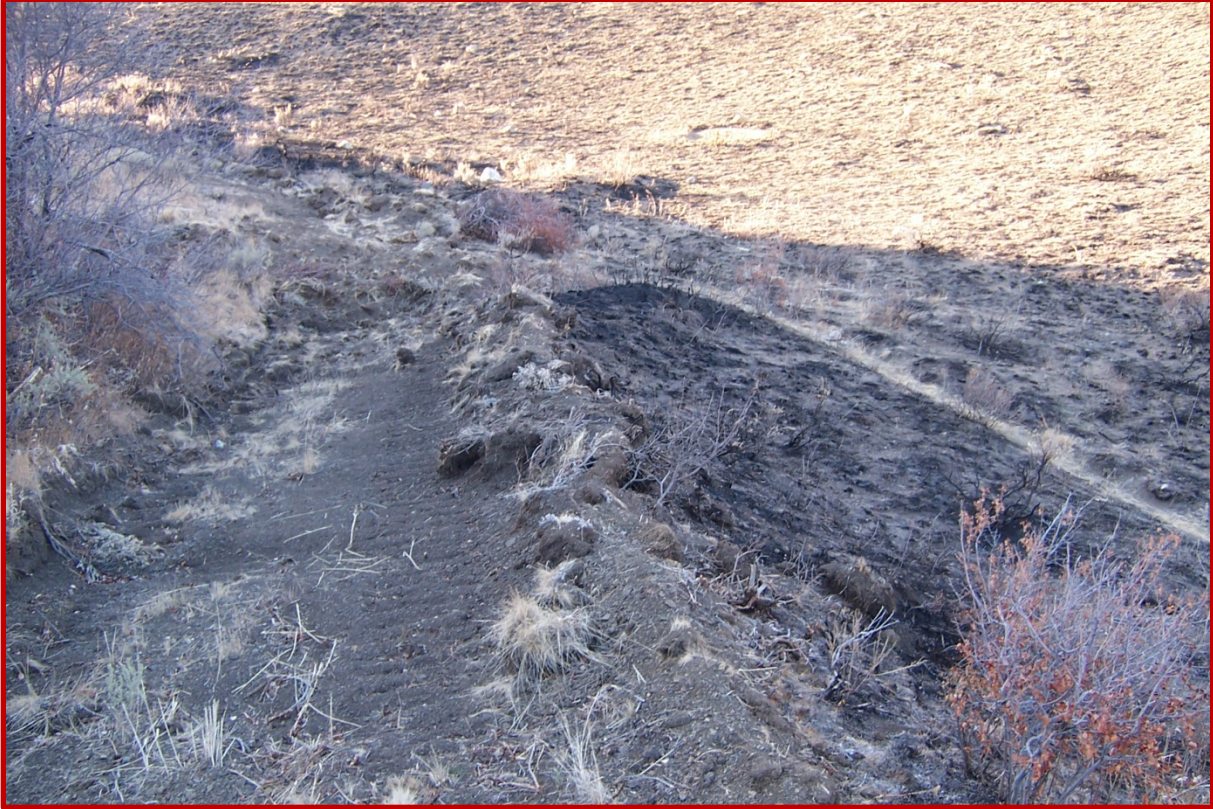
Figure 67. Portion of damaged Chinese Ditch southeast of the intersection with the firebreak.

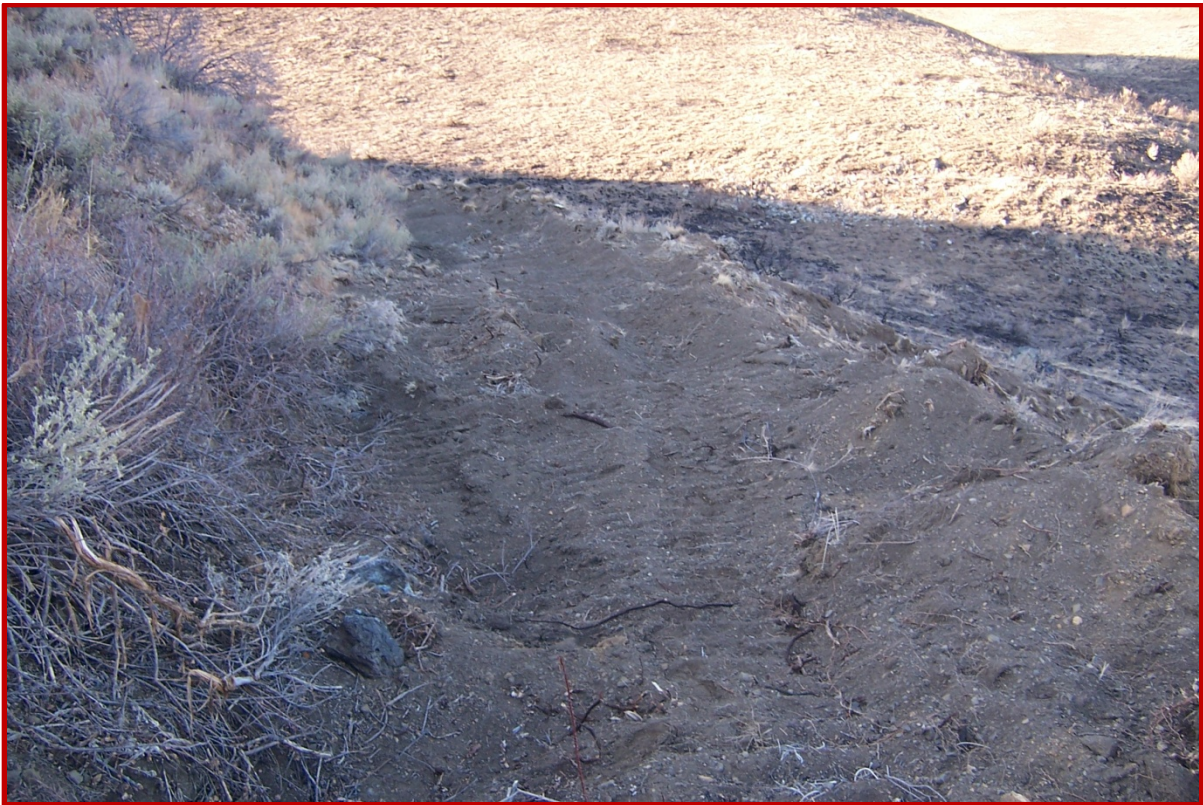
Figure 68. Middle portion of the damaged part of the Chinese Ditch.

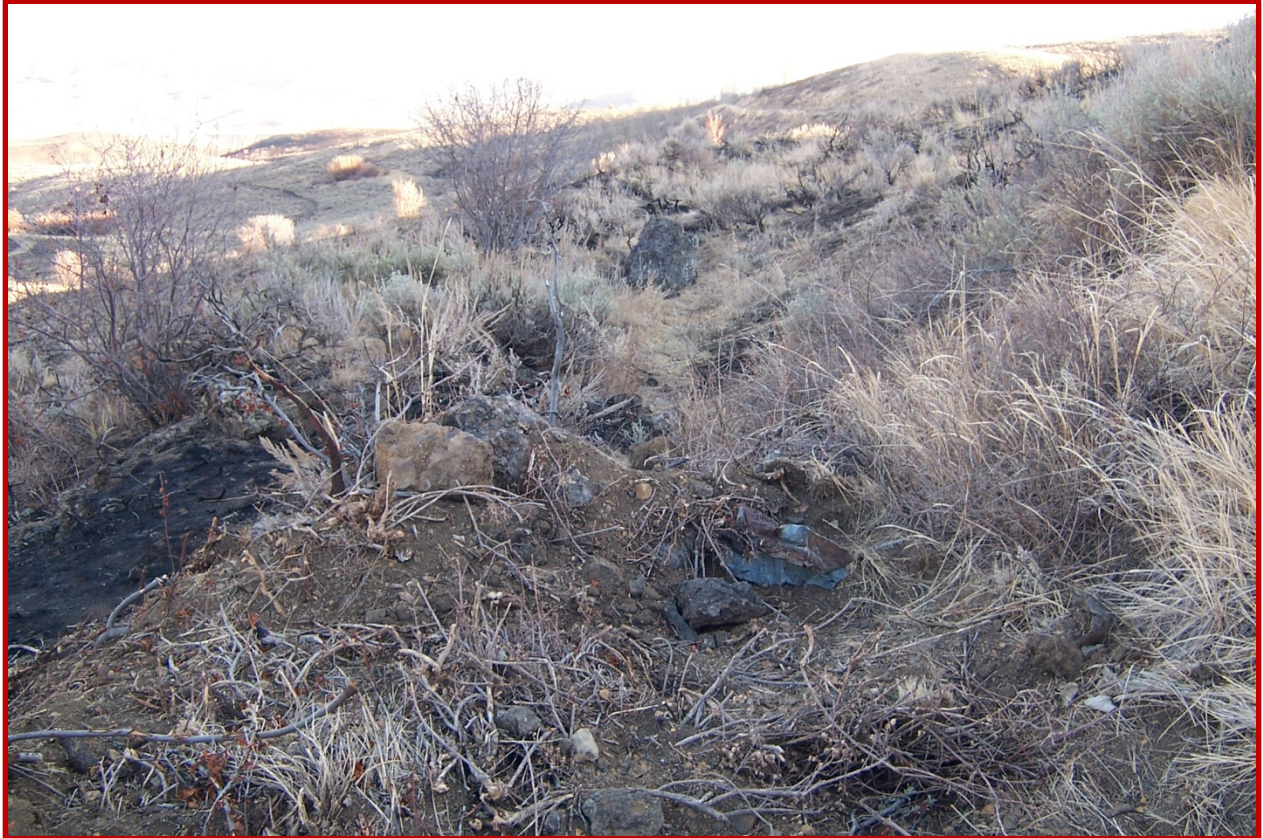
Figure 69. Southeast end of the damaged section of the Chinese Ditch. The firebreak continued to the left into the valley bottom.
