Fire Review Report for the Island Mountain Property and Surroundings, Elko County, Nevada

Field Visit Performed on November 7-9, 2018

**Douglas C. Peters
President
ARNEVUT Resources Nevada LLC**

Report Date: November 20, 2018

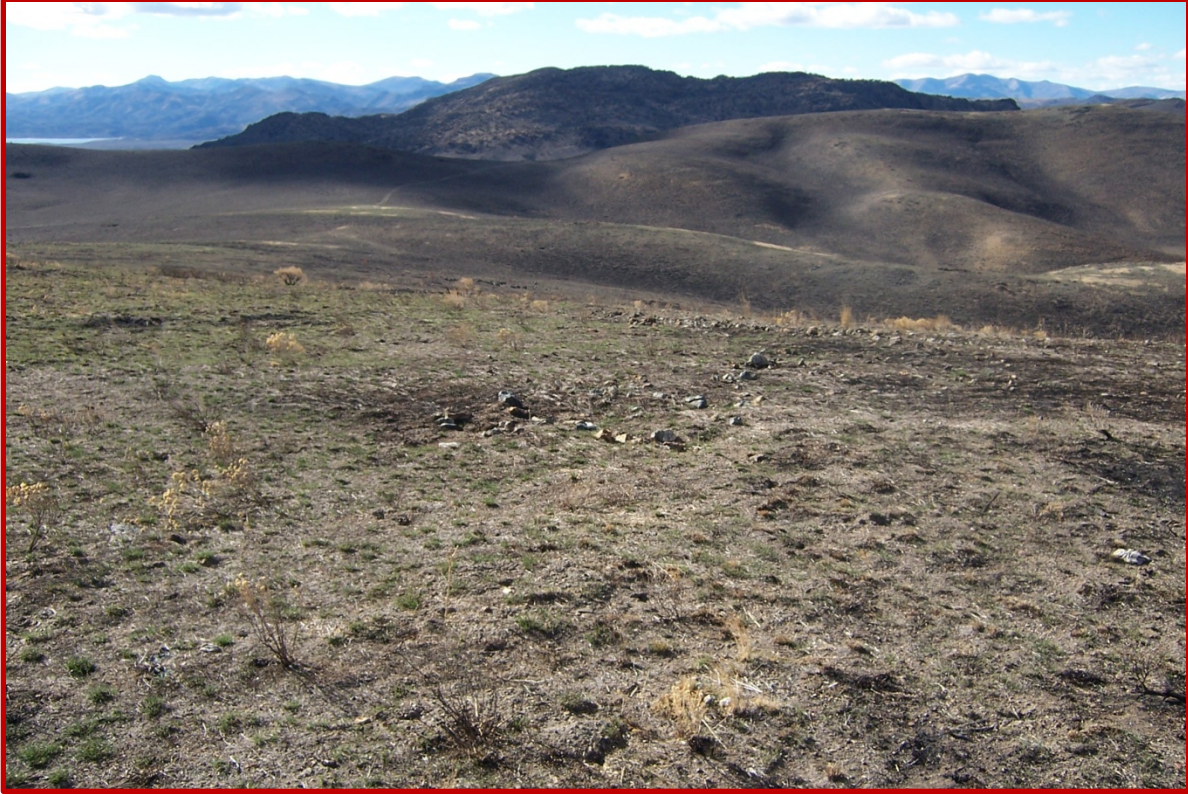
Drill site GG-NW1 (Figure 5) is burned in excess of 95%. Of interest is that grass sprouts were common to abundant in this area (visible as green in the foreground and in the

background in Figure 5), so there should be significant ground cover in 2019 if the winter is sufficiently wet. There was little sage in this area originally, but any present before has been mostly (low blackened bushes in background) to fully burned. Some of the patchy nature of the burn area north of the ridge where this site is located can be seen in the background on the right side. This site is on USFS land.

Figure 5. Dill site GG-NW1 looking west (drilled in 2012).

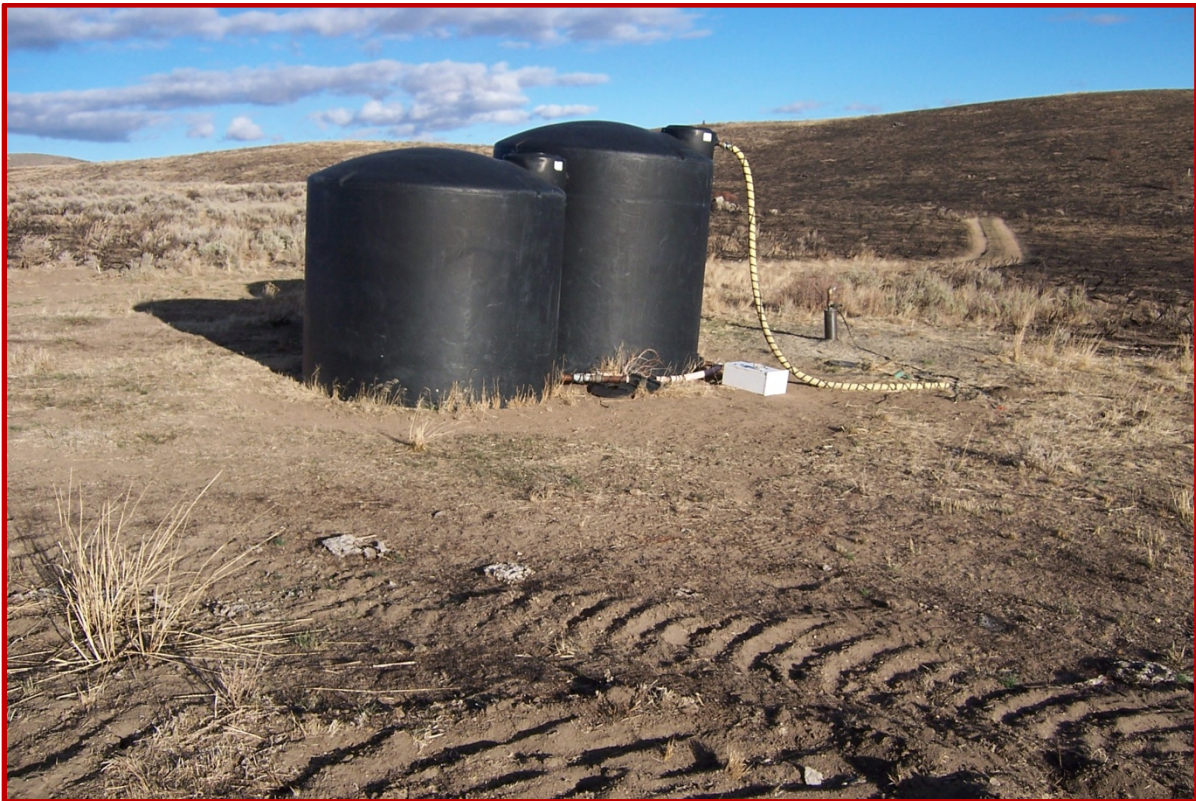
Drill site WW1, the exploration water supply well drilled in 2013, coincides with Staging Area 2 for the Island Mountain project (Figure 6). The two water tanks installed in 2013 remain to allow future use of the well and water storage for planned further drilling. The staging area also will be used in further exploration work. Therefore, no reclamation work was performed at this site in 2013 and will not be done until the staging area is no longer needed for exploration activities. This site is on private land.

Nonetheless, the site remains largely unburned (80%) except for the western edge (just visible in Figure 6). The disturbed and partially denuded nature of the site and the adjacent

Figure 6. Drill site WW1 (water well; drilled in 2013) and Staging Area 2 looking northeast.

USFS road appear to have acted as a small firebreak. A significant area of the sage and grass immediately to the northeast of the site remained unburned. Likewise, the water tanks and wellhead appear to have been unaffected by the fire.

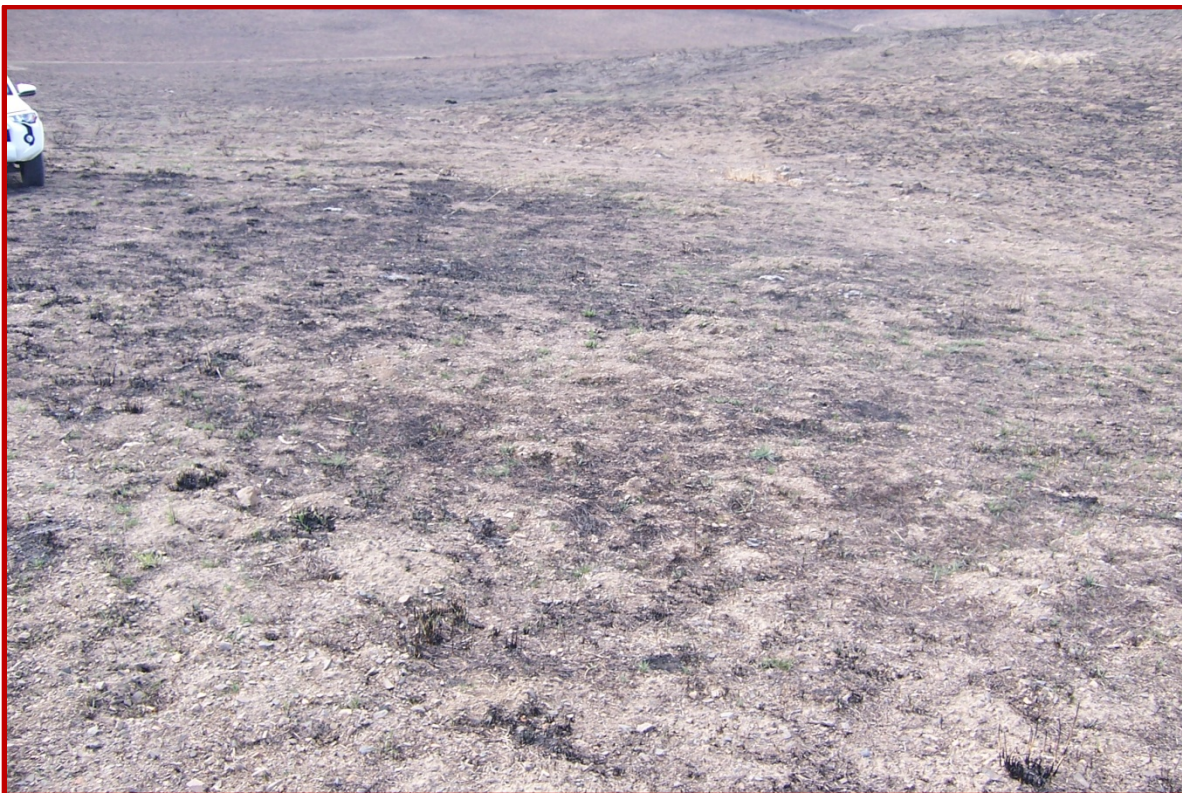
Drill site NW3 (Figure 13) is burned 100%. Significant but patchy regrowth of grasses and a few forbs has occurred since the fire, with many sprouts visible in Figure 13. Also, an unburned stem and seed head for a Rocky Mountain Bee Plant was found at the site, indicating that this species (first seen here in 2013 after 1 full year of revegetation) likely will continue growing here in the future. This site is on USFS land.

Figure 13. Drill site NW3 looking northwest (drilled in 2012) with part of accessway to NW6 in the background.

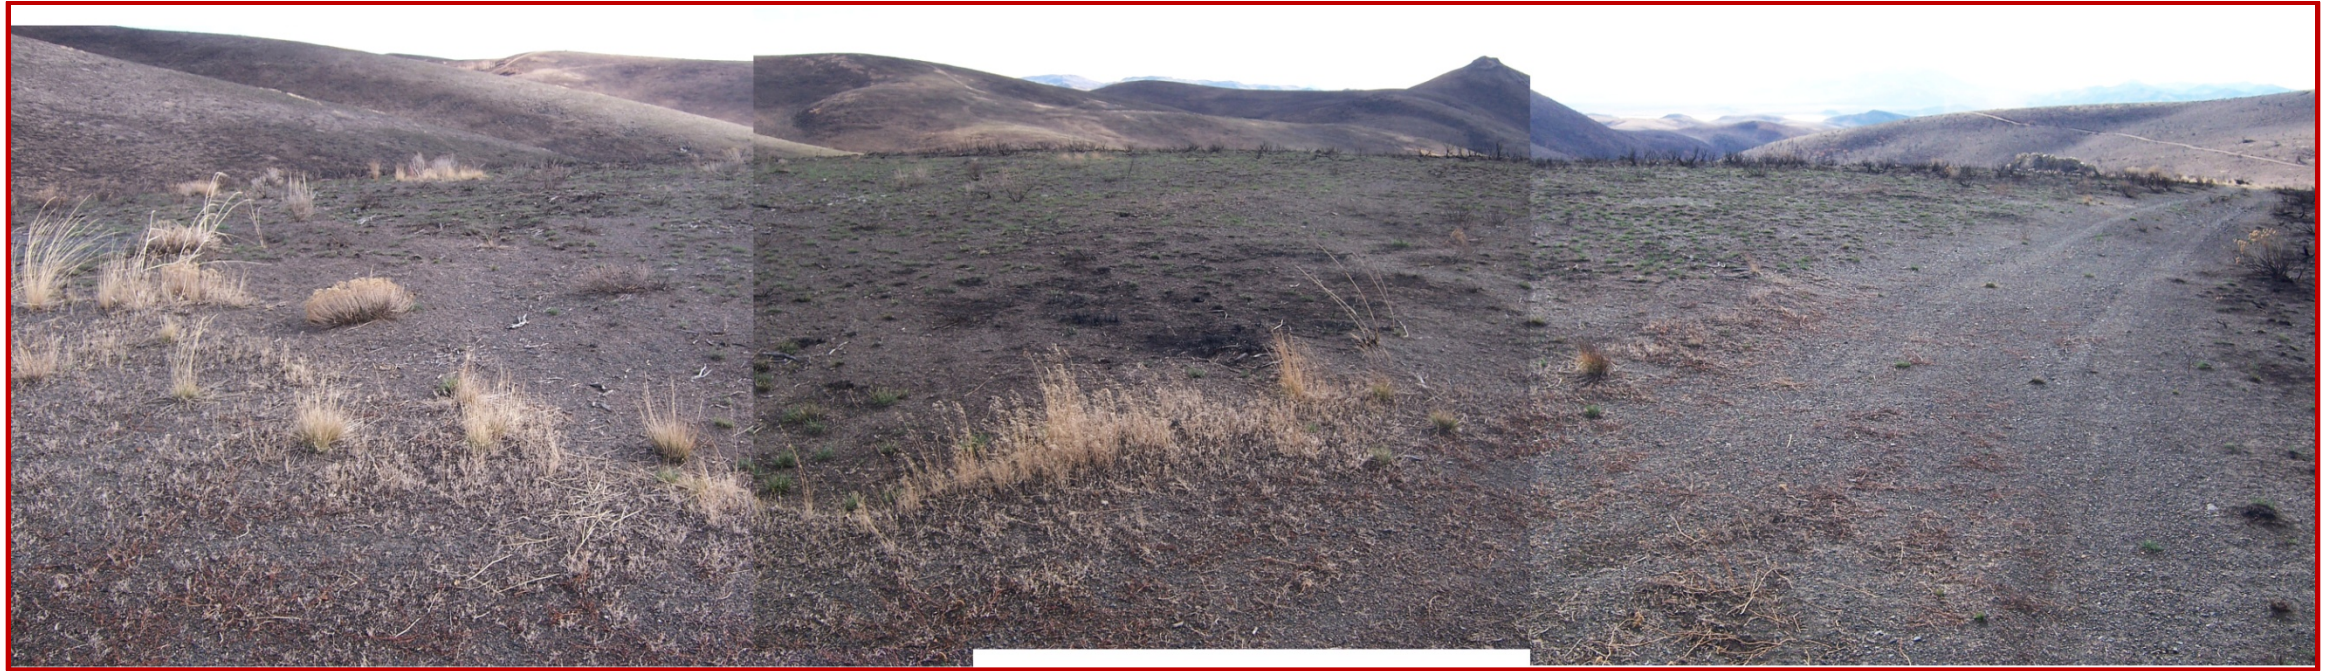
Drill site DT8 (Figures 15 and 16) is burned close to 100%. The drill site is included in the general area of Staging Area 1 that ARN used and is using for equipment and other logistical support for drilling and other exploration activities on the property. The overall staging area is burned in excess of 80%. The berm seen in Figures 15 and 16 was retained after recontouring of the drill site so that supplies, vehicles, and trailers would have a backstop for the hillside when parked in this flat area. Staging Area 1 (additionally shown in Figure 17) was set up based on an

Figure 17. Panorama of Staging Area 1 looking south to southwest.

already heavily disturbed area probably left over from previous operators and perhaps also from ranching activities. This site is on USFS land.

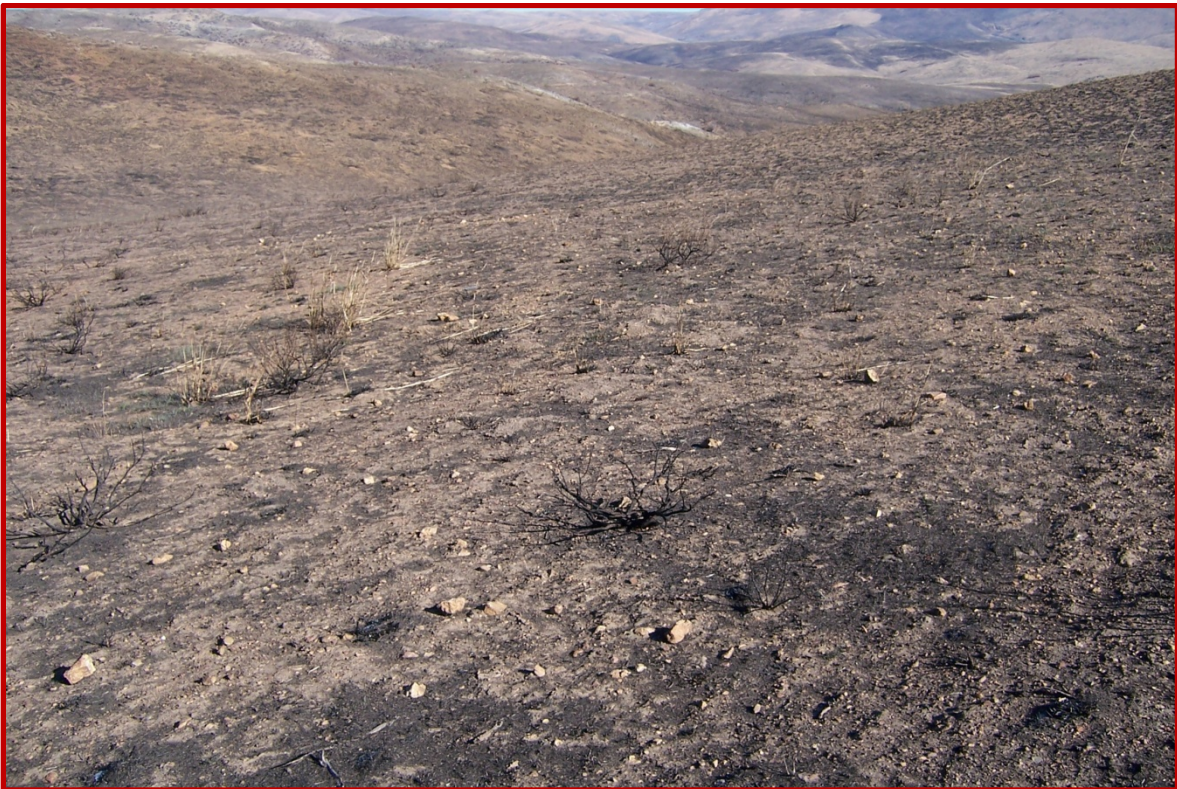
Drill site C10 (Figure 39) is burned close to 100%. Very scattered and patchy regrowth of grass is visible in Figure 36 (left middleground). This site is on USFS land.

Figure 39. Drill site C10 looking northeast (drilled in 2012).

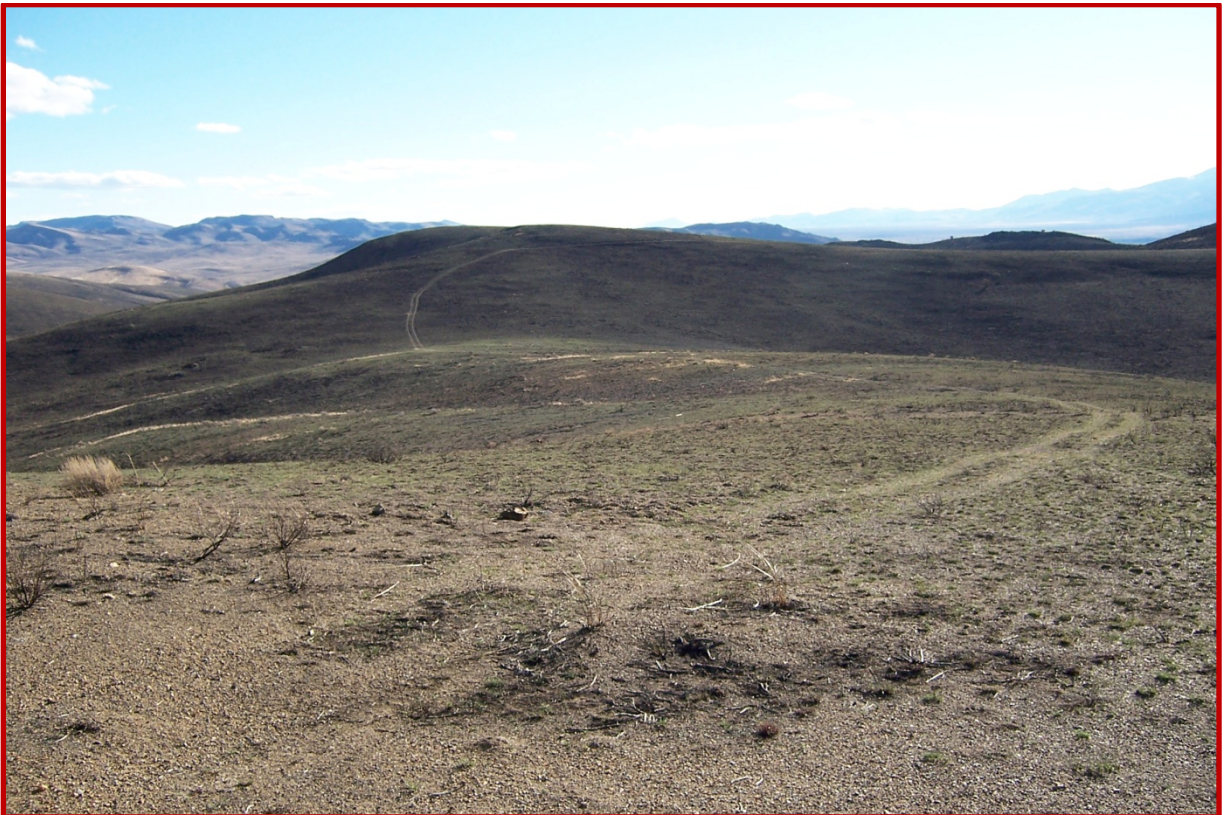
Of interest for future plant growth in this part of the project area and surroundings is that there is abundant new growth of grass to the south of drill site DT5 as visible in Figure 45. This area was dominantly grass before the fire.

Figure 45. View to the south from near drill site DT5.

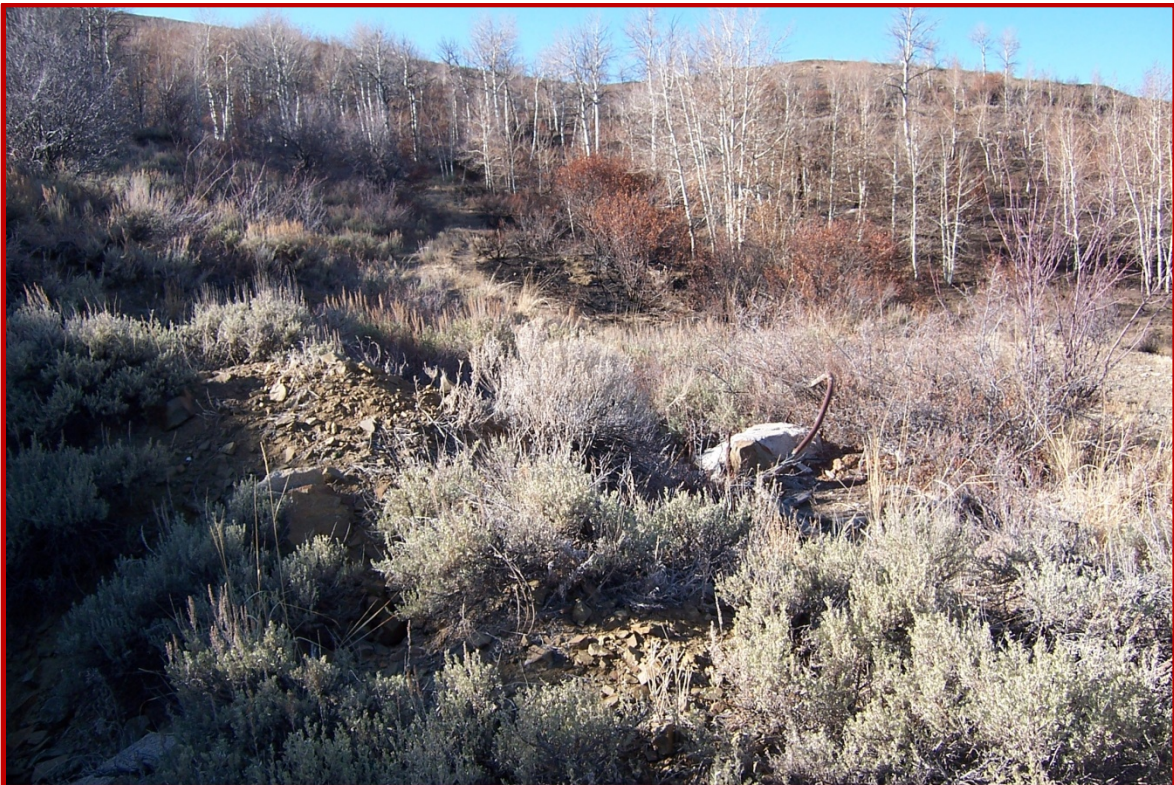
Figure 56. View of old mining area from the collapsed shaft looking northwest.

There were no standing complete or remnant wooden or other vulnerable structures in the upper Coleman Canyon mining area prior to the fire. However, it is possible that artifacts were destroyed or damaged within the areas that did burn.

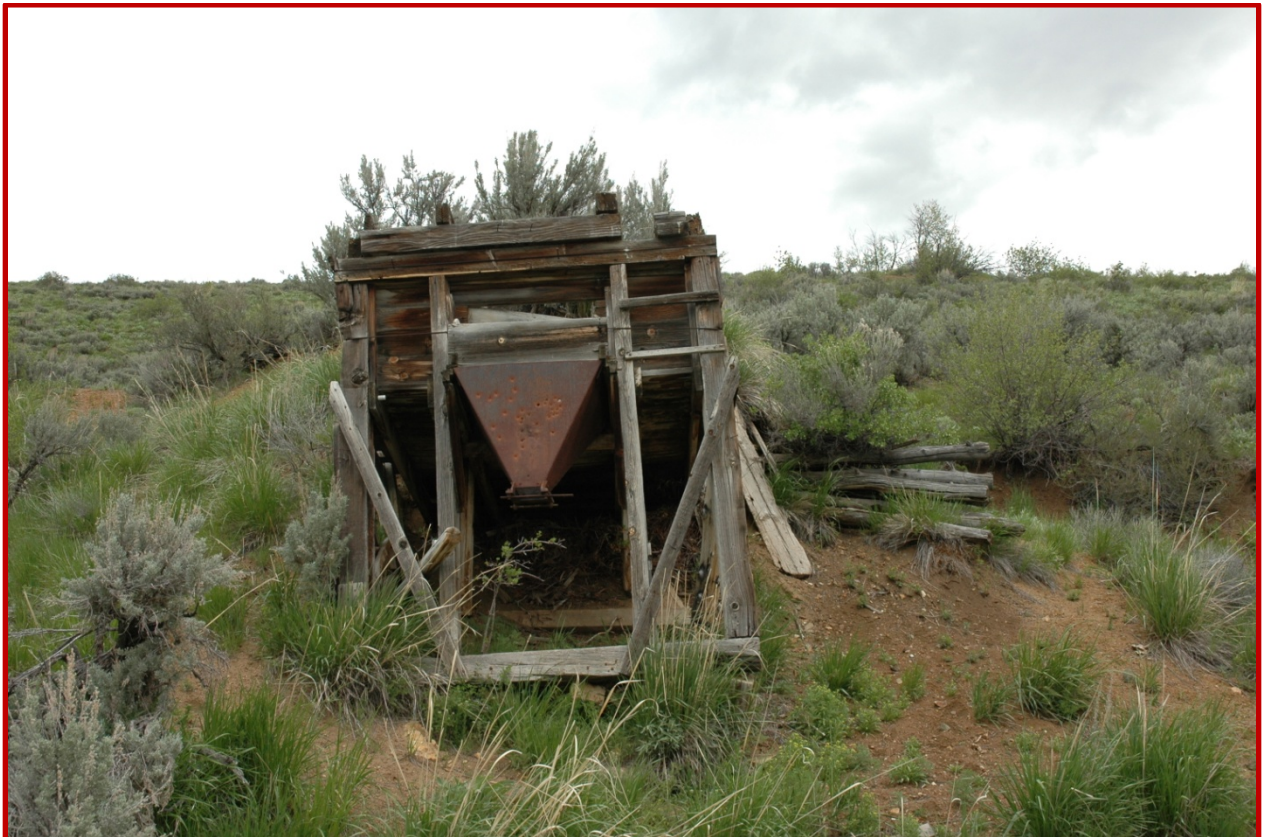
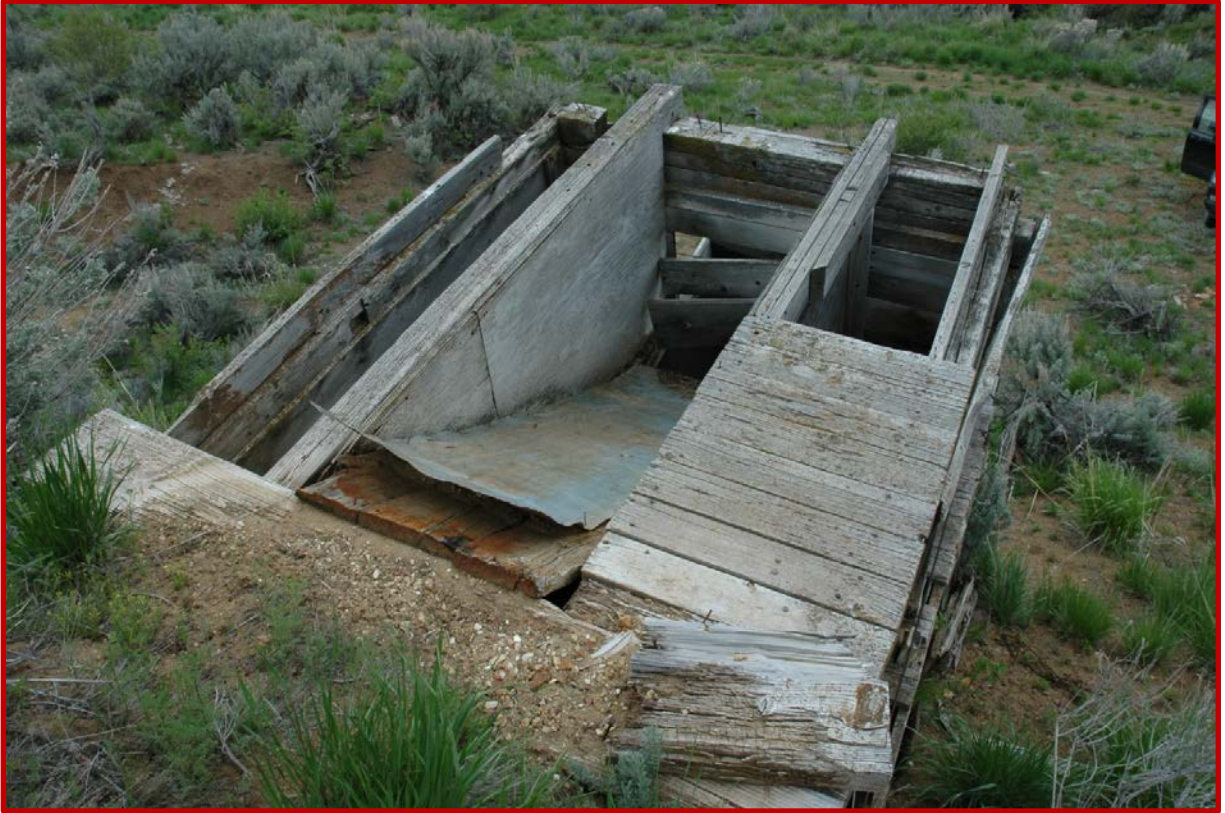
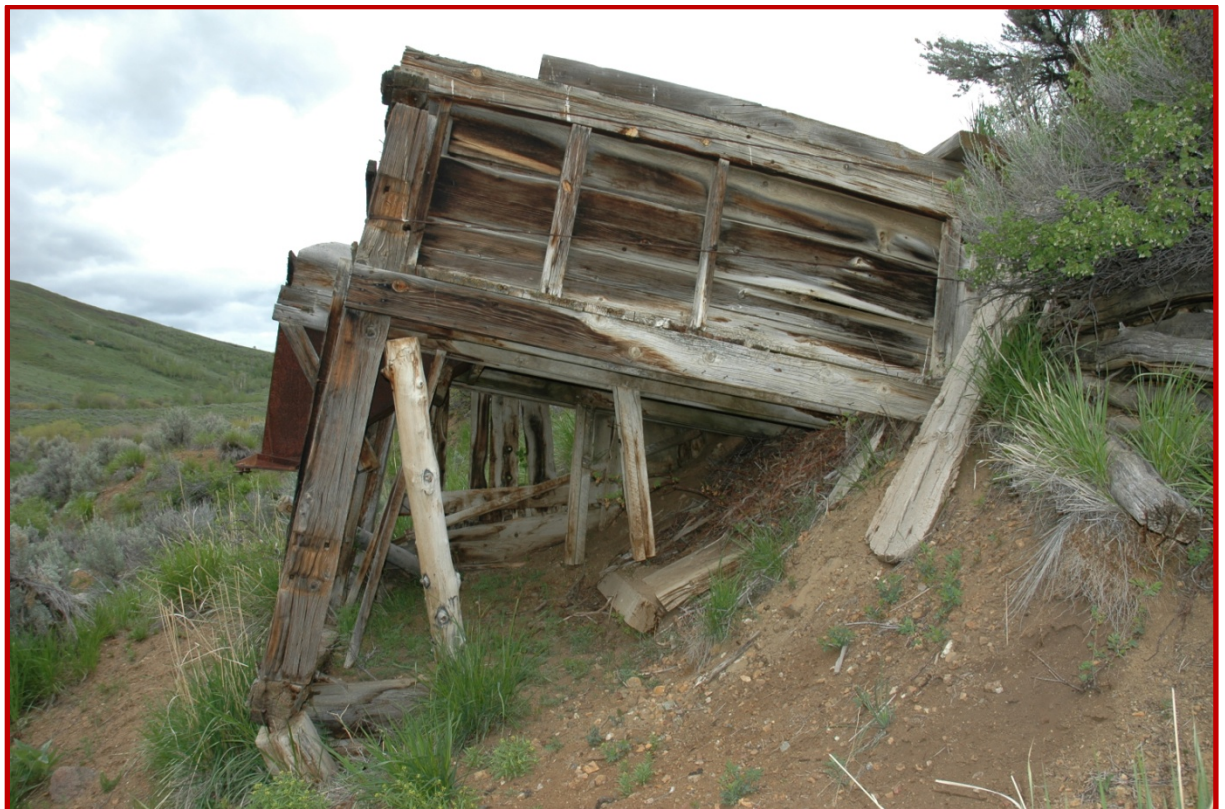
There is a collapsed adit in lower Coleman Canyon on the north side of the road about 300 m upstream of the Chinese Placer workings. Prior to the fire, the ore loading bin (Figures 57-59) to the southeast of the adit was the only standing mine structure in Coleman Canyon. That bin almost completely burned during the fire (right of center in Figure 60). Only the metal hopper, the wear plate that was above the hopper, and a couple unburned pieces of wood remain.

Figure 57. Ore loading bin (front view) in lower Coleman Canyon (taken June 9, 2010).

Figure 58. Ore loading bin (top view) in lower Coleman Canyon (taken June 9, 2010).

Figure 59. Ore loading bin (east side view) in lower Coleman Canyon (taken June 9, 2010).

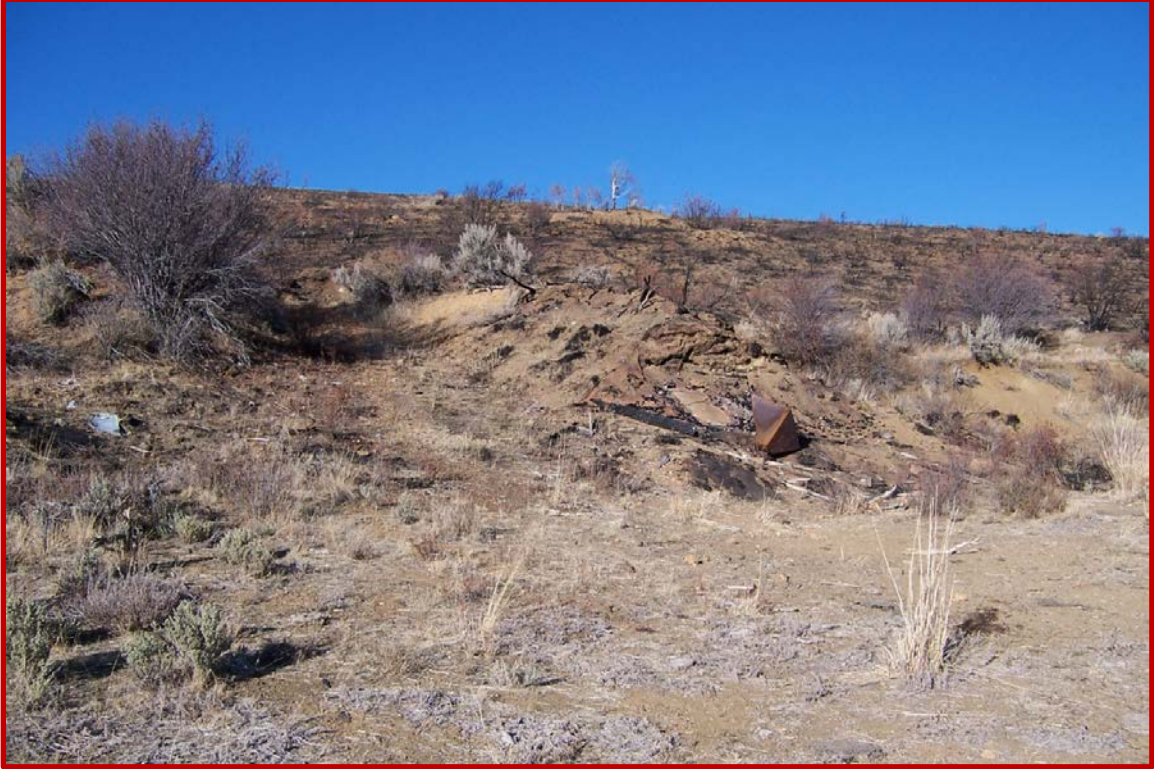
The overall area of the adit and related workings farther up the hill is shown in Figure 61. No other standing full structures were known in this area. However, there is an intact pile of lumber on the waste pile to the left of the adit (behind the large bush at upper left in Figure 60) which could have been a small hut or other building at one time. There also was a remnant structure (floor boards and lowest wall boards) of a small cabin about 50 feet to the east of the collapsed adit. This remnant structure also completely burned during the fire. Only part of a stovepipe, nails, the “foundation excavation” (a building outline a few inches deep at most), a stove “mound” (raised dirt square where a stove likely was located), and miscellaneous trash (such as metal cans) remain from that structure.

Figure 60. View of collapsed adit area and former ore loading bin looking north from USFS road.

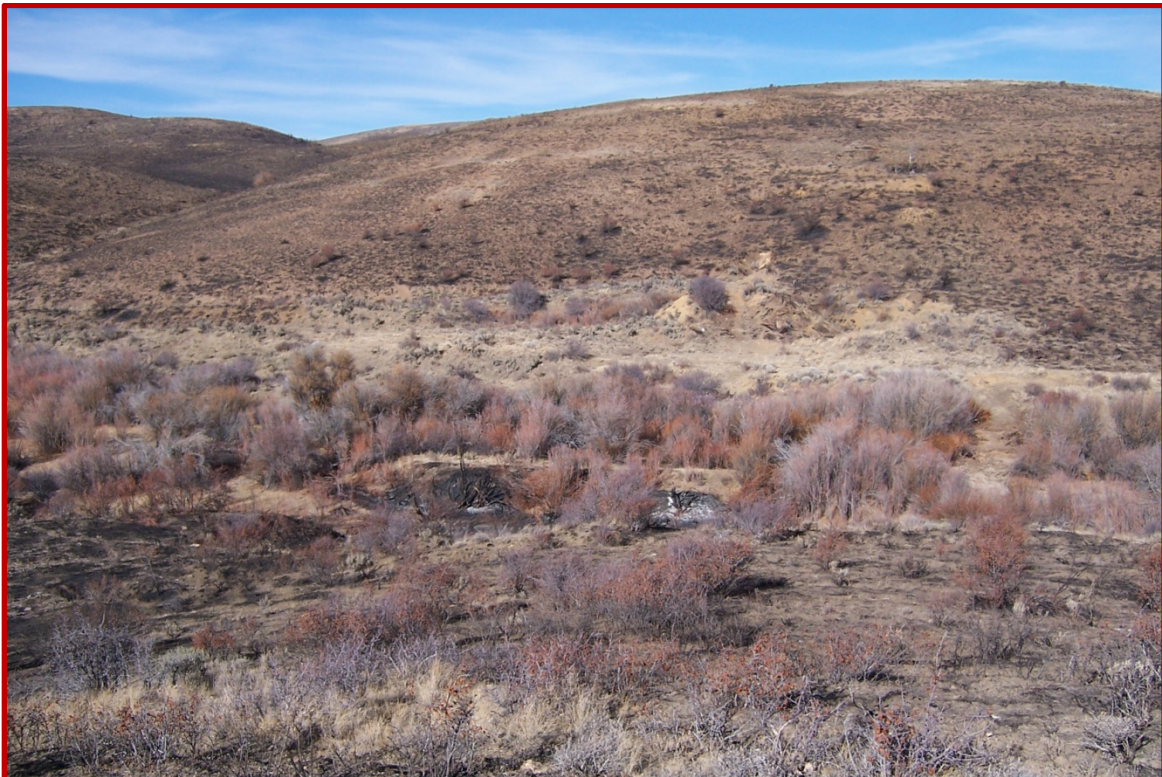
Figure 61. View of collapsed adit area in lower Coleman Canyon looking north from south side of the canyon.

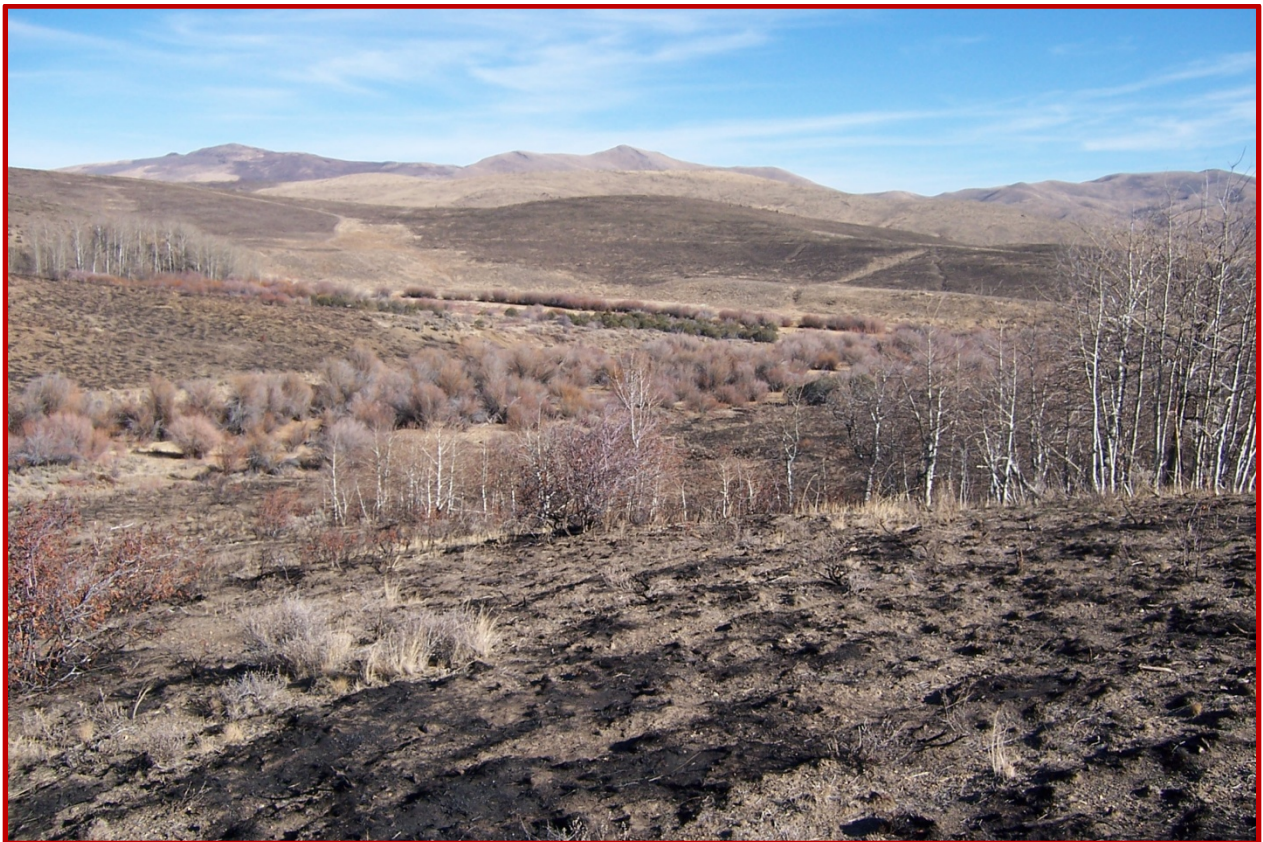
The main part of the Chinese Placer workings in lower Coleman Canyon was not burned to any significant extent. These cover the area of large green bushes and unburned sage (to the left of the bushes) in the center of Figure 62.

Figure 62. View of part of lower Coleman Canyon near the confluence with Hammond Canyon.

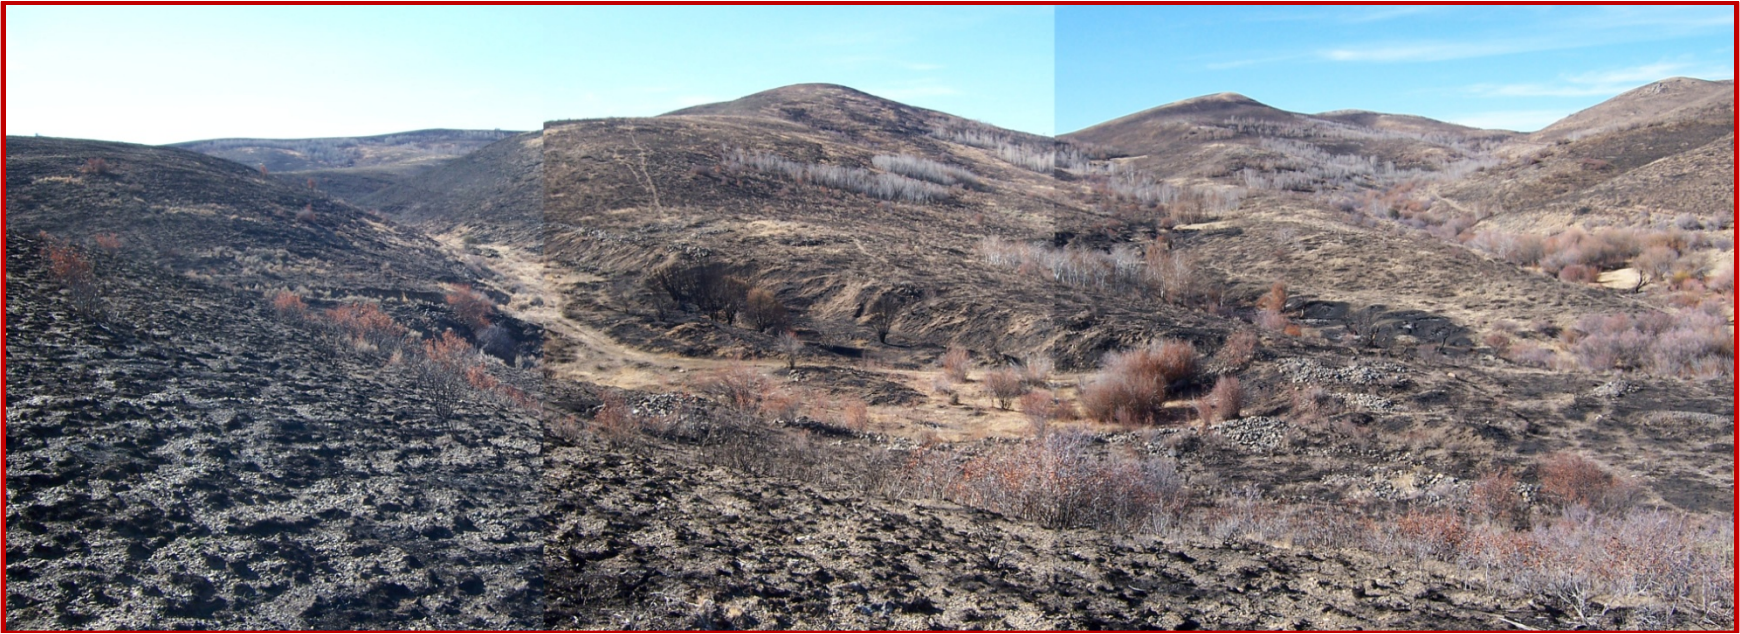
There are smaller workings (defined by various piles of stream cobbles and gravel) along the southwestern unnamed tributary to Coleman Creek, which joins Coleman Creek just south of the collapsed adit, that are burned in excess of 90%. Figure 63 is a panorama of the lower half of this tributary. This tributary also is significant because the upper part of the tributary was the southern terminus of the Chinese Ditch, which was used to supply extra stream water to the Chinese Placer workings. Presumably, the more limited alluvial gravels and cobbles along the tributary contained enough gold to make it worthwhile to move those materials up the slopes of the tributary where the workers could sort and pan through them for metal content. The visible piles likely were neatly stacked to keep the worked material out of the way of further excavations.

It is unknown if any non-building artifacts existed in this tributary area before the fire. Given the extent of the burn in this area, it is unlikely any burnable artifacts would have survived.

Figure 63. View of the lower part of the southwest tributary to Coleman Creek with small Chinese placer workings visible as piles of gravel and cobbles on slopes above the streambed.

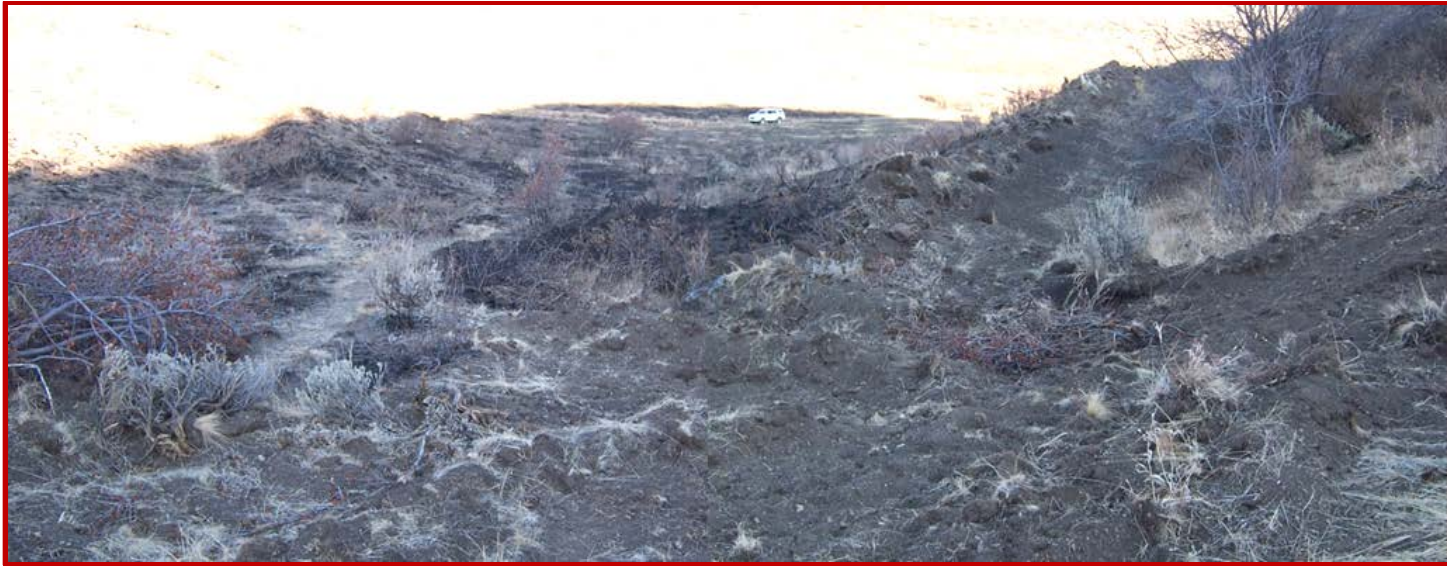
Figure 65. Panorama of the intersection of the Chinese Ditch and the bulldozer firebreak.

The unaffected parts of the Chinese Ditch can be seen on the far left side of Figure 65 and in the background of Figure 69. The bulldozer firebreak intersected the ditch at the cattle path up the center of the tributary.

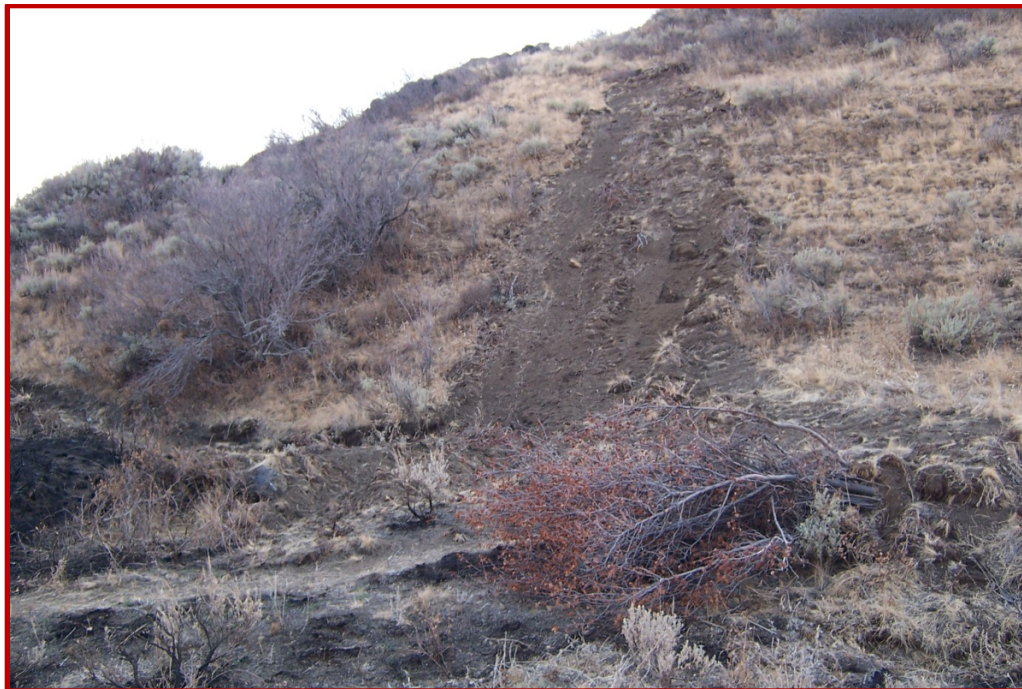
Figure 66. Short section of intersecting firebreak cut up the hillside above the Chinese Ditch.

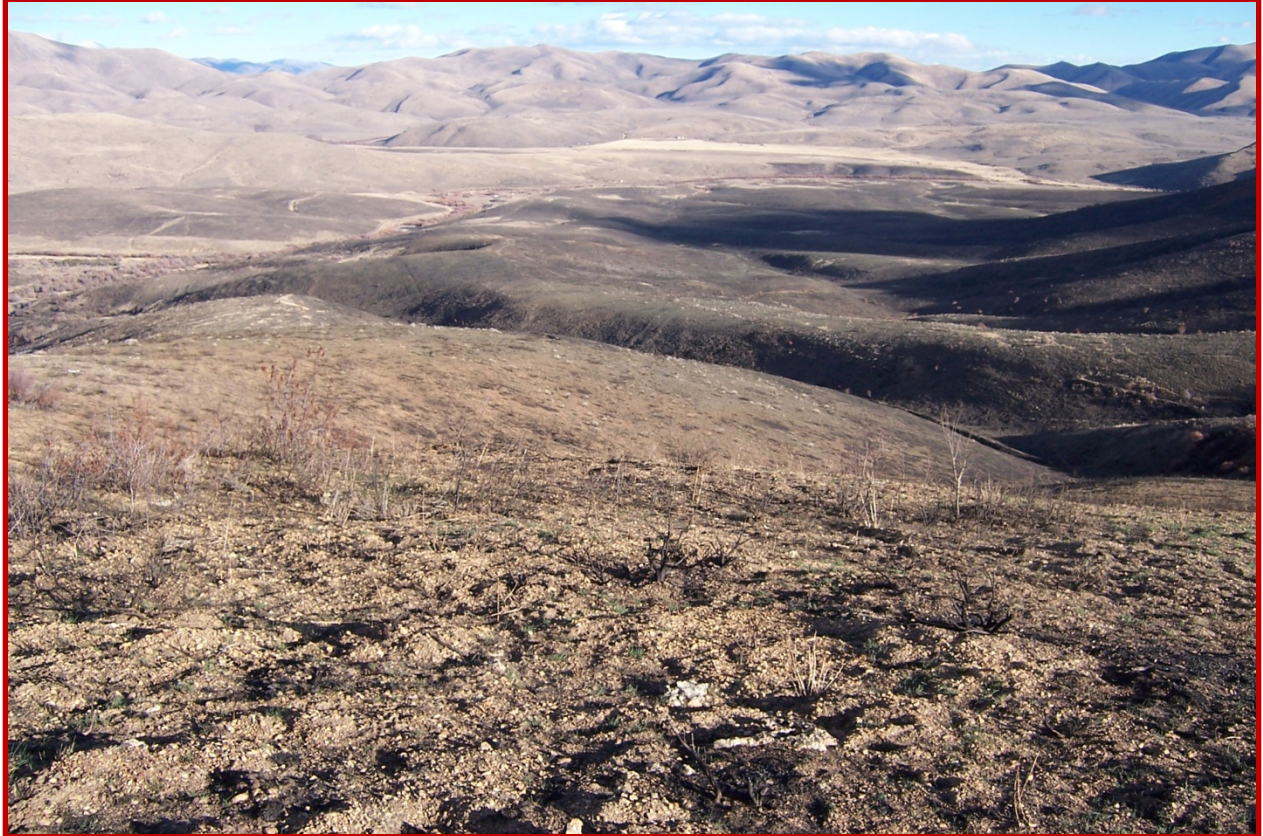
The Gold Creek Placer patented claims could not be directly assessed because they are behind locked gates at both the northwest and south fence entrances. Nonetheless, from a distance (Figure 70), it appears that the Gold Creek placer area was mostly unaffected by the fire. The northern and middle parts of the placer area appear to not be burned based on the light brown colors of the vegetation in those areas and on the hill to the east of Gold Creek. The southern third of the placer claims area may have been at least partially burned based on the fact that the hill immediately to the east between the creek and Gold Creek Road was burned (upper right part of Figure 70).

Figure 70. View of the southeastern part of the Island Mountain property, Gold Creek Placer area, and extent of burned area to the southeast. The southern terminus of the Chinese Ditch is partially visible at middle right.
